Safety Advisory SA01/24

Consideration of extreme weather events in safety management systems

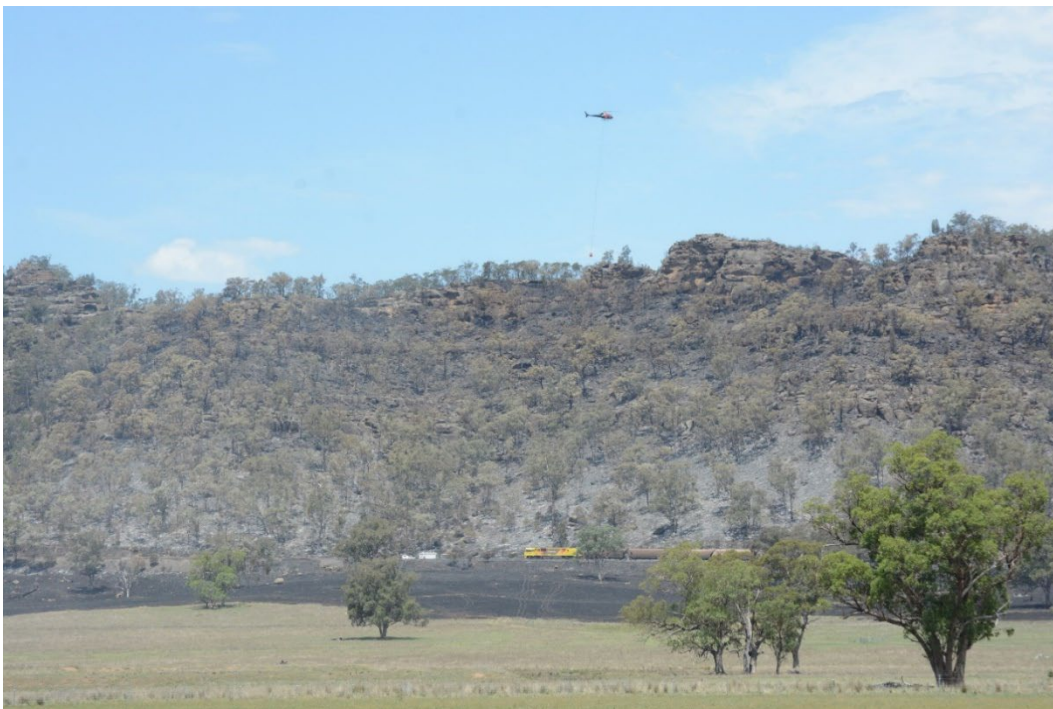
On 6 December 2023, freight train WG185 derailed on approach to Murrumbo crossing loop on the Ulan line in the Hunter region of NSW. Approximately 20 empty wagons derailed during the incident, damaging two kilometres of track infrastructure. The derailment also sparked a wildfire which impacted neighbouring private land and the Wollemi National Park.

Figure 1: Murrumbo Valley derailment site and fire ground

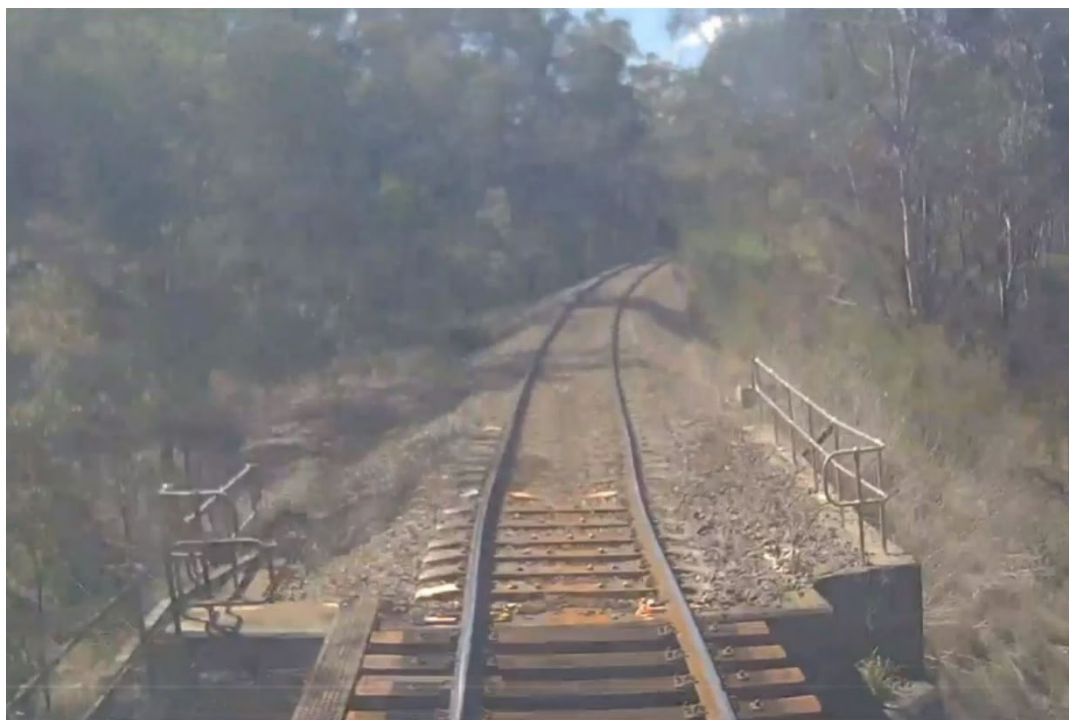
- A track misalignment was observed at the Bylong Valley Way overpass.
- The temperatures in the area at the time of the incident reached a recorded maximum of 40.1°C.
- High temperature speed restrictions were enacted in areas designated as special locations.
- Bylong Valley Way overpass was not a designated special location.
- As required under the rail infrastructure manager's procedure, the train crew contacted network control to report concerns about the condition of the track at Bylong Valley Way, unaware that the train had already derailed.
- On reaching the points at the Murrumbo crossing loop, the derailment worsened, resulting in the decoupling of wagons which caused the train to automatically come to a stop.

Figure 2: View of the track buckle (367.538 km) at Bylong Valley Way overpass

- Ensure risk management for extreme weather events and track stability is current and considers Bureau of Meteorology advice for predicted events throughout the year.
- Remind rail safety workers to remain vigilant and continually assess the condition of the track and make timely reports of any defects to network control.
- Ensure rail safety workers' induction and refresher training includes sufficient operational information for identifying and traversing track defects (such as buckles).
- Ensure rail transport operators' emergency management plans are current, routinely practised and provide information relating to seasonal hazards and the roles and responsibilities of each rail safety worker during an emergency response, including scenarios where external agencies may assume jurisdictional control over the incident.

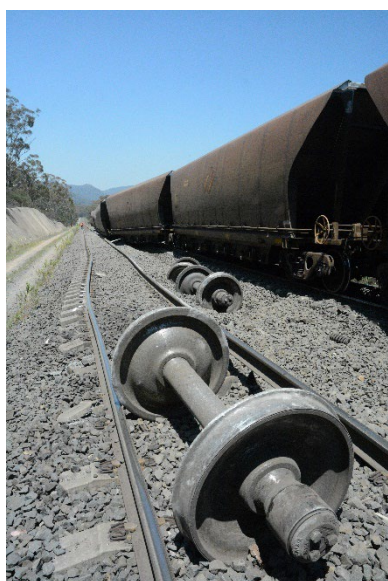
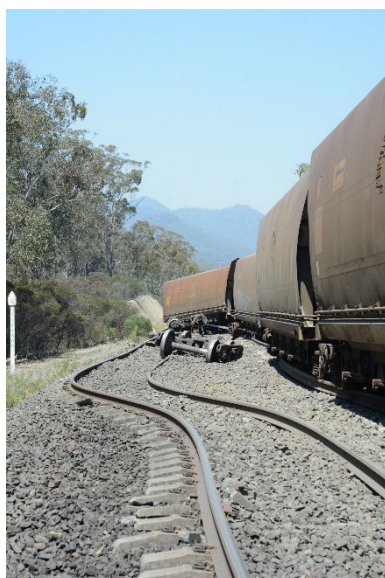
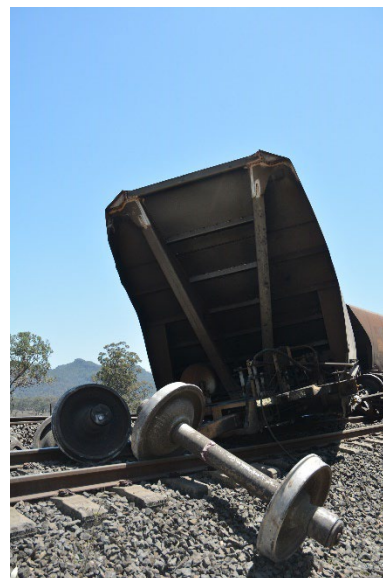
Figure 3: View of the wreckage at Murrumbo crossing loop
