Bus Safety Investigation Report

Bus Fire MO9994 — Green Valley, 8 August 2022

Published
March 2024

Investigation Reference I02028

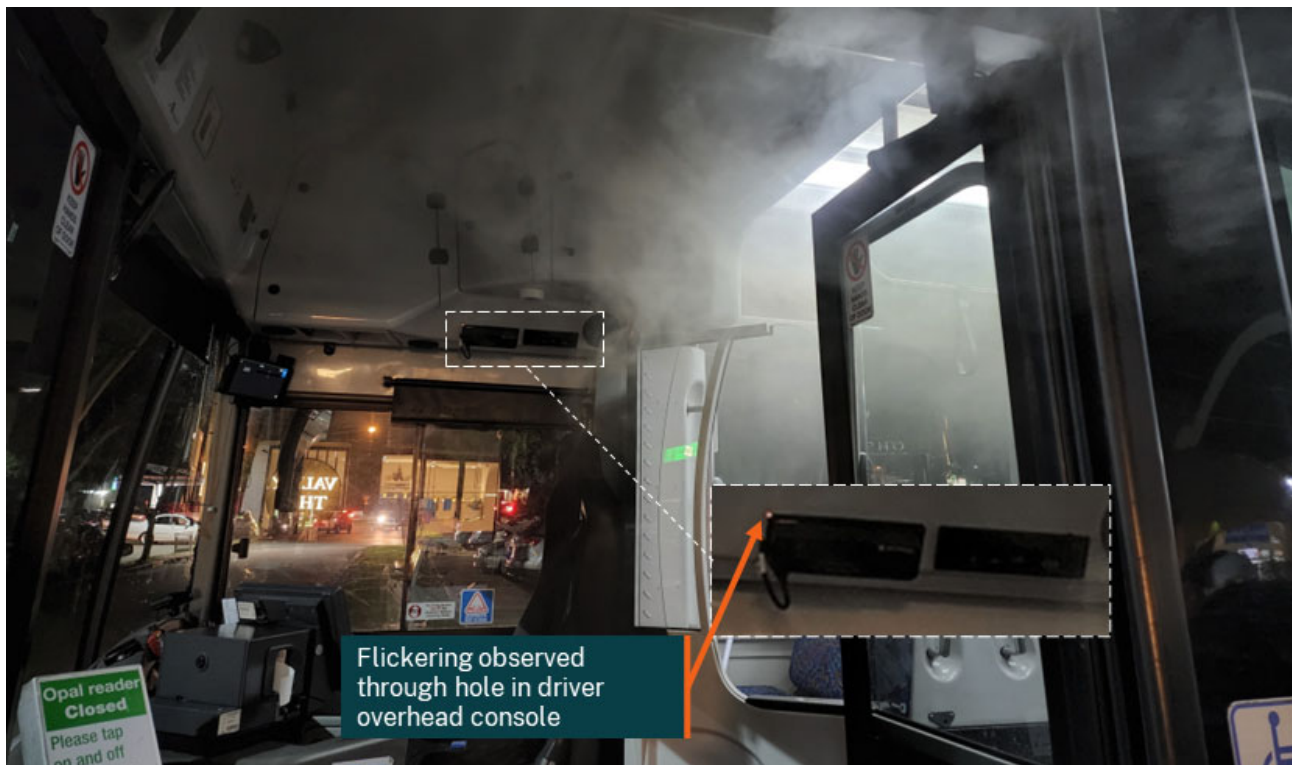
Figure 1: Illumination in the overhead console observed by the driver

- 1.9 At approximately 1814, while investigating the bus exterior, the driver, who was standing near the open front doors, looked into the bus and observed what they later described as 'sparkling' near the radio above the driver's seat (Figure 1). The driver commenced recording the smoke using the video function of their personal mobile phone.

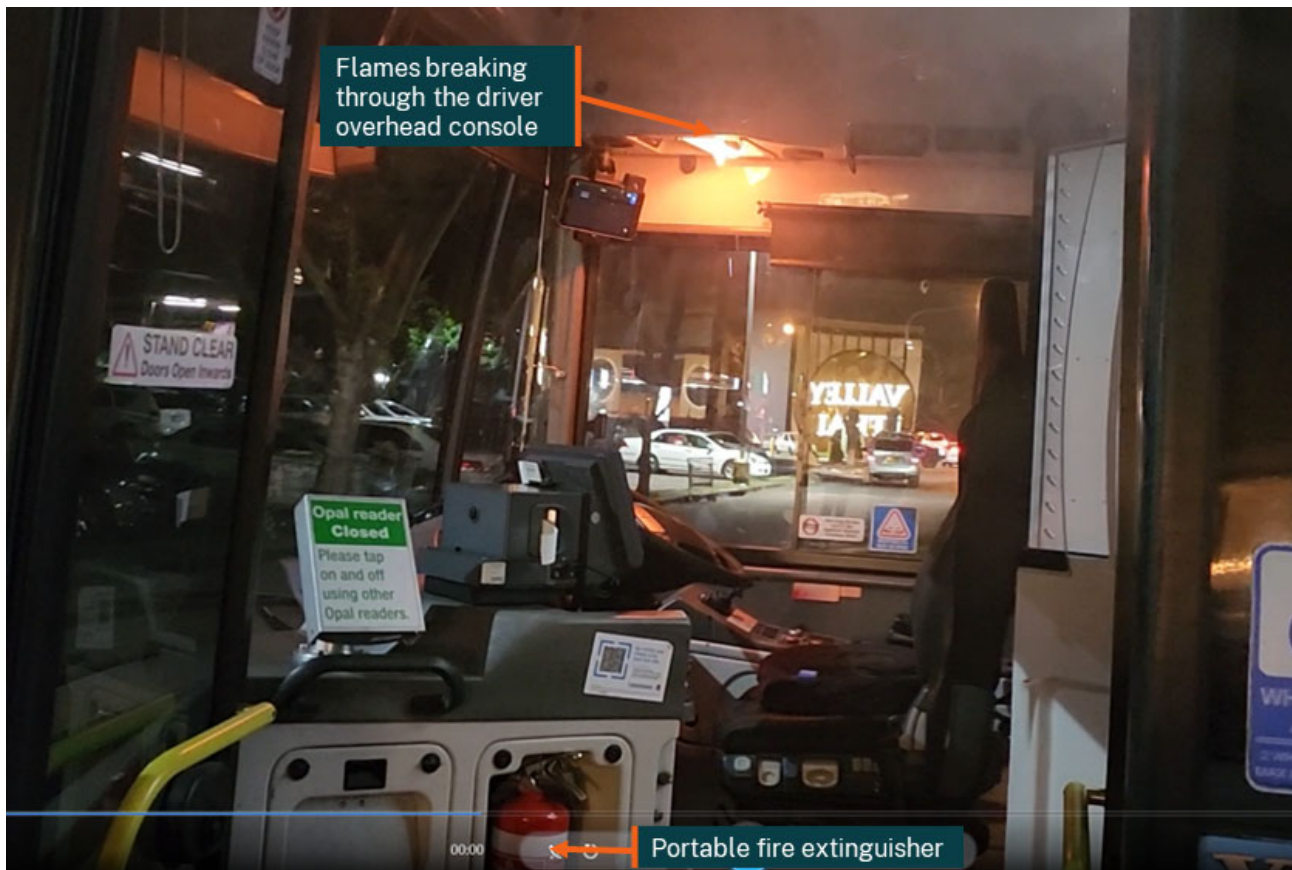
Figure 2: Flames breaking through the overhead console panel

- 1.10 The driver, concerned about what they observed, called the company control centre on their mobile phone. As the driver spoke to the radio room, they noticed the 'sparkling' turn to flames. The company controller informed the driver to hang up as they would call emergency services.
- 1.11 The driver entered the bus and instructed the remaining three passengers to disembark. The driver retrieved their own belongings from the driver's position and exited.
- 1.12 While waiting for emergency services, the driver observed flames intensify in the console above the driver's seat (Figure 2). The driver did not discharge the onboard fire extinguisher.

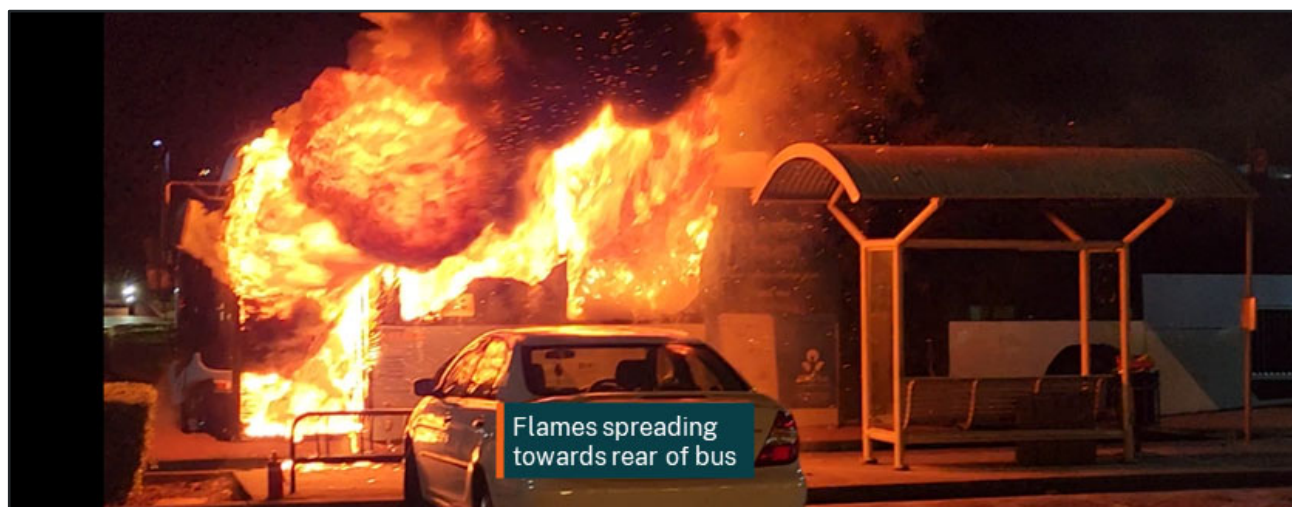
Figure 3: Escalation of fire

1.13 By 1819, the salon of the bus was filled with black smoke and flames, which spread to the ceiling inside the forward section. Shortly after, the flames spread to the bus exterior, through the forward passenger windows and front door. The fire engulfed the bus before Fire and Rescue NSW arrived (Figure 3, Figure 4).

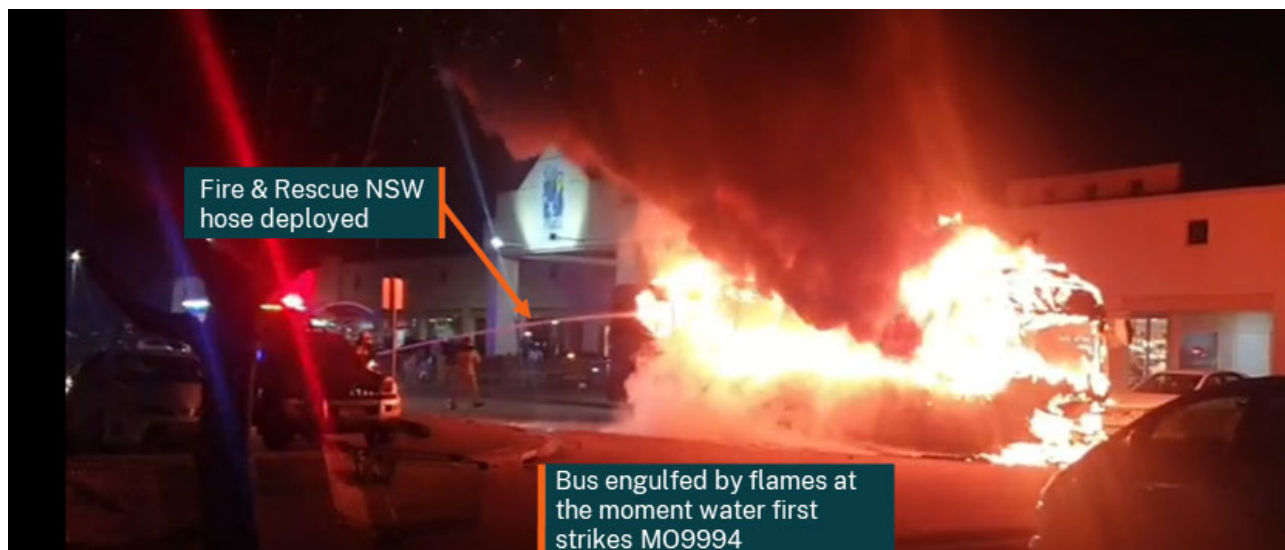
Figure 4: MO9994 engulfed in flames when fire hose first deployed

1.14 Fire and Rescue NSW extinguished the fire. The bus was destroyed.

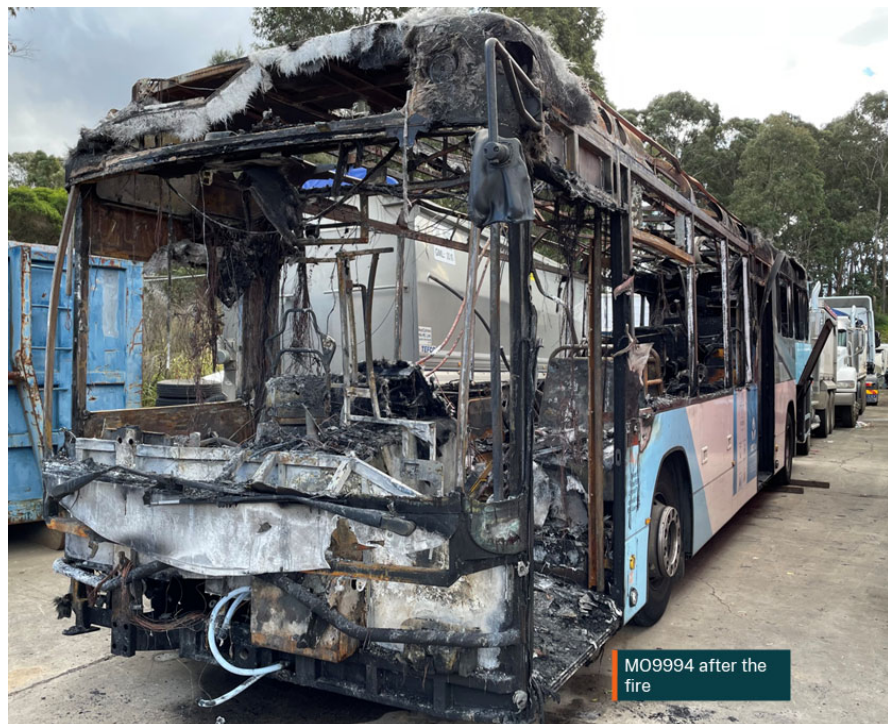
Figure 19: M09994 after the fire

- 2.6 Footage from the bus closed circuit television system could not be reviewed due to fire damage of the associated hard drive.
- 2.7 The bus body was destroyed by fire. The lower external body panels below the window line were still intact (Figure 19).

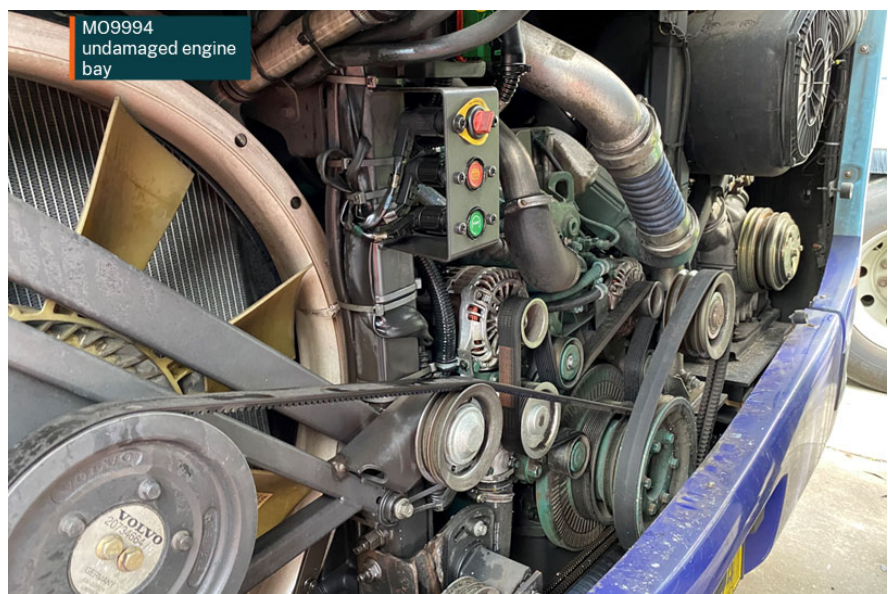
Figure 20: Undamaged engine bay

- 2.8 The engine bay area was undamaged by fire (Figure 20).

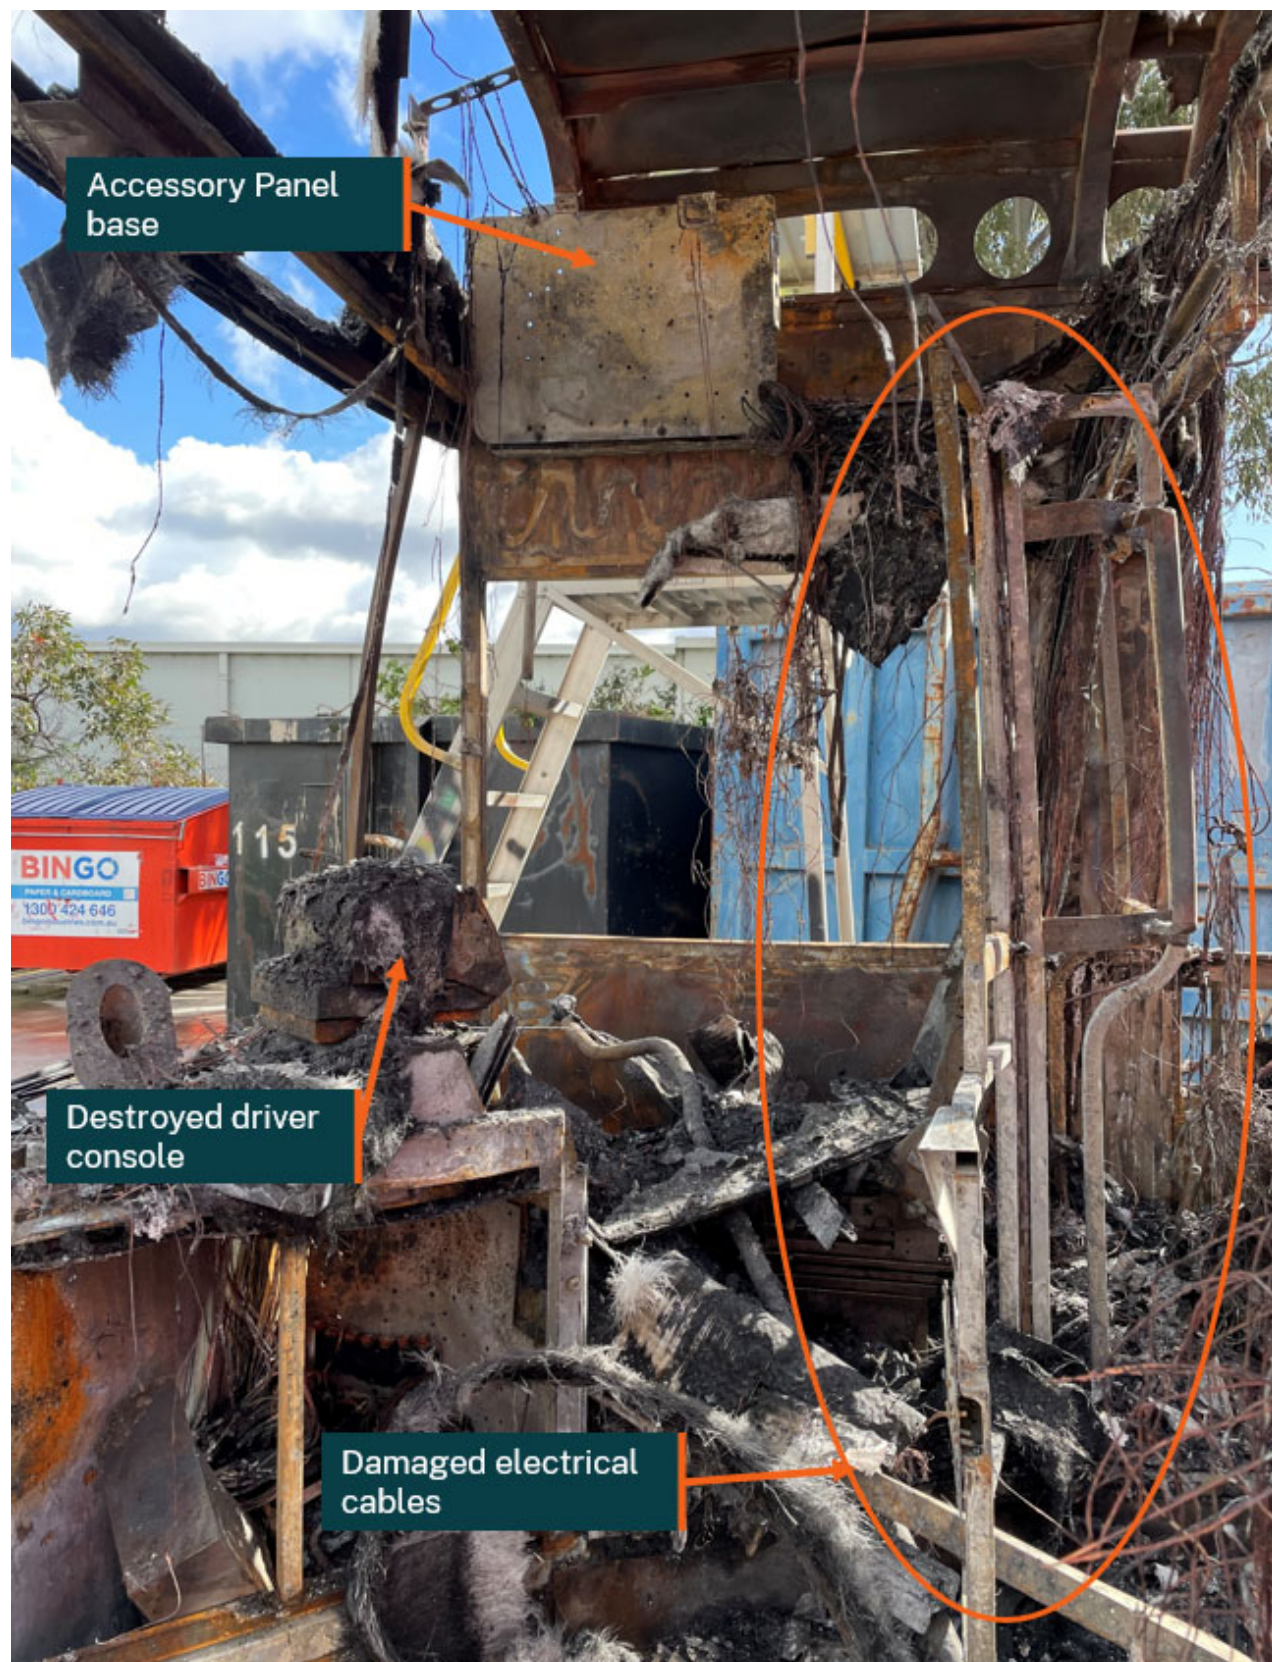
Figure 21: Damage to driver's position and overhead Accessory Panel

- 2.9 An inspection of the driver's cabin identified fire damaged electrical cabling, near the Accessory Panel above the driver's seat (Figure 21).

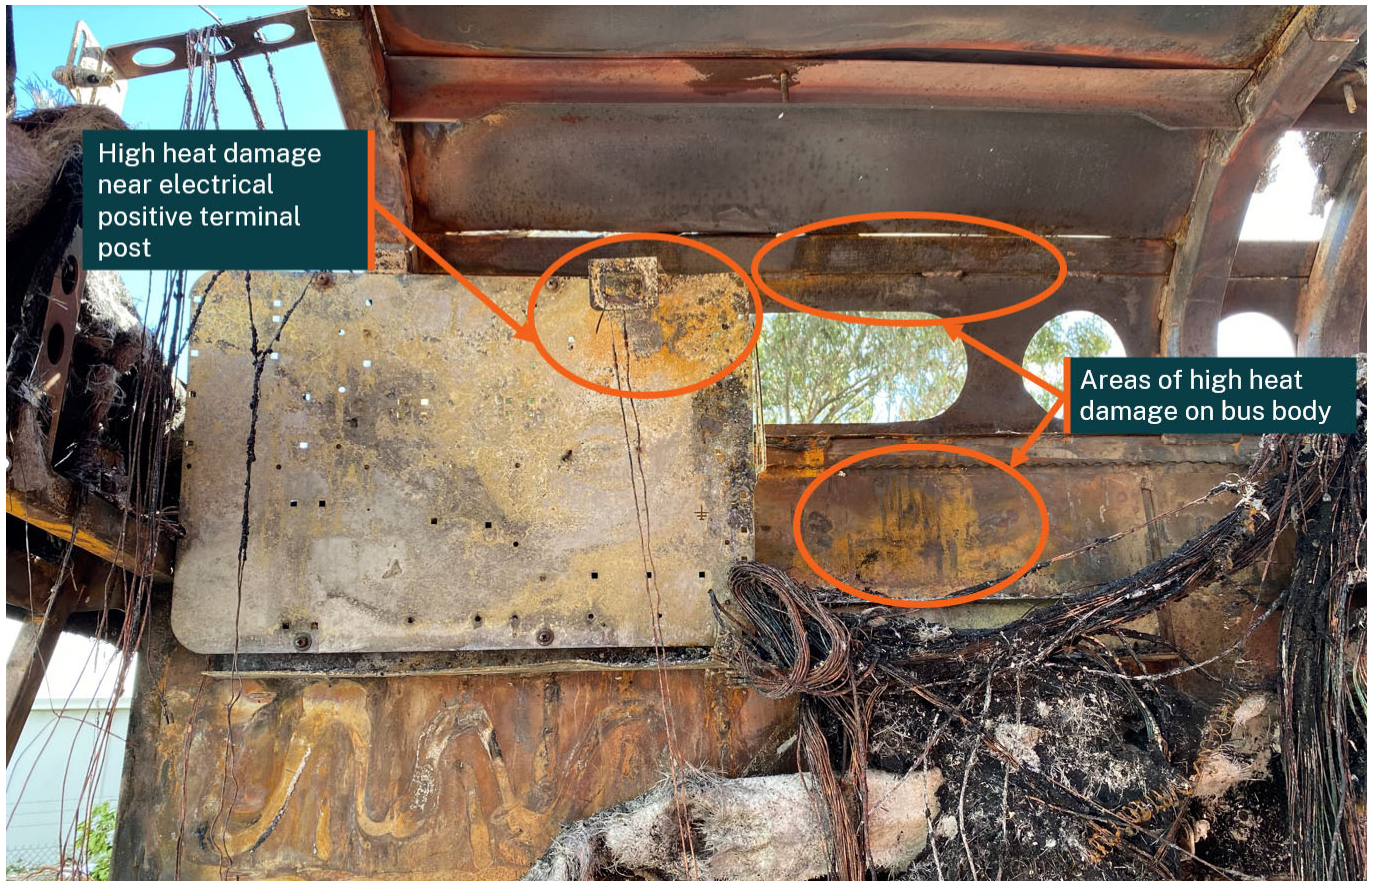
Figure 22: Heat damaged Accessory Panel

The investigation identified that an electrical fault within the Accessory Panel, located above the driver’s position, likely generated heat which ignited surrounding combustible material, resulting in an intense fire. The Accessory Panel electrical circuit on the involved bus, and two exemplar buses inspected as part of the investigation, were not adequately protected from over current faults, such as a short circuit. The fuse protecting the circuit exceeded the ampacity of the associated cables.

2.10 Inspection of the Accessory Panel identified evidence of high heat damage on the panel base plate, near the power supply positive post (Figure 22). All components mounted on this panel were destroyed. Heat patterns on the bus body panels, to the rear of the Accessory Panel, indicated areas of more intense heat.

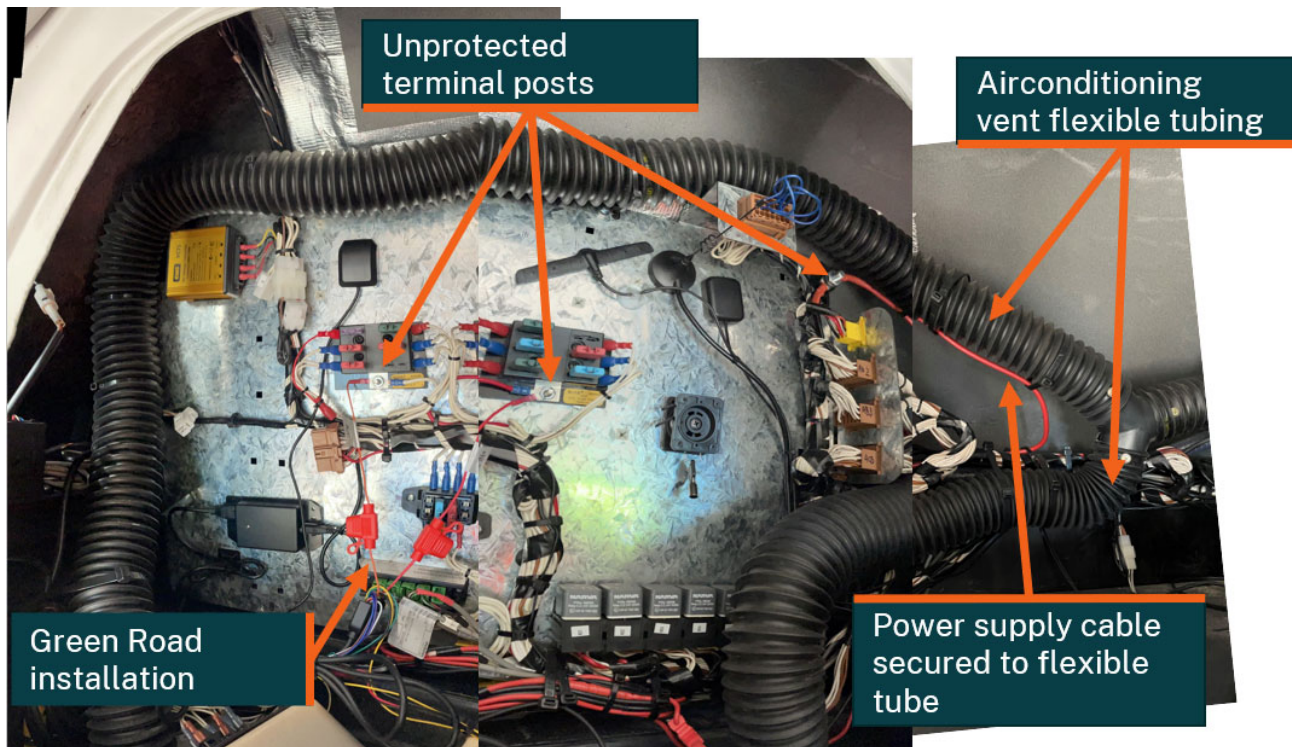
Figure 23: Internal layout of Accessory Panel in exemplar bus M09992

- 2.11 OTSI identified several uninsulated terminal posts on the Accessory Panel in the exemplar buses. These unprotected posts increased the risk of an electrical short circuit⁹ when the circuit was live if contact was made with conductive materials.
- 2.12 Electrical arcing was evident on the cable likely connected to the main B+ terminal post of the Accessory Panel located above the driver's position.
- 2.13 OTSI noted that the air conditioning flexible tubing in exemplar bus M09992 was mounted near metal components, including unprotected terminal posts, and associated wires on the Accessory Panel (Figure 23, Figure 24). The flexible tubing was constructed of a continuous wire coil covered in plastic.

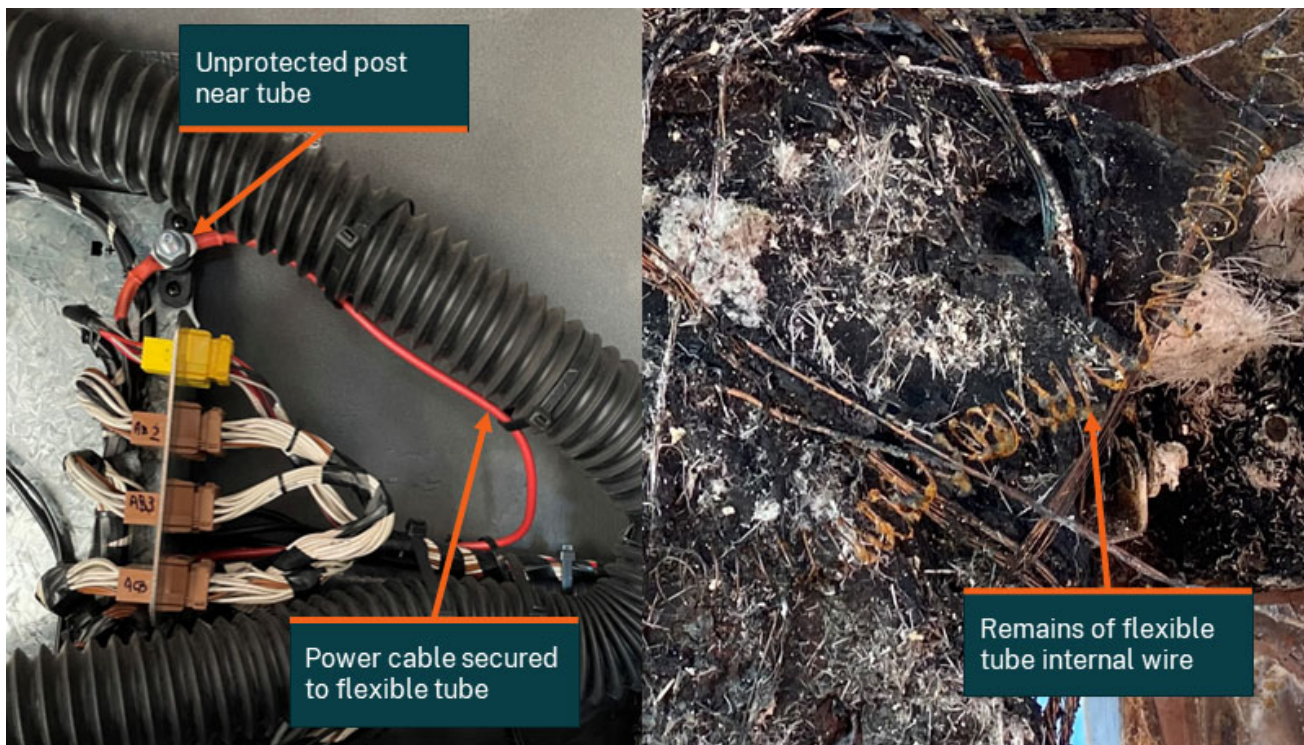
Figure 24: Flexible tubing proximity to unprotected post in exemplar bus and M09994

2.14 Movement of this tubing against other surfaces, due to vibration from the bus travelling over irregular road surfaces, could potentially cause abrasion damage to the tubes, exposing the

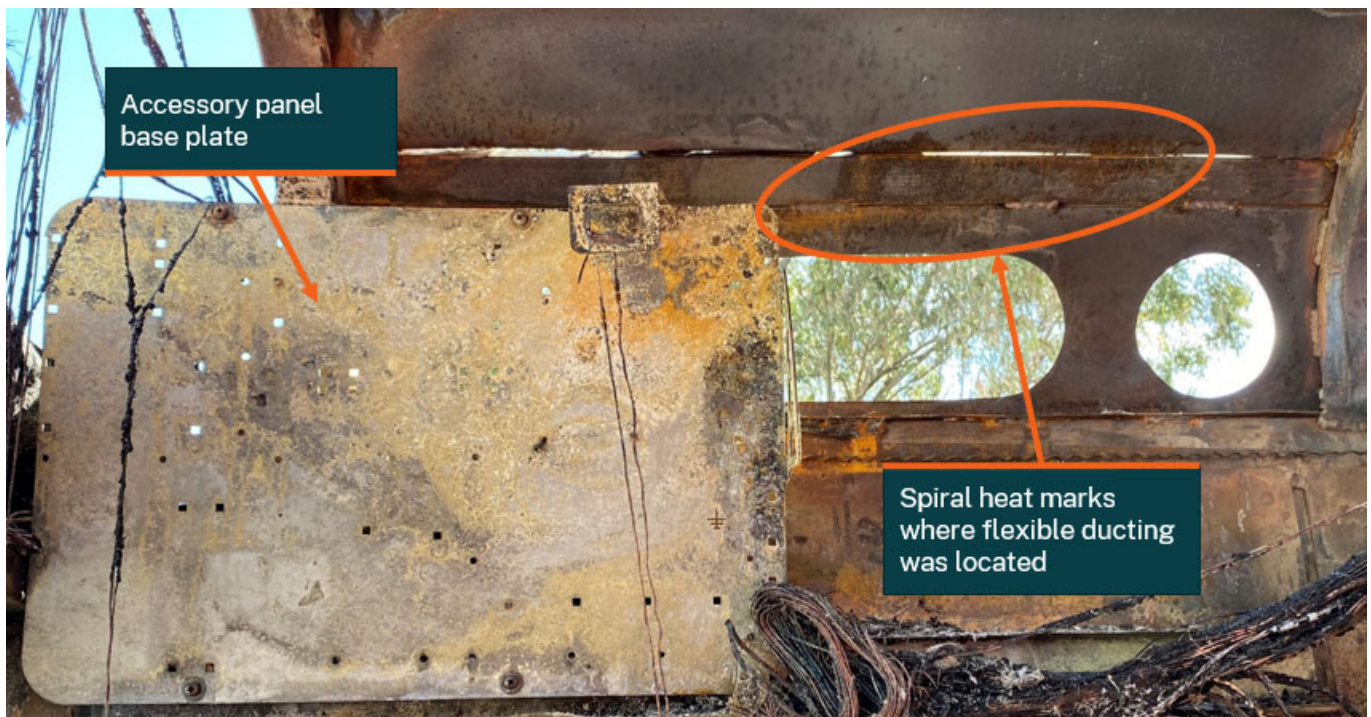
Figure 25: Spiral heat markings on bus body

- 2.15 Heat generated in the components by a short circuit increased the risk of nearby combustible materials igniting, resulting in a fire. A closer examination of the heat damage in the area around the Accessory Panel revealed a heat pattern that matched the shape of the flexible tube coil (Figure 25).

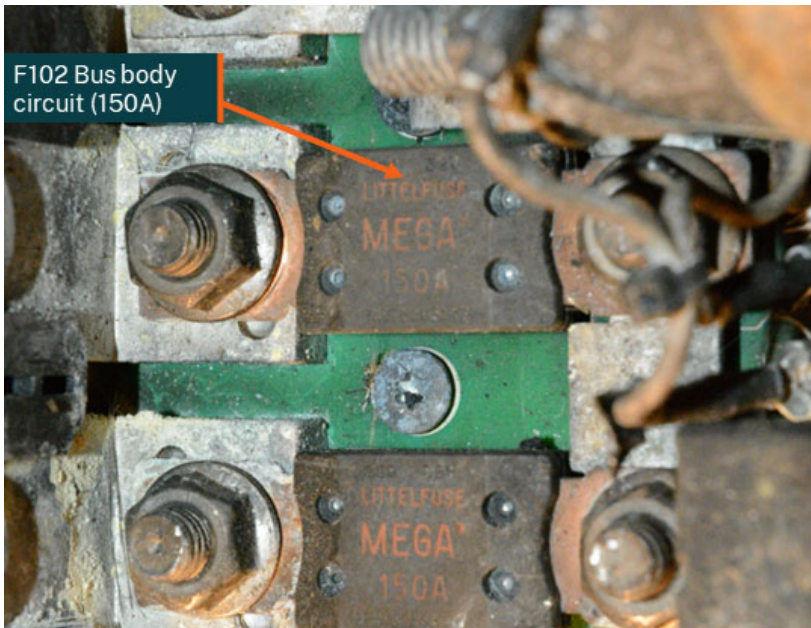
Figure 27: MO9994 fuse F102 post fire

2.21 The investigation determined that the F102 fuses fitted on MO9994 (Figure 27) and two exemplar buses were rated at 150-amp.

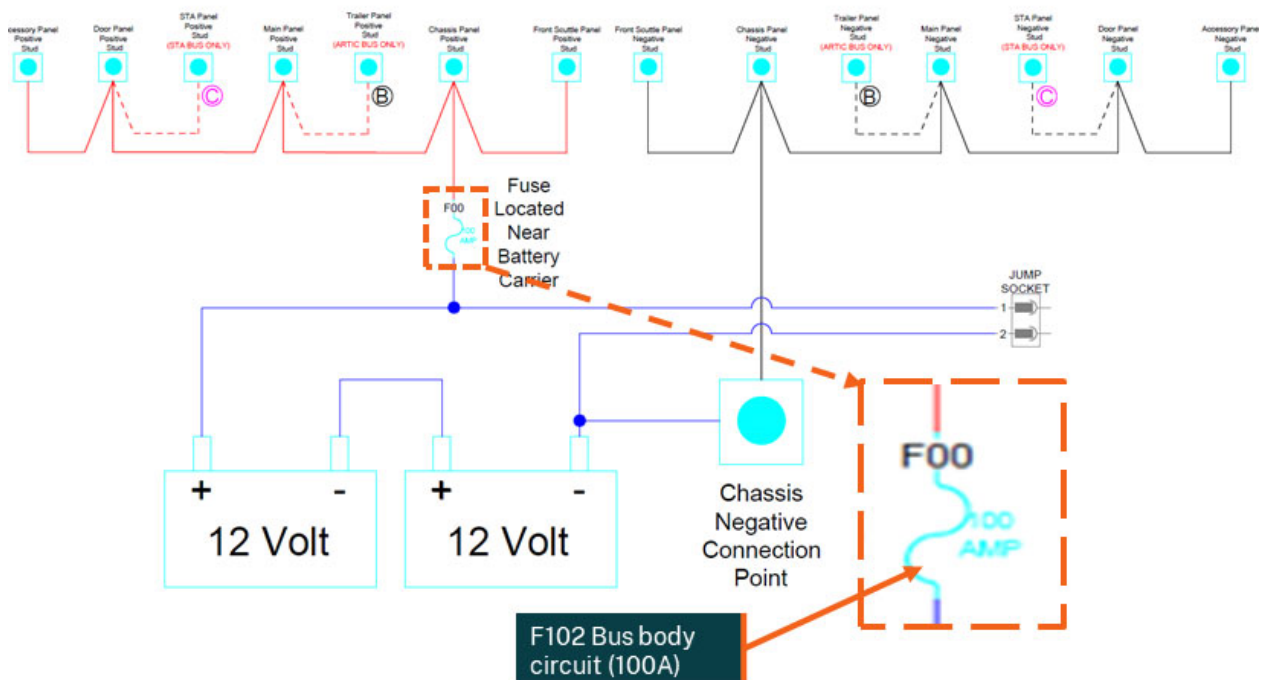
Figure 28: Custom electrical drawing for chassis to bus power supply

2.22 A review of the Custom Metro CB80 Electrical Drawings documented a 100-amp fuse for the F102 Bus body circuit (Figure 28).

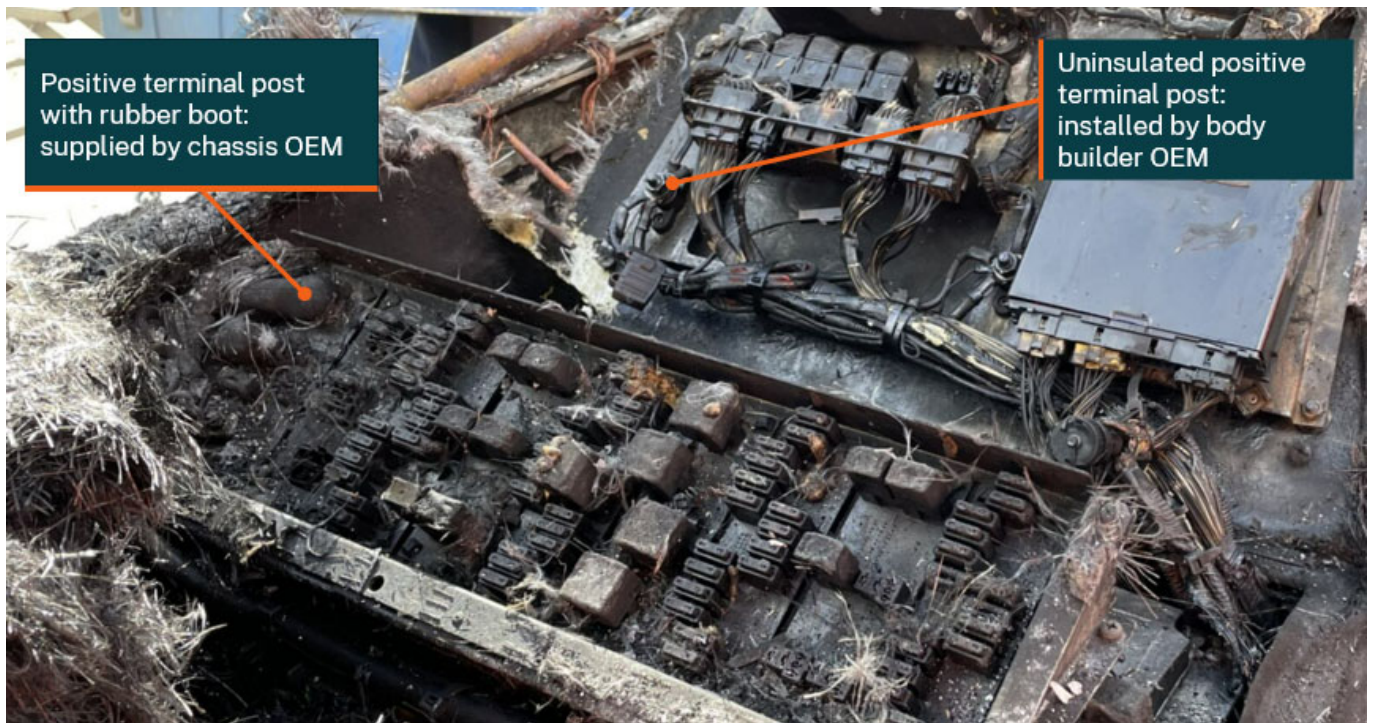
Figure 30: M09994 electrical chassis centre post incident

- 2.25 The 4 B&S cable was connected to the Chassis Electrical Centre at an uninsulated metal terminal post (Figure 30), which had been installed by the body builder OEM. OTSI noted that the positive terminal post supplied by the chassis OEM was fitted with a rubber boot.

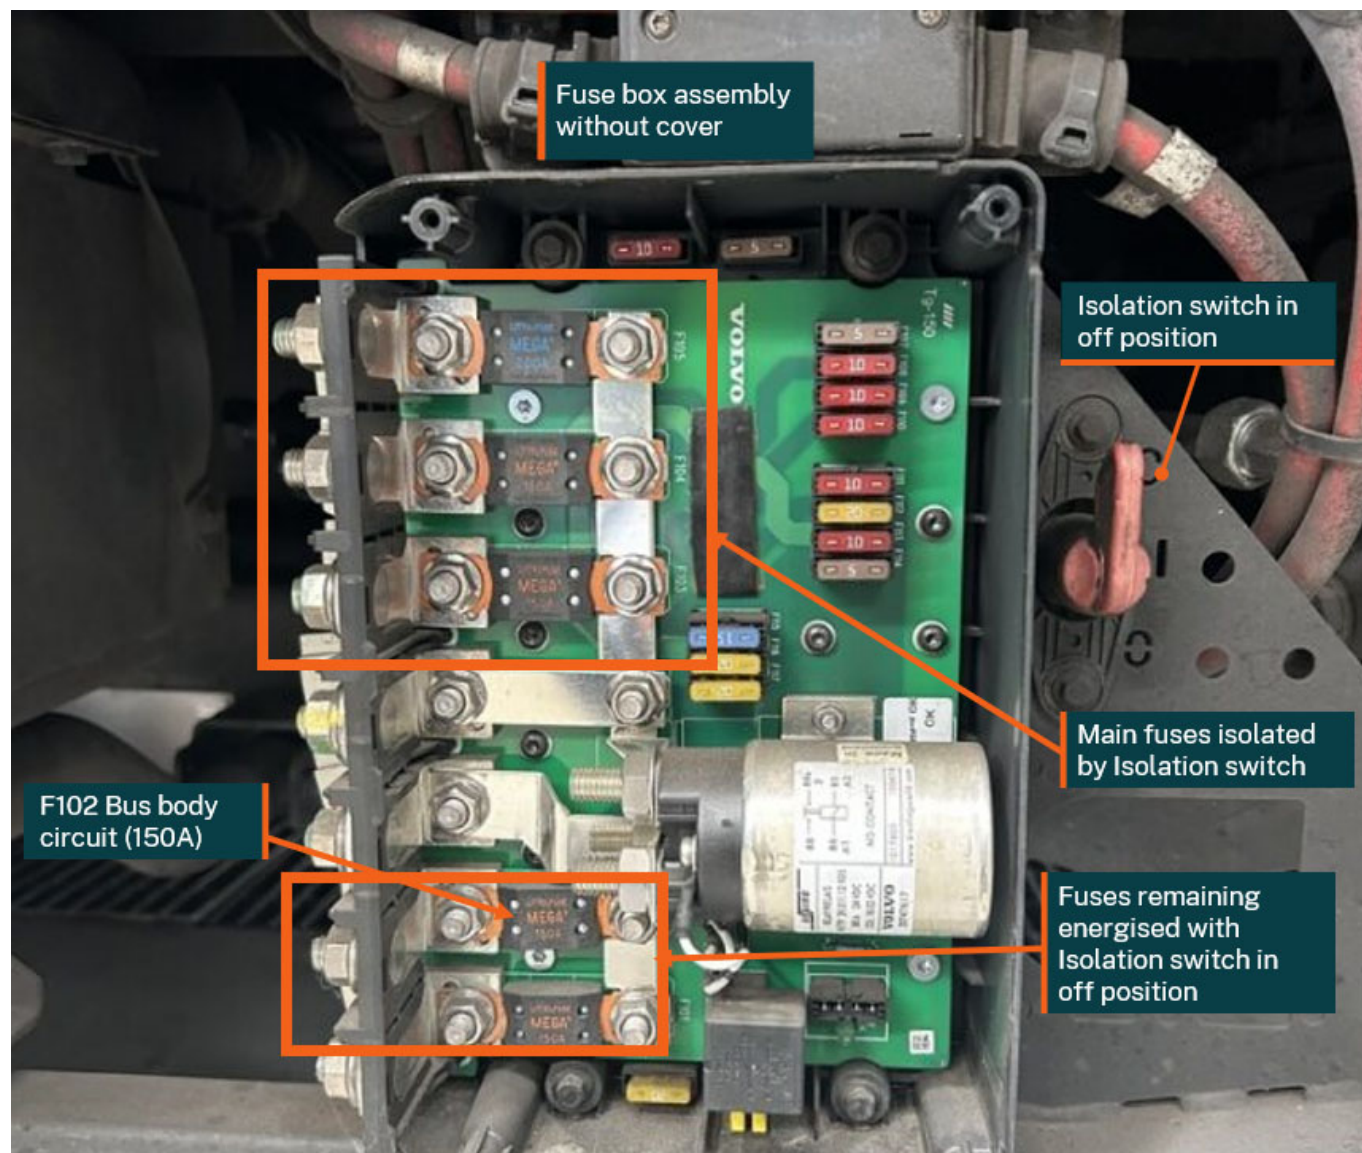
Figure 32: Volvo fuse box in an exemplar bus showing circuit isolation configurations

- 2.31 OTSI performed a series of tests, which involved first isolating the one and/or both switches on the driver console (Figure 12), then isolating the mechanical isolation switch next to the fuse box (Figure 13).
- 2.32 The isolation of one, two or all three of these switches had no effect on the continued electrical supply to the bus body circuit (Figure 32, Figure 33). The batteries could only be isolated from the bus body by using tools to remove the associated fuse or physically disconnecting the battery leads.

- 3.5 The electrical circuit isolation design and configuration of the involved bus, and two exemplar buses, did not allow isolation of the Accessory Panel circuit, resulting in inadequate system protection from ongoing provision of a source of energy for the escalation and propagation of fire from an electrical short circuit in that location.
