# Bus Safety Investigation Report

Collision between buses m/o9982 and m/o1531  
Campsie

20 March 2024

Released under the provisions of  
Section 45C (2) of the *Transport Administration Act 1988* and  
Section 46BBA (1) of the *Passenger Transport Act 1990*  
Investigation Reference I02041

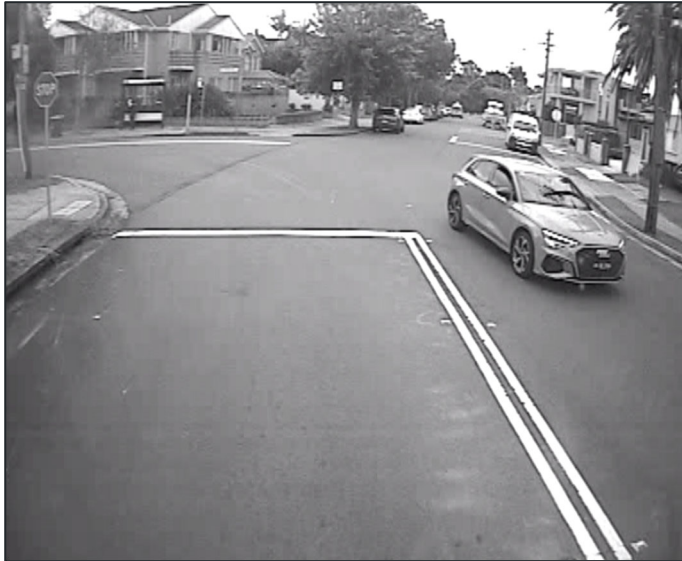
**Figure 1: Recorded position of bus m/o1531 at 1616:40 from the forward-facing CCTV camera<sup>2</sup>**

At 1616:42, the driver of bus m/o1531 continued through the STOP sign and solid line marking at the intersection of Beamish Street and Seventh Avenue, without stopping or slowing the vehicle. There was no directly conflicting traffic.

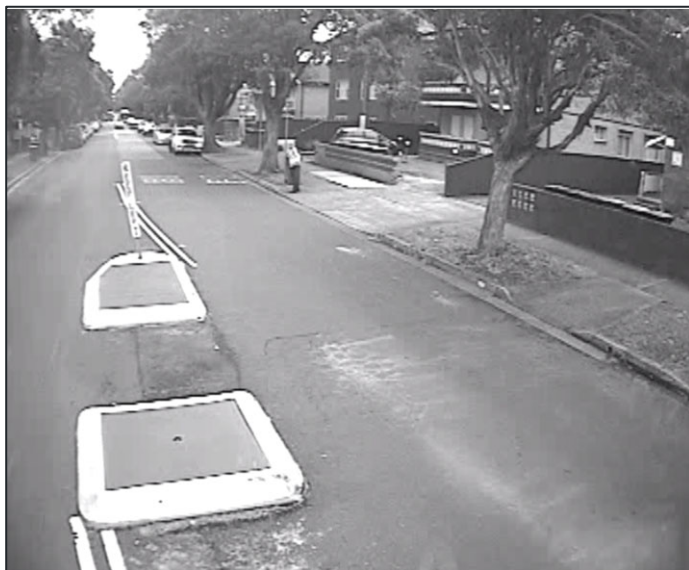
The driver conducted a left turn into Seventh Avenue, to travel in a westerly direction, which was in accordance with Route 410. The bus's indicator was activated, then deactivated. The forward-facing CCTV camera recorded the bus's line of travel into Seventh Avenue as directly approaching two traffic islands in the centre of the road, which were positioned about 22 m in from the intersection. At that time (1616:49), the recorded speed of the bus, based on GPS data, was 12 km/hr (Figure 2).

**Figure 2: Recorded position of bus m/o1531 at 1616:49 from the forward-facing CCTV camera**

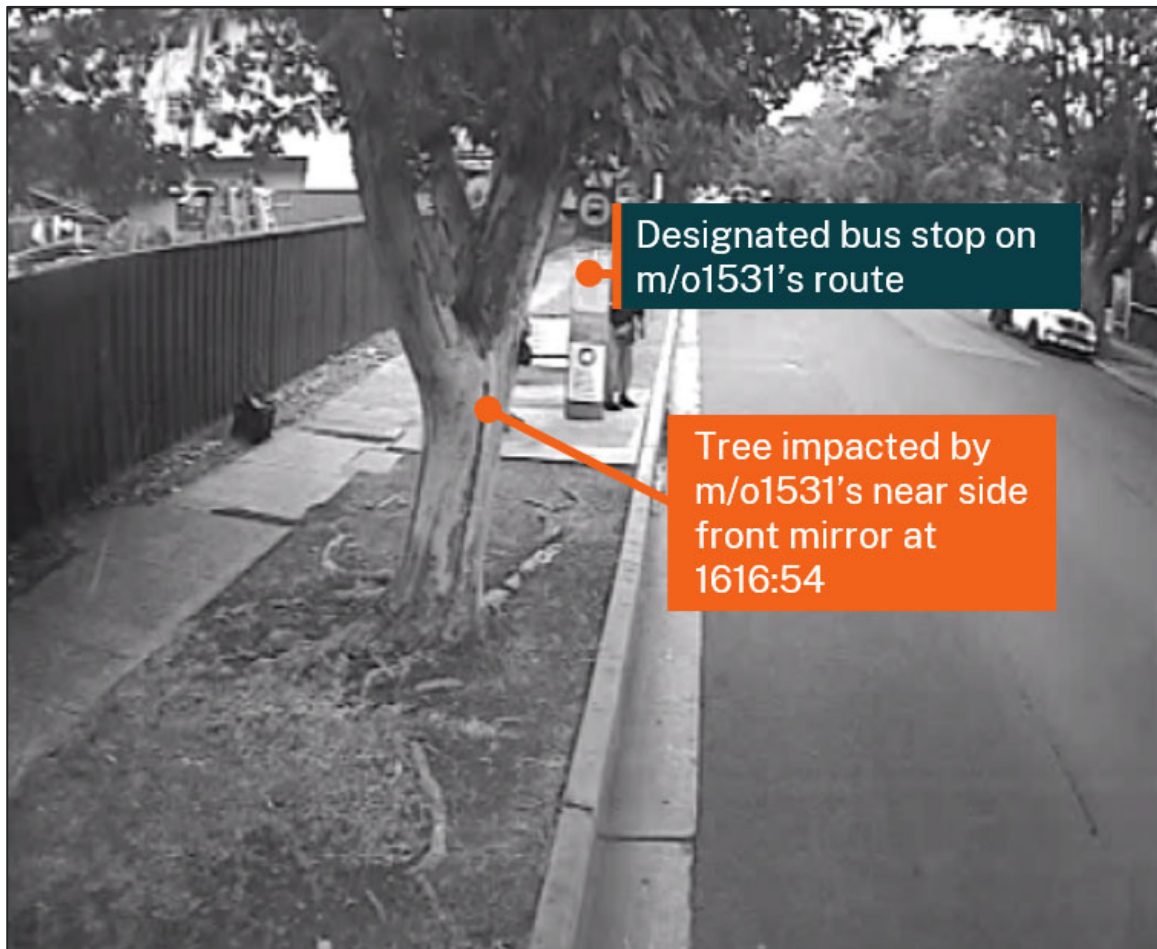
Just before the bus stop located at Seventh Ave after Beamish Street, the front near side<sup>3</sup> external mirror of the bus hit a tree, which was planted on the nature strip (Figure 3). The part of the tree impacted was not directly overhanging the road but offset from the kerb. The impact removed the bus's mirror and housing, which then travelled down the exterior near side of the bus before landing on the ground.

**Figure 3: Recorded position of bus m/o1531 at 1616:54 from the forward-facing CCTV camera, immediately before mirror impact with the tree**

At the bus stop, which was a designated stop on Route 410 (Figure 3), two people were waiting to board the bus. They were recorded on the bus's forward-facing camera as quickly moving back from the kerb, after the bus's mirror collided with the tree.

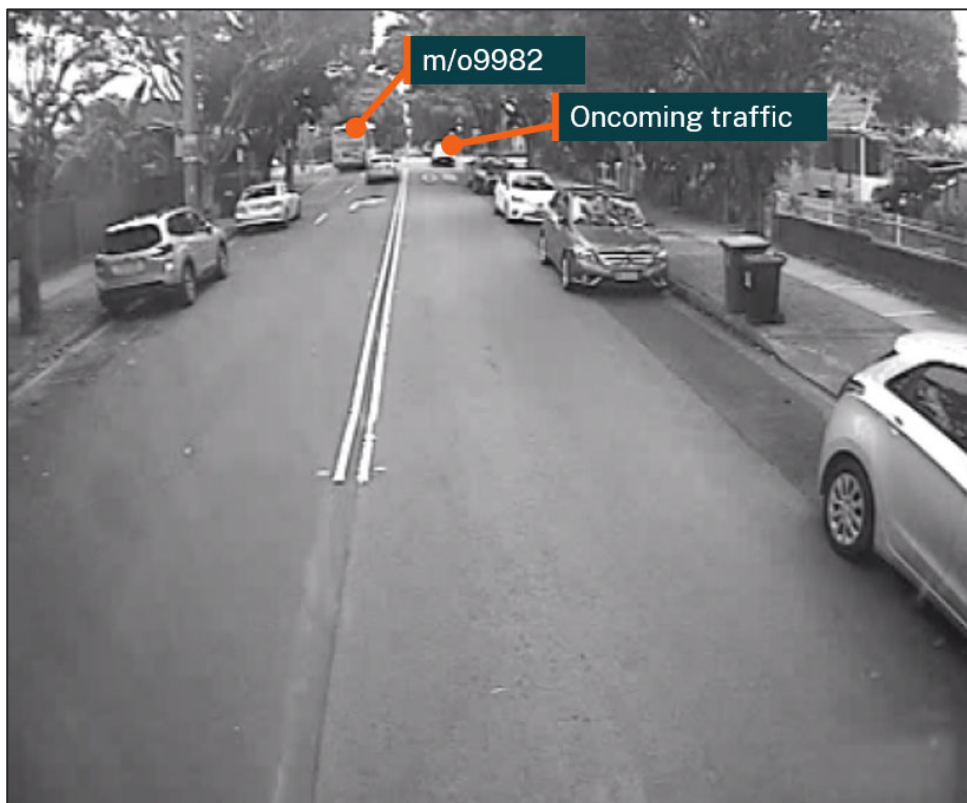
After the roundabout, at 1617:11, the onboard CCTV system recorded the bus travelling over the centreline on Seventh Avenue, into the oncoming lane. There was oncoming traffic travelling in an easterly direction down Seventh Avenue. Bus m/o9982 was entering the intersection ahead (Figure 4).

**Figure 4: Recorded position of bus m/o1531 at 1617:11 from the forward-facing CCTV camera**

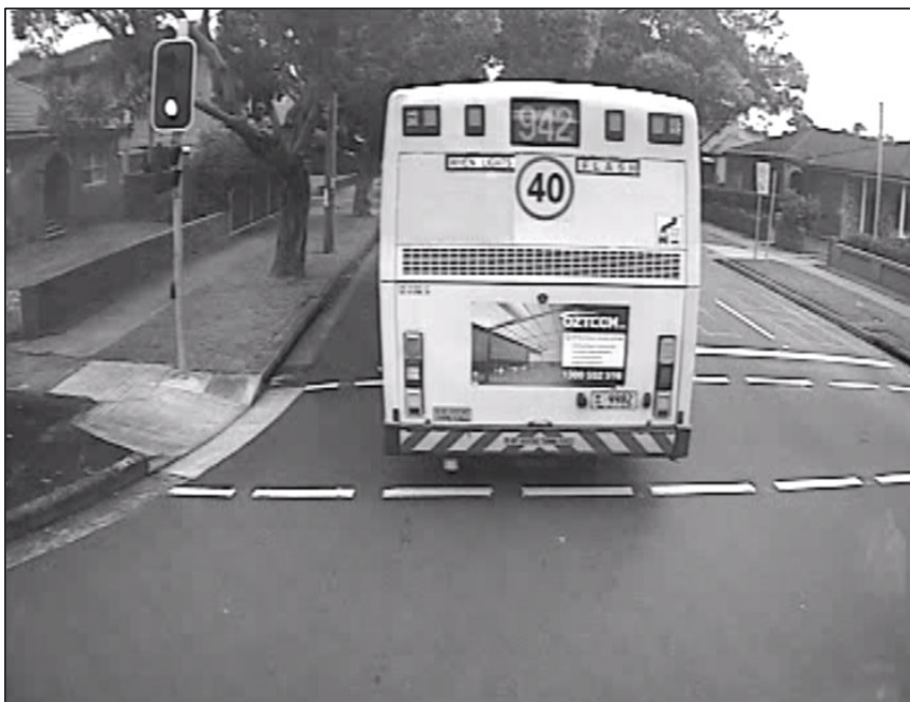
The rear of m/o9982 was within the marked pedestrian crossing and not obstructed from view to traffic behind (Figure 6). There was no oncoming traffic recorded in the two lanes to the right of m/o9982.

**Figure 6: Recorded position of bus m/o9982 at 1617:15 from the forward-facing CCTV camera onboard bus m/o1531**

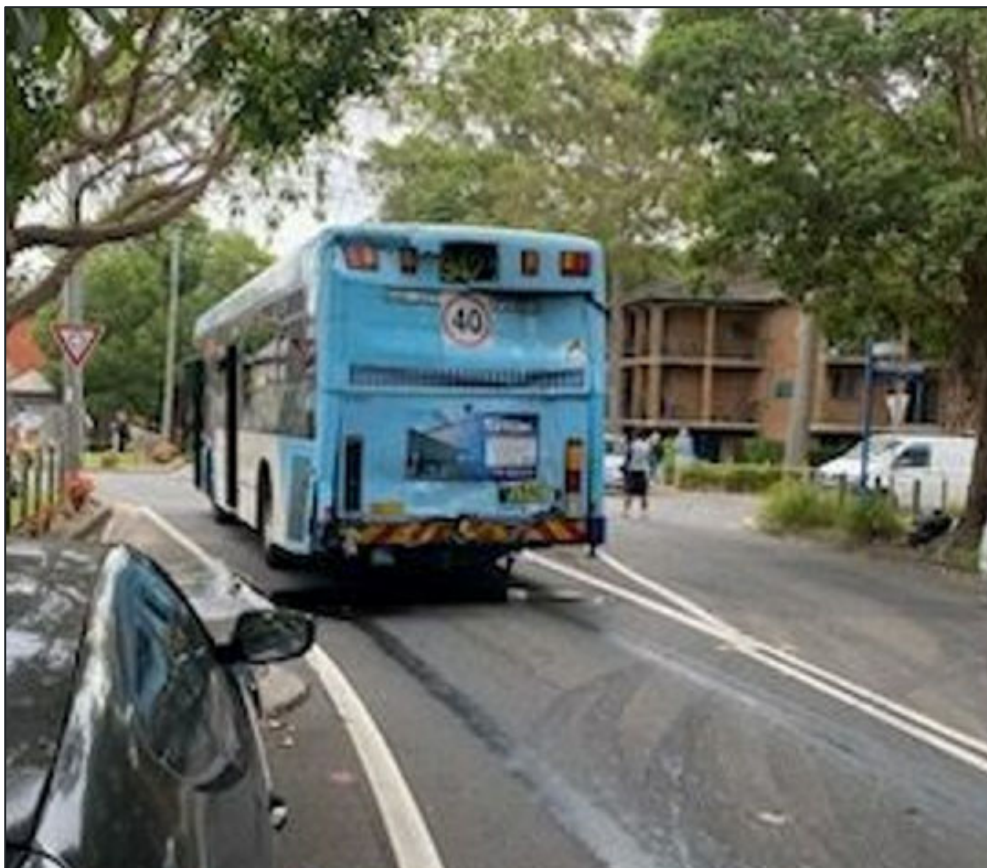
Bus m/o9982 then travelled further down Seventh Avenue, separating from the front of m/o1531 and stopping before the roundabout intersecting Seventh and Fourth Avenues, which was approximately 95 m from the point of collision (Figure 7). The doors of this bus were not damaged in the incident and were used for passenger evacuation.

**Figure 7: Final position of bus m/o9982 after the collision**

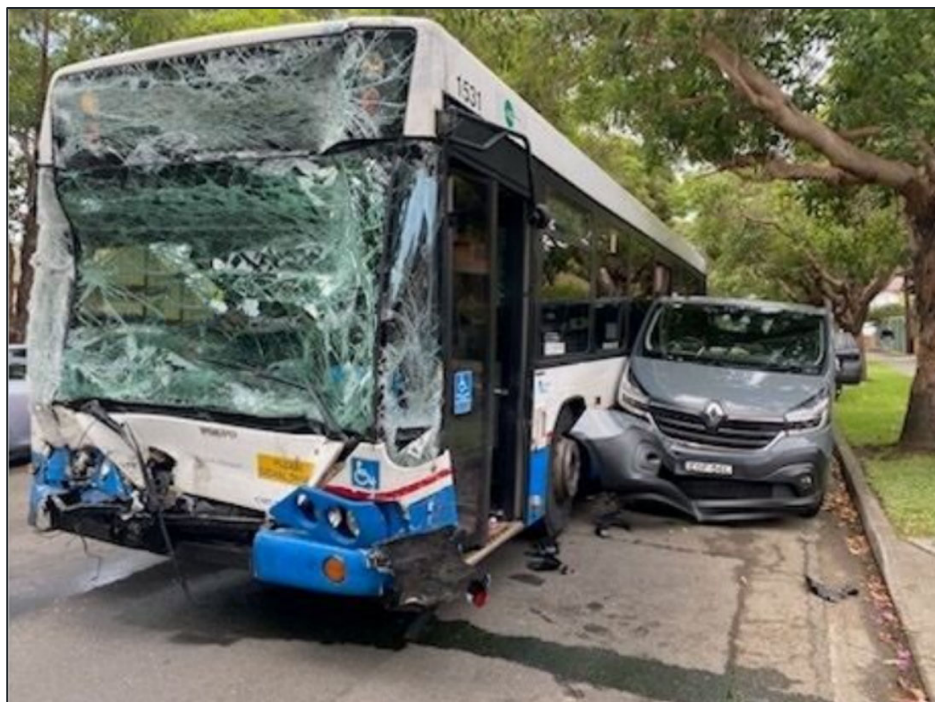
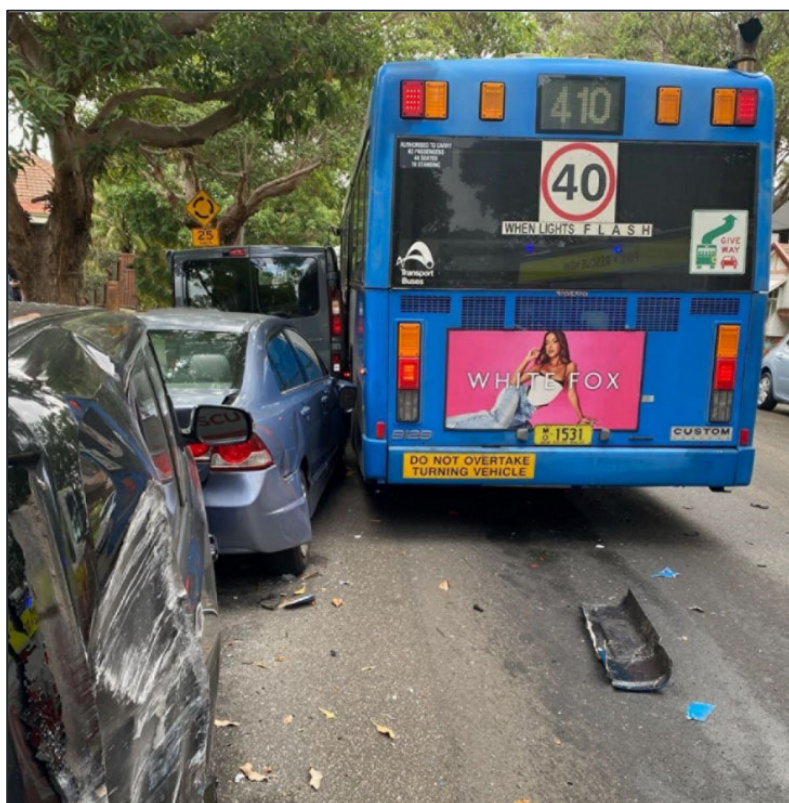
Bus m/o1531 came to a stop with the rear doors directly against the offside of the parked vehicle, blocking passengers from being able to exit via the rear. One panel of the front door self-opened due to damage from the collision (Figure 8, Figure 9).

**Figure 8: Front view of final position of bus m/o1531 on Seventh Avenue**

**Figure 9: Rear view of final position of bus m/o1531 on Seventh Avenue**

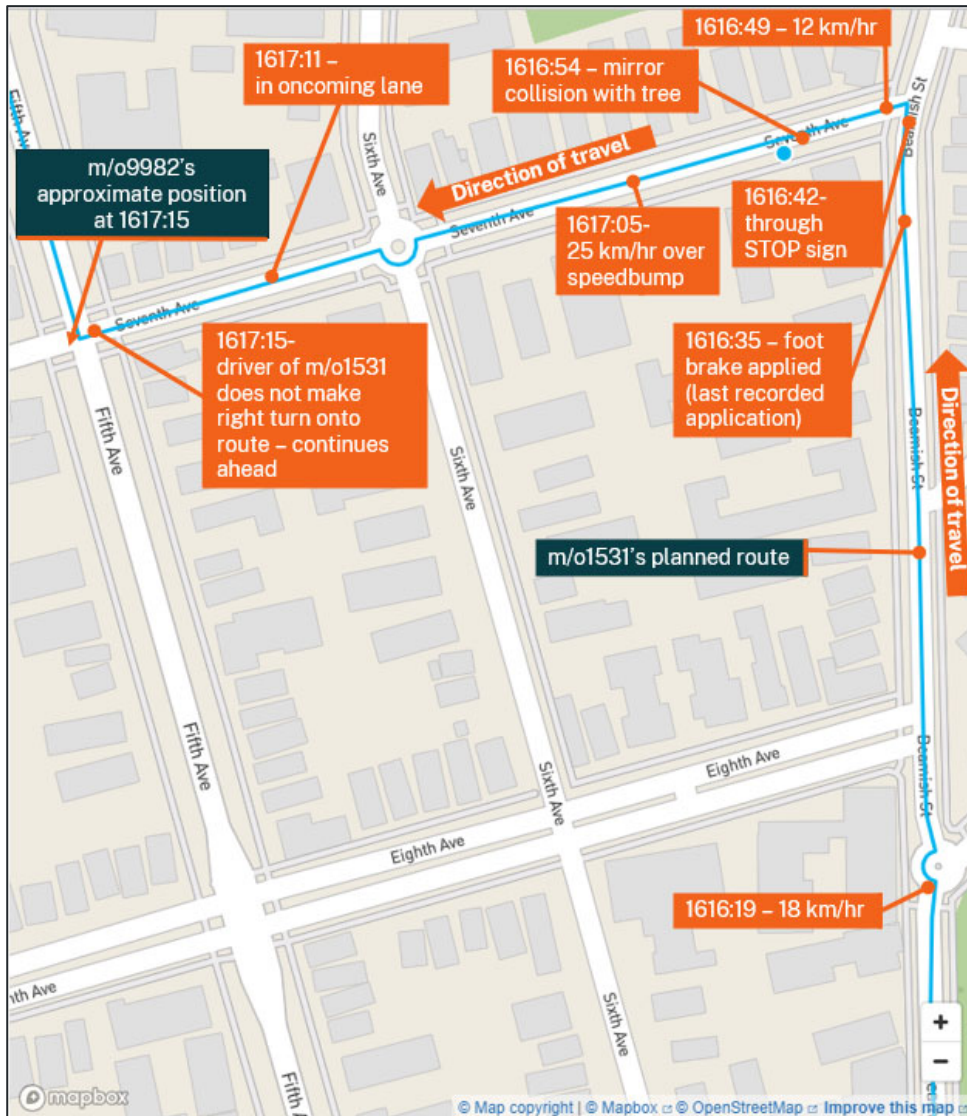
OTSI's investigation included a review of key events in the lead up to the collision and supporting evidence (Figure 10). There was no evidence to support that driver rostering or fatigue contributed to the incident.

**Figure 10: Overview of key events involving bus m/o1531 in the lead up to the collision**
