# Bus Safety Investigation Report

Bus collision with road barrier, Belmont  
North, 13 November 2022

Investigation Reference IO2033

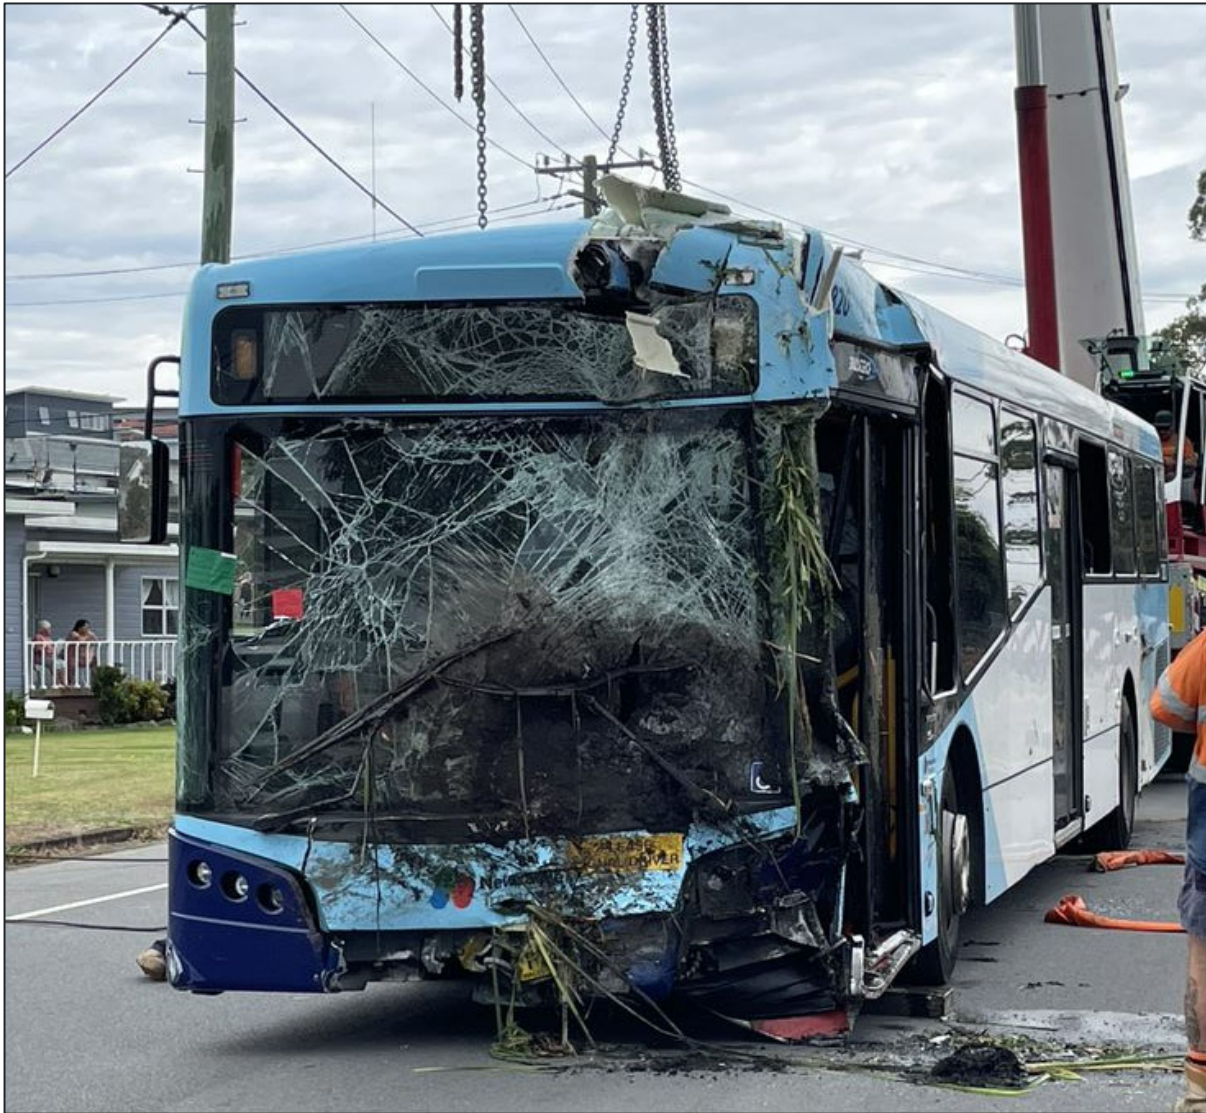
**Figure 9: Image of bus m/o8219 during vehicle recovery process, showing impact marks and front damage**

- 2.3 A post incident inspection of the involved bus determined that there were no identified technical defects or failures that contributed to the collision with the barrier.
- 2.4 Bus m/o8219 had a Gross Vehicle Mass (GVM) of 19,000 kg. However, the actual weight of the bus at the time of the incident was likely less than the GVM as the bus did not have a full load of passengers on board and likely did not have full tank of fuel.
- 2.5 During the impact sequence, the front of the bus, just to the right of centre, collided with the sloped leading edge of the barrier. This resulted in significant damage to the front of the bus (Figure 9).

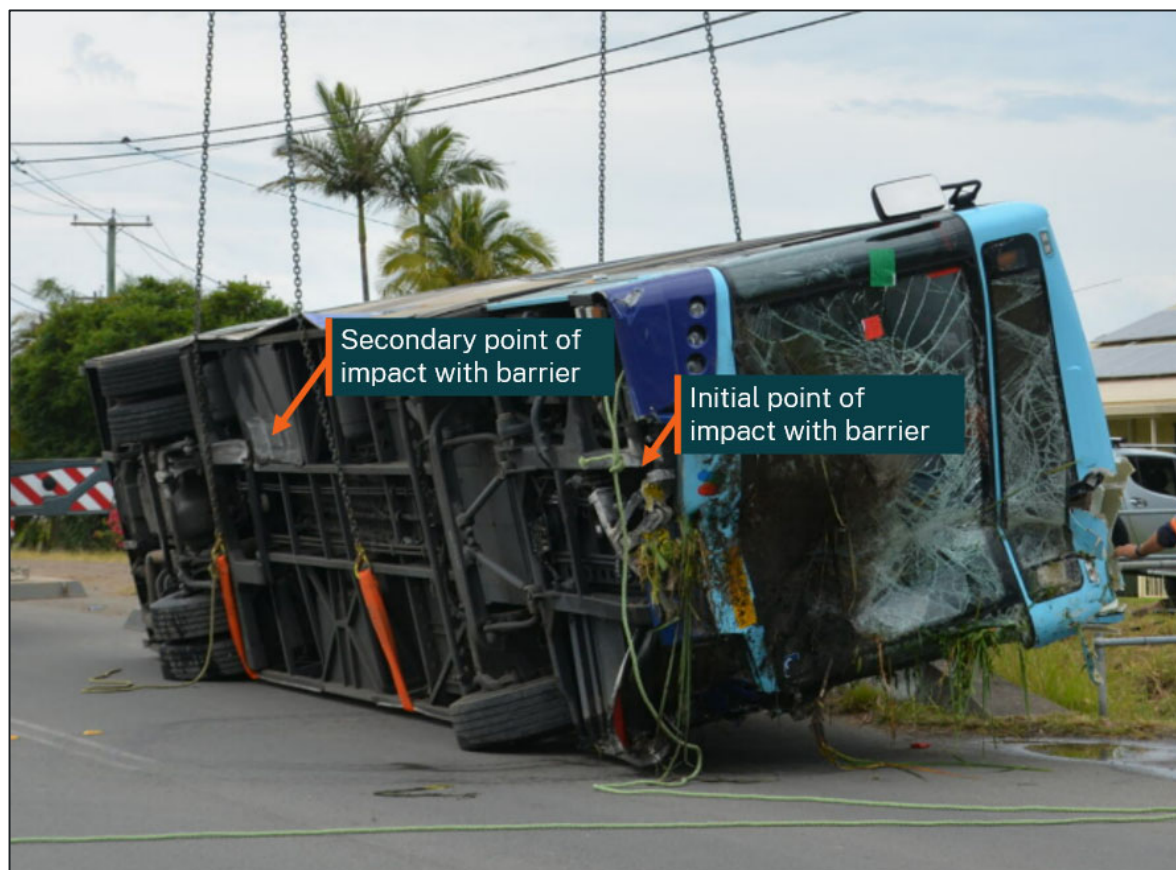
**Figure 10: Image of bus m/o8219 in rollover position showing initial and secondary impact marks**

2.6 After initial impact (Figure 10), the bus travelled up the sloped front of the barrier and across the level top section. The metal guard under the fuel tank, then the off side rear sway bar, located under the vehicle (Figure 10, Figure 11), impacted the top of the barrier as the bus continued moving forward. This resulted in the bus becoming airborne, then rotating onto its near side, dropping down towards the channel.

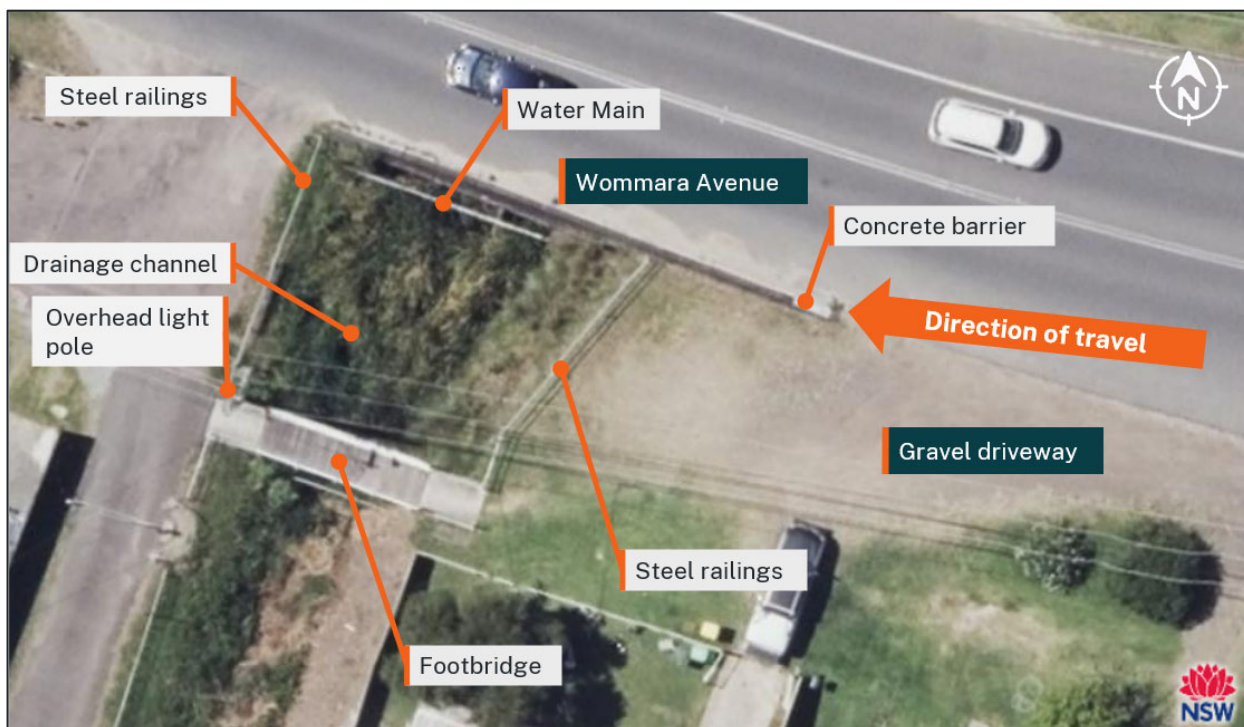
**Figure 12: Overview showing the layout of infrastructure in the incident location**

- 2.8 In this incident, a drainage channel ran perpendicular to Wommara Avenue, with a culvert<sup>14</sup> under the road (Figure 12). This drainage channel, which was filled with vegetation at the time of the incident, was approximately 2 metres deep where the bus rolled over.
- 2.9 A 'Type-F' concrete barrier was positioned along the side of Wommara Avenue, across the top of the drainage channel and a water main pipe. Markings found on the water main were consistent with contact with the bus in the rollover sequence.
- 2.10 Steel railings were positioned along the eastern and western sides of the drainage channel, with a pedestrian footbridge across the southern side. An overhead light pole was located at the southwest corner of the channel (Figure 12). This provided downward illumination of both the edge of the drainage channel and adjacent sealed drive.

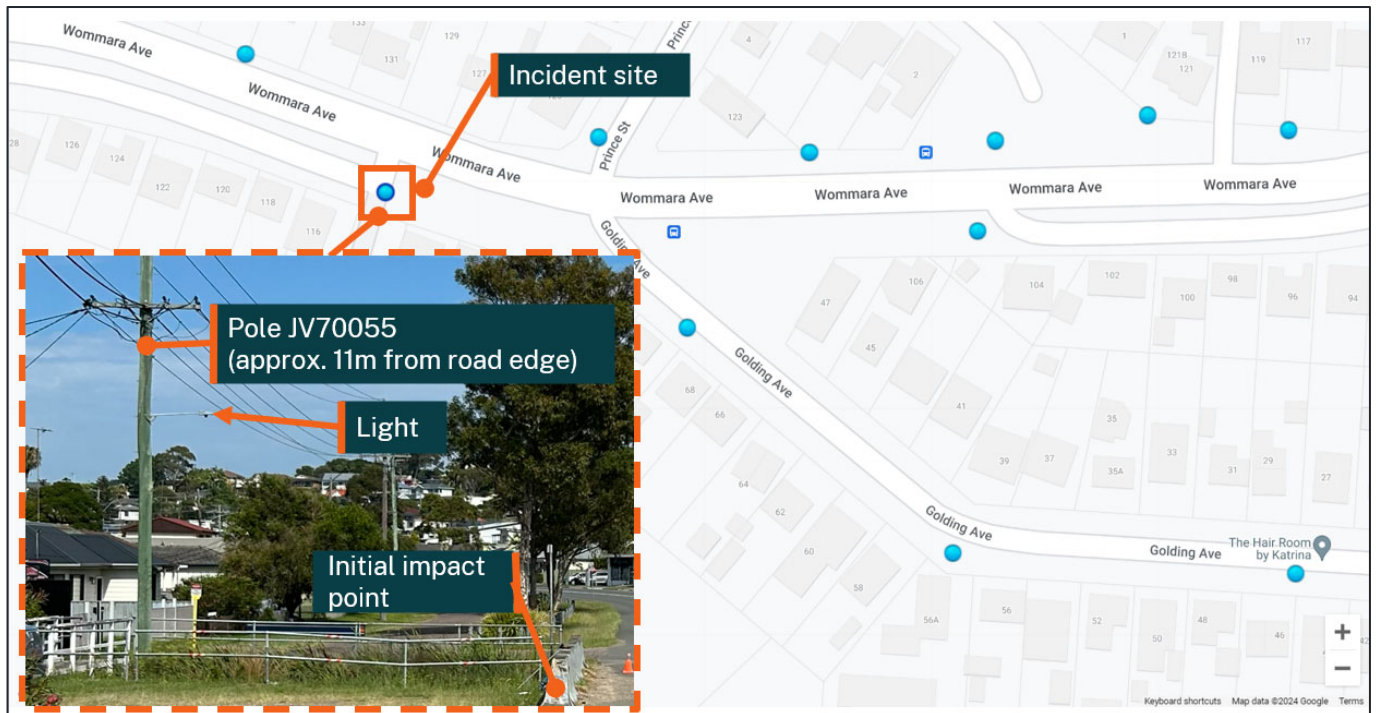
**Figure 13: Image showing location of streetlights in Wommara Avenue area, with light near incident site highlighted**

2.13 There were five streetlights positioned along the right-hand (northern) side of Wommara Avenue with the one remaining streetlight positioned on a utility pole (JV70055) located on the southwest corner of the drainage channel (Figure 13). This light was offset approximately 11 m from the edge of Wommara Avenue.

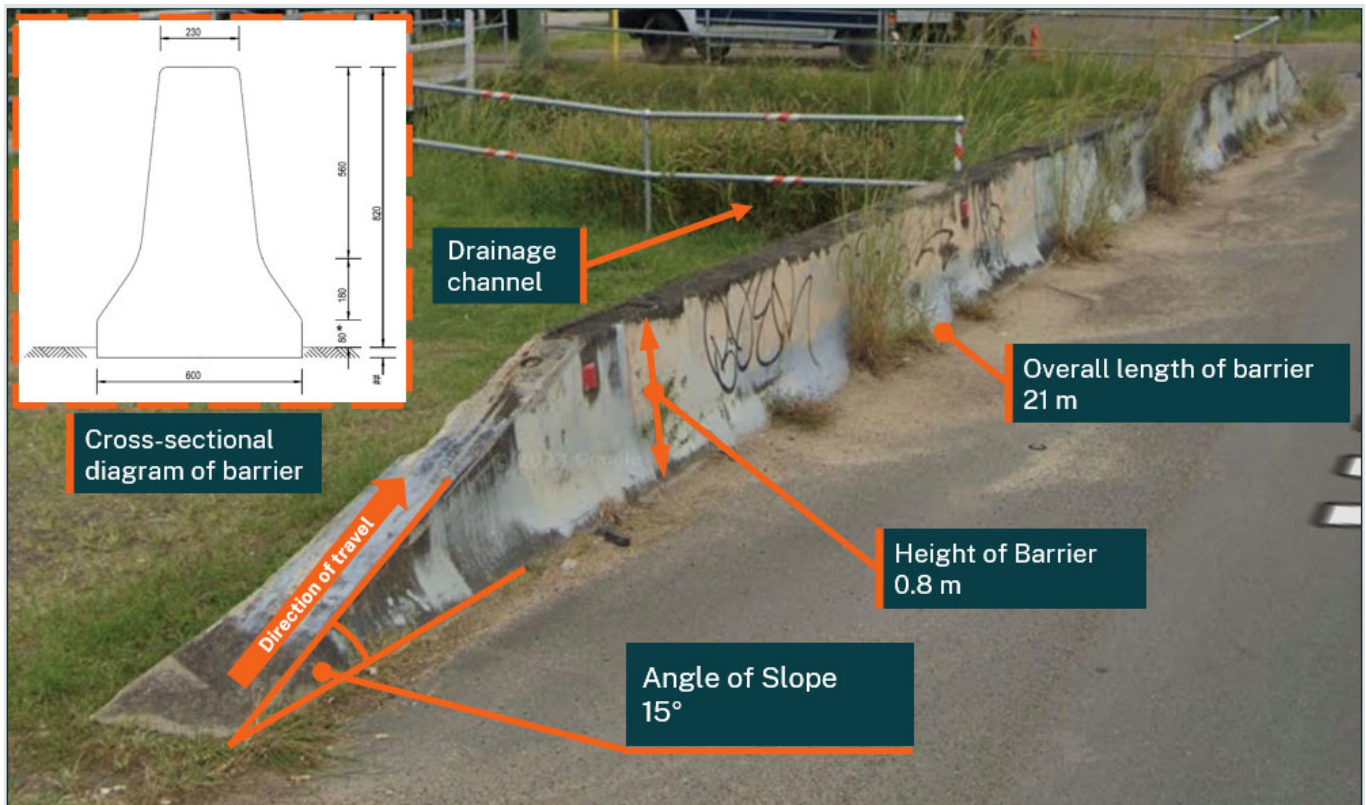
**Figure 14: Road barrier involved in the incident**

2.14 The overall length of the involved road barrier, inclusive of the sloped end terminals, was approximately 21 m. It consisted of seven individual units, which were made up of five Type-F concrete barrier units with two Type-F sloped-end concrete terminal units attached to each end of the barrier. Each of the seven units, including the sloped terminals, were three metres long at the base. The height of the parallel sections of the road barrier were approximately 0.8 m. The slope of the end terminals was approximately 15 degrees (Figure 14).

- 2.15 TfNSW standards for sloped end terminals had a prescribed slope limit of 1 in 7.4 for the approach end sloped terminal, or an incline of approximately 7.7 degrees. However, it is noted that Local Council managed roads, such as Wommara Avenue, were not required to meet TfNSW road and infrastructure standards. It is also noted that standards change with time, and a different slope limit may have applied at the time of installation.
- 2.16 There were two red coloured Raised Retroreflective Pavement Markers (RRPM)<sup>17</sup> positioned near the leading edge of the road barrier on the road facing side. There were no other reflectors present on the concrete road barrier besides the two RRPMs attached to the road facing sidewall of the barrier.

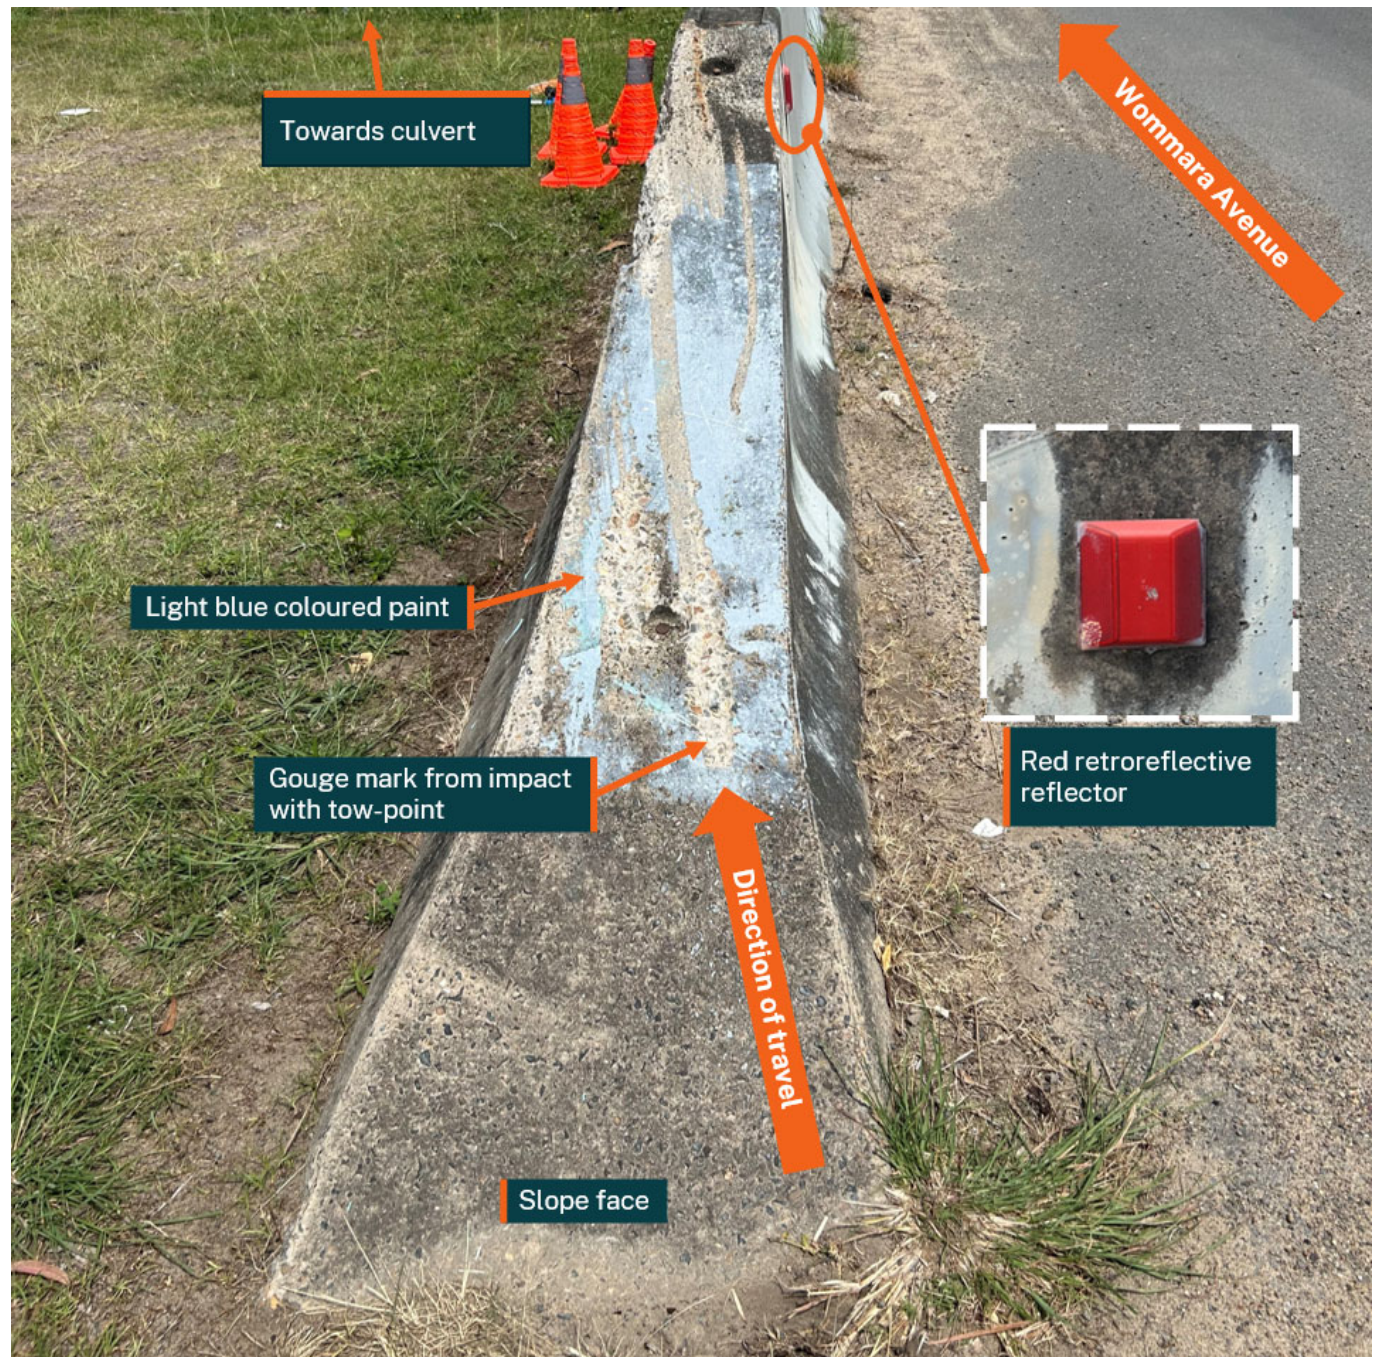
**Figure 15: Post incident damage to the involved barrier and reflector placement**

2.17 On the face of the approach end sloped terminal, there was a gouge mark of approximately 500 mm long and 50 mm wide likely created by the initial impact with the front lower frame of the bus (Figure 15).

2.18 On inspection the top of the barrier was missing the section joining plates designed to keep the sections together, and metal screws had deteriorated with rust.

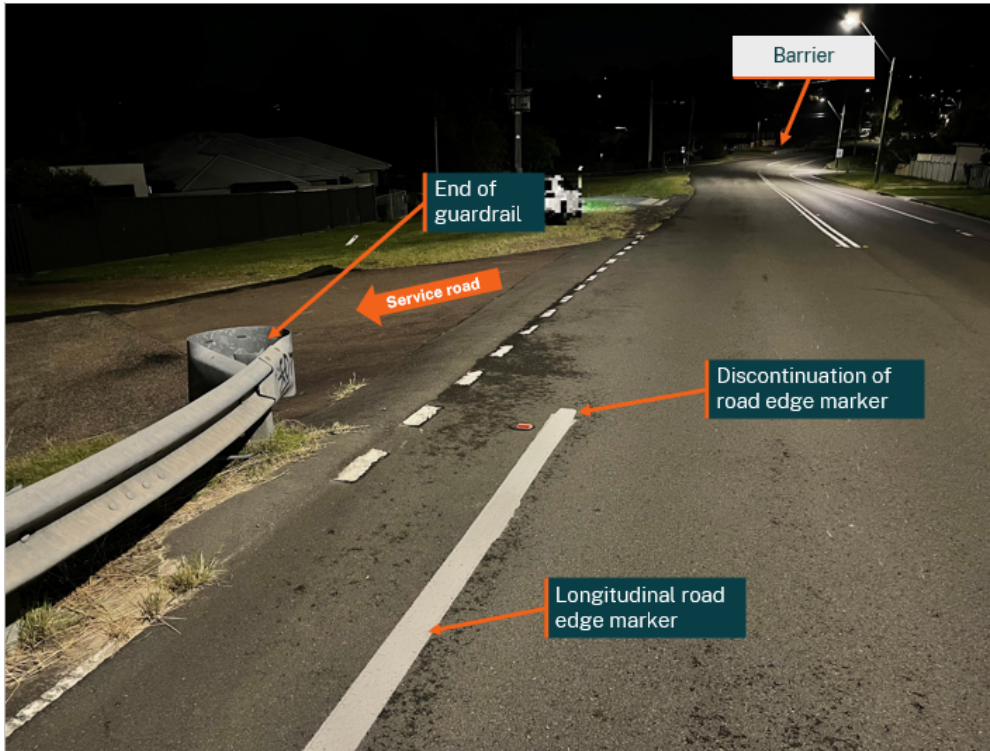
**Figure 16: Discontinuation of longitudinal road edge marker and guardrail on Wommara Avenue, towards barrier**

2.19 There was a W-Beam metal guard rail with a length of approximately 281 m positioned along the southern edge at the top of the crest, around a right-hand bend. The rail was accompanied by a white longitudinal road edge marker of the same length. The guard rail and road edge marker ended approximately 156 m prior to the incident site and did not continue westbound along Wommara Avenue towards the drainage channel (Figure 16).

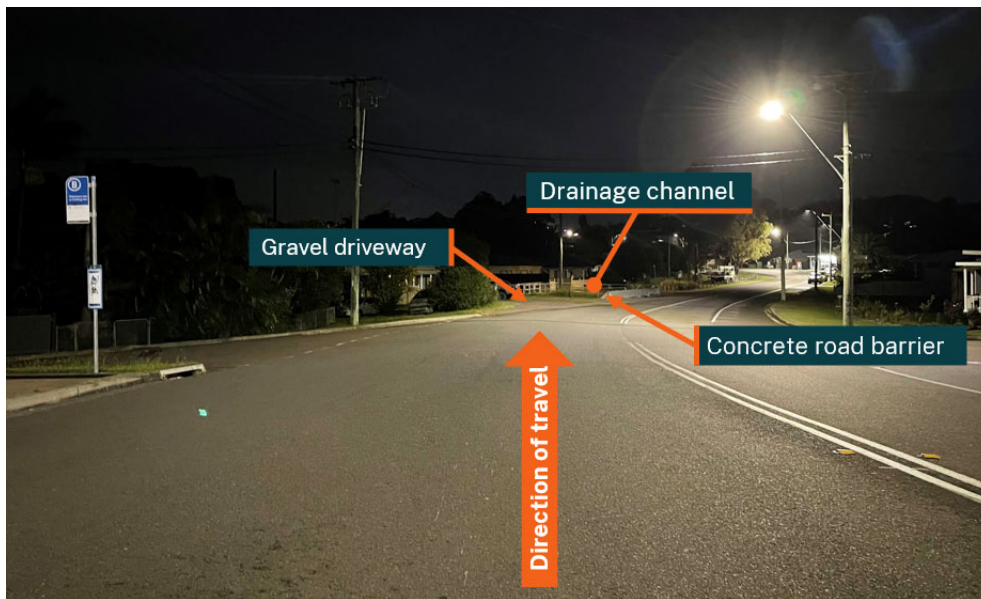
**Figure 17: Wommara Avenue facing towards incident site**

2.21 An unsealed driveway was positioned immediately before the incident site as the road curved to the right. This driveway was at the front of several houses and provided local residential access (Figure 17).

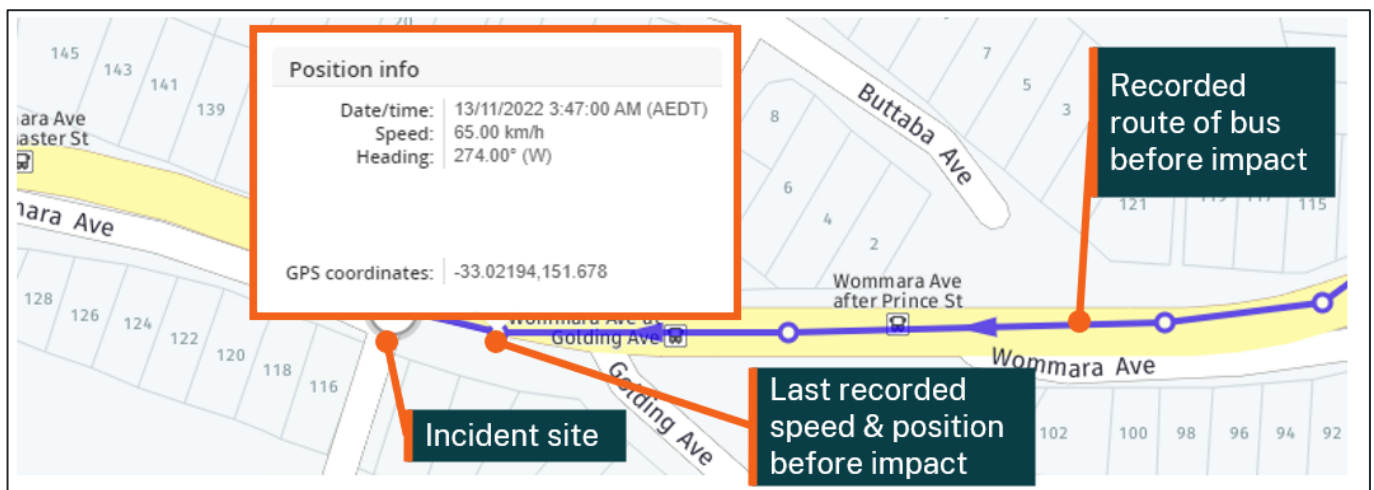
**Figure 18: Copy of the onboard telematics, showing data for route and position immediately before point of impact**

- 2.31 The investigation considered the likely speed of the vehicle in consideration of the driver's reported challenges in maintaining visibility ahead. The driver reported slowing the speed of the bus earlier on the route due to reduced forward visibility on fog. It is likely that the driver was focused on maintaining forward visibility and considered at that time that they had correctly positioned the bus, so did not need to significantly reduce speed.
- 2.32 The onboard telematics system recorded the speed of the bus as 65 km/hr immediately prior to the collision (Figure 18). However, this speed was likely to have been uncalibrated. As such, the investigation could not determine the actual speed of the bus at time of impact with the barrier.

- 2.33 Figure 18 also displays the recorded position of the bus approaching the incident site. The bus was recorded as operating in the oncoming lane as it travelled down the incline of Wommara Avenue, then aligning with the leading face of the barrier, which was undetected by the driver.

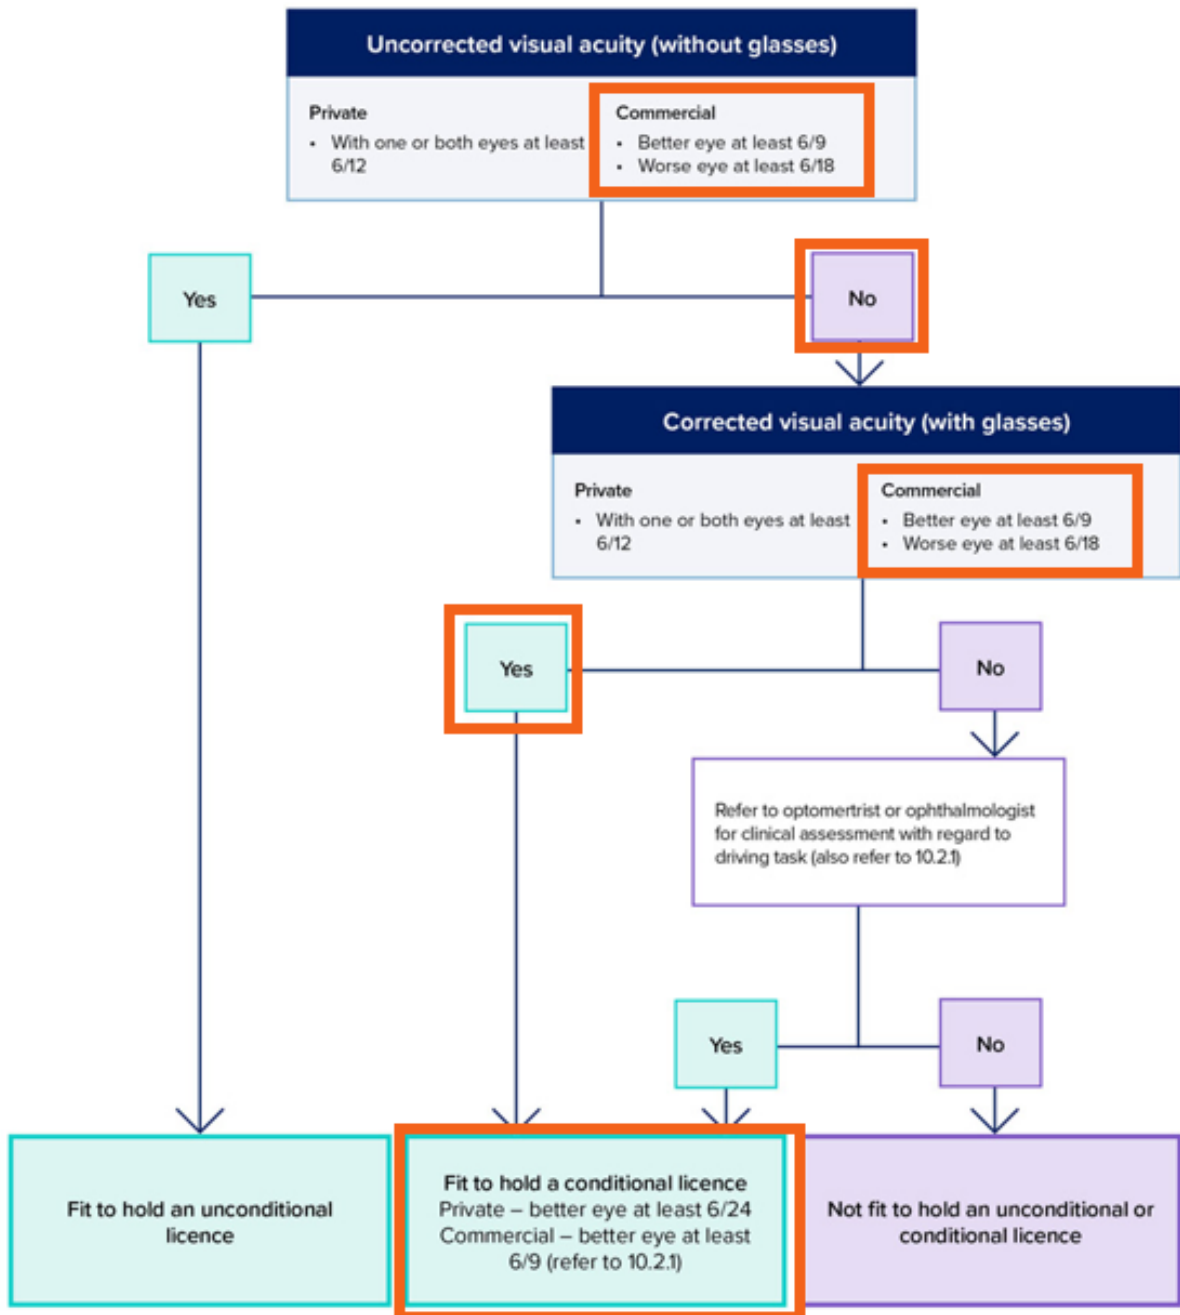
**Figure 19: Visual acuity requirements for private and commercial drivers, marked to show involved driver's results**

2.42 When the driver completed their NSW commercial drivers licence assessments in 2021 and 2022, the driver's visual acuity scores, with glasses worn, were recorded as meeting the commercial licence corrected visual acuity (with glasses) scores. These results met the AFTD requirements of the driver to be issued a conditional commercial licence (Figure 19).

- 2.43 However, the General Practitioner who completed the medical assessments in both 2021 and 2022 recorded that the driver fulfilled the medical criteria for an unconditional commercial drivers licence.
