# Insights from 20 Years of OTSI Safety Investigations 2004 - 2023

## Insights from 20 Years of OTSI Safety Investigations 2004 – 2023

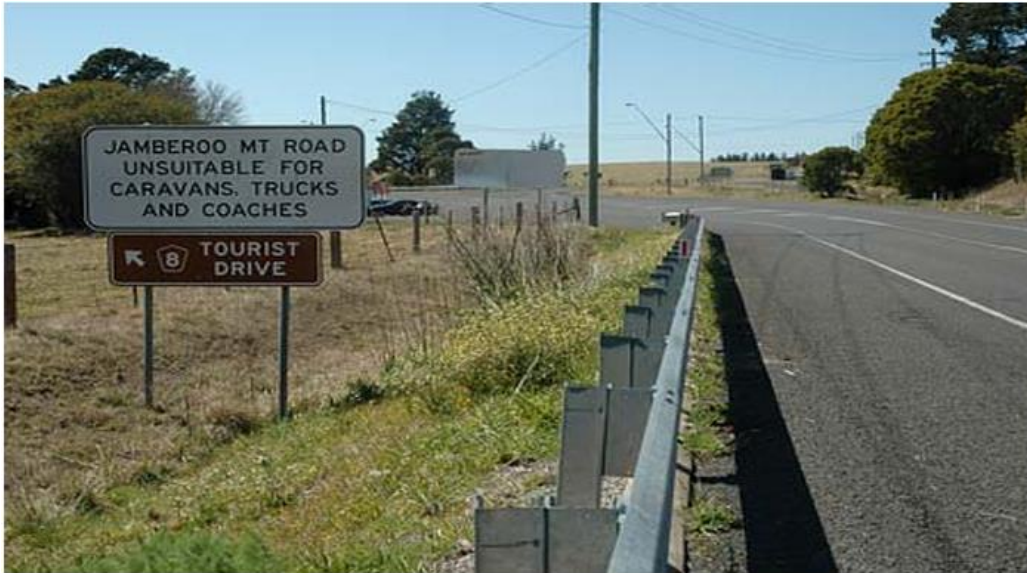
The bus operator required the driver to use a route which was sign-posted as being unsuitable for coaches, and with which they were largely unfamiliar. The bus was also being driven with a defective air brake pressure alarm system.

Figure 1: Signage on the Illawarra Highway, approximately 100 m before its intersection with Jamberoo Mountain Road.

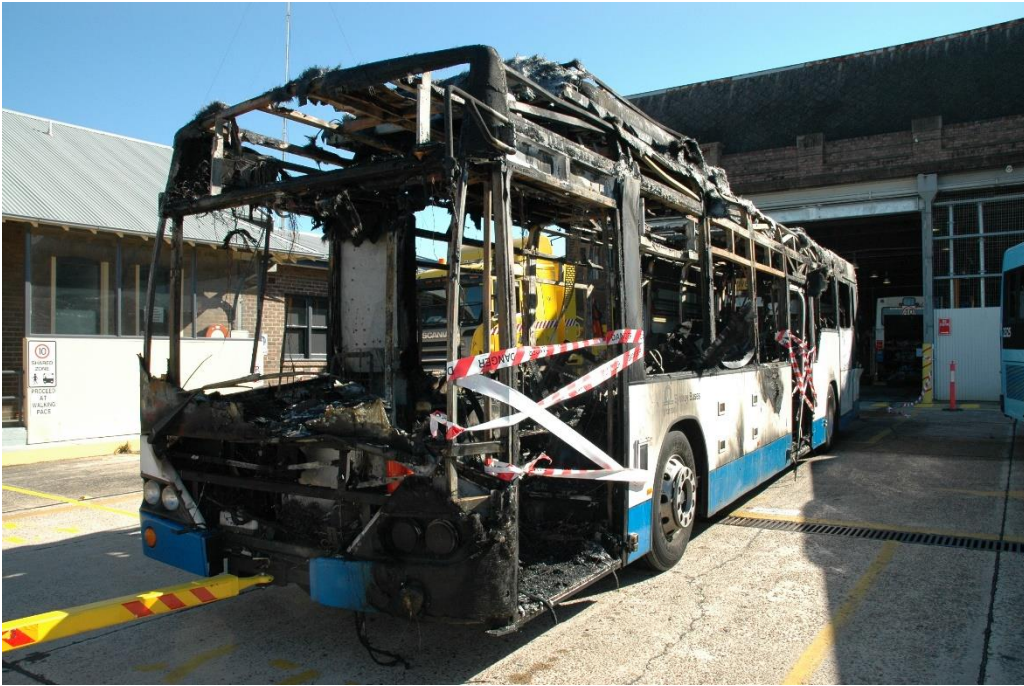
The most likely cause of the fire was found to be coolant being sprayed onto the engine from a split hose connection on the turbocharger coolant return line to the compressor. The water content of the coolant evaporated on the hot surface of the engine allowing the residual ethylene glycol to crystallise and ignite.

Figure 4: Fire damage to the bus exterior.

The split hose connection on the turbocharger coolant line should have been replaced by the manufacturer during a recall program of the part but the manufacturer missed the bus. A regular maintenance and inspection regime is critical to identify defects and prevent similar occurrences.

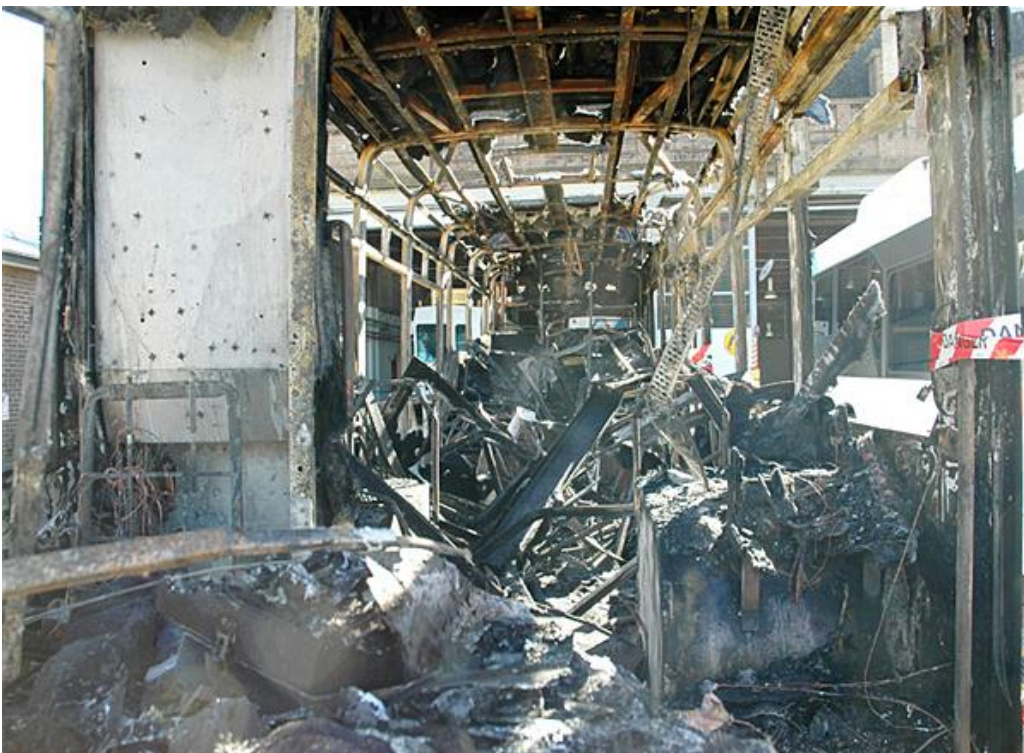
As the fire intensified, it burnt through the rear floor hatch and the passenger saloon. Although the timber plywood floor hatches were the most vulnerable area, they were not protected with stainless steel shielding like other areas of the engine bay. About 19 minutes after the fire was detected, the connection of the CNG line at the solenoid valve succumbed to the intense temperature. The resultant increase in pressure vented in a jet of flame.

Figure 5: Fire damage to the bus interior.

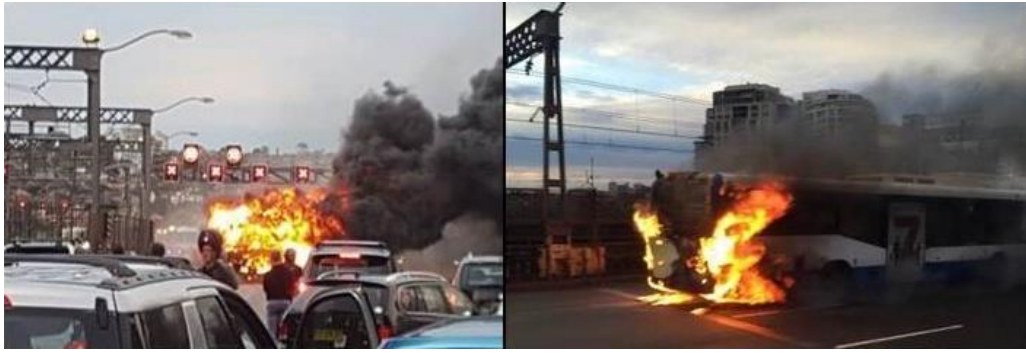
The investigation found that the fire started due to an electrical malfunction in the engine bay at the rear of the bus. The fire intensified, consuming flammable materials in the engine bay and eventually spread into the passenger saloon. The rear half of the bus suffered substantial damage.

It is likely that the fire was initiated by a short circuit of the auxiliary alternator cables where they crossed the edge of the near side rear chassis rail. Another short circuit likely occurred in the primary alternator cable when consequential damage occurred to its insulation following the development of the fire.

Figure 6: Flames from the rear of the bus.

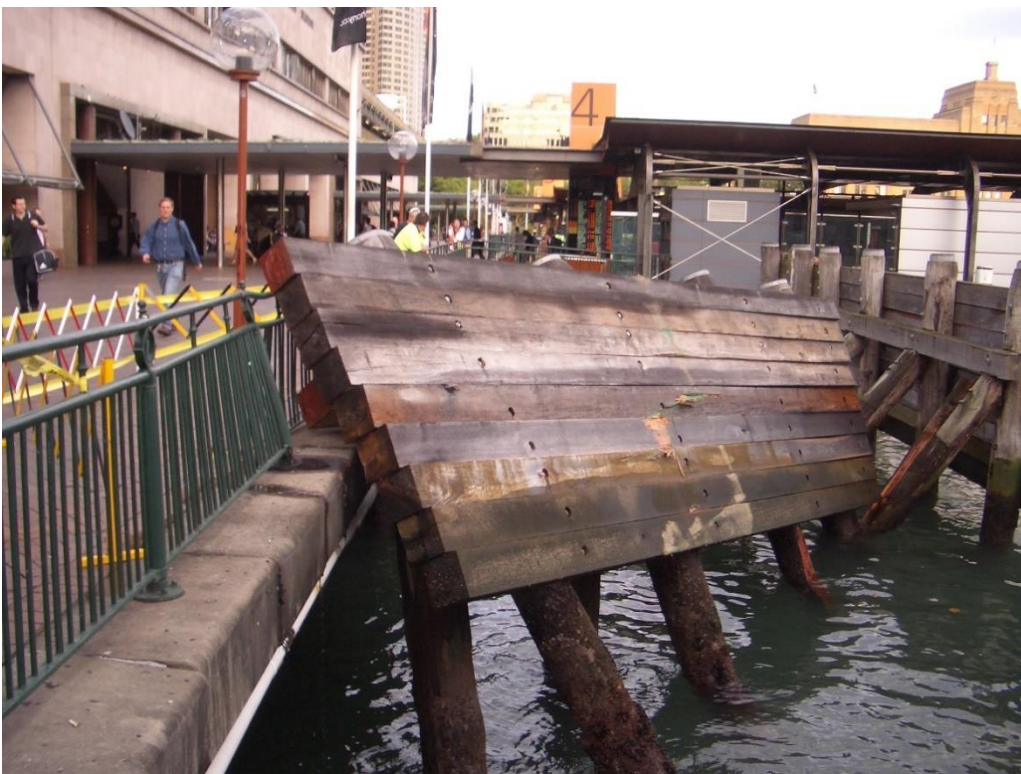
Figure 11: Damage from Freshwater class vessel Collaroy collision at Circular Quay.

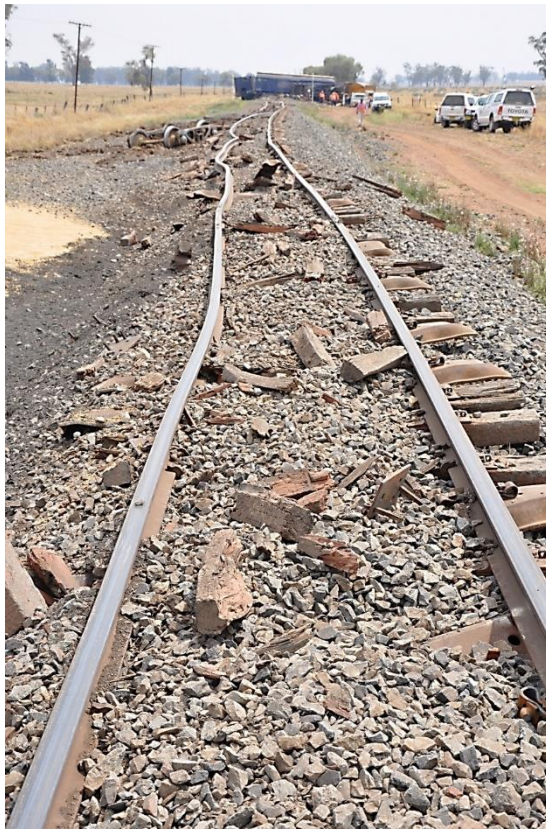
Figure 21: Looking towards the rear of the train from the 26th wagon.

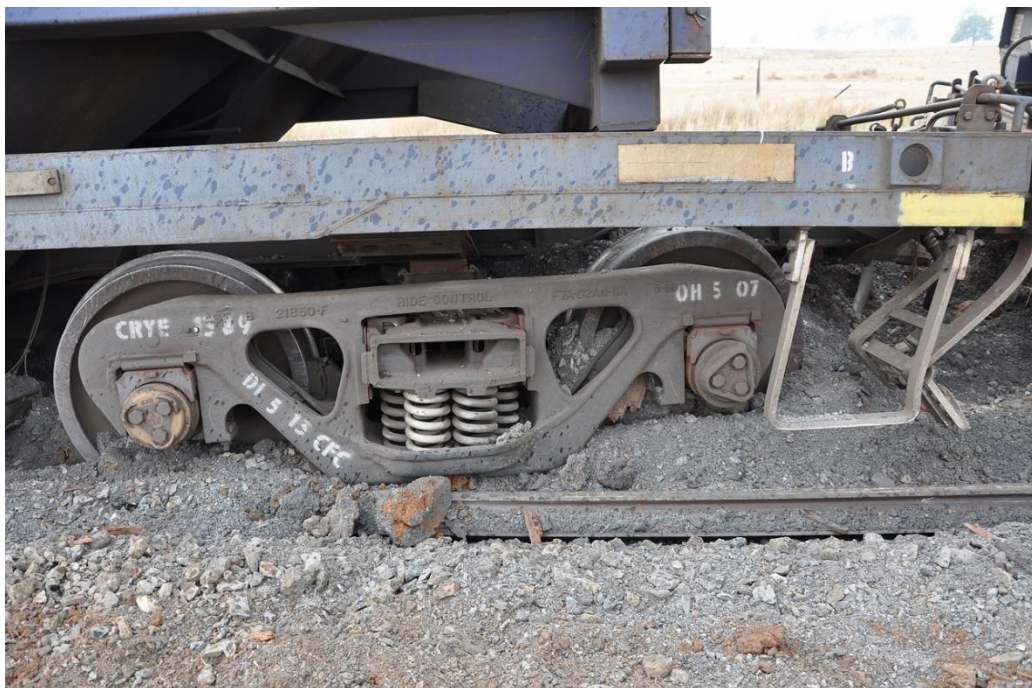
Figure 22: Poor quality ballast disturbed by the derailment.

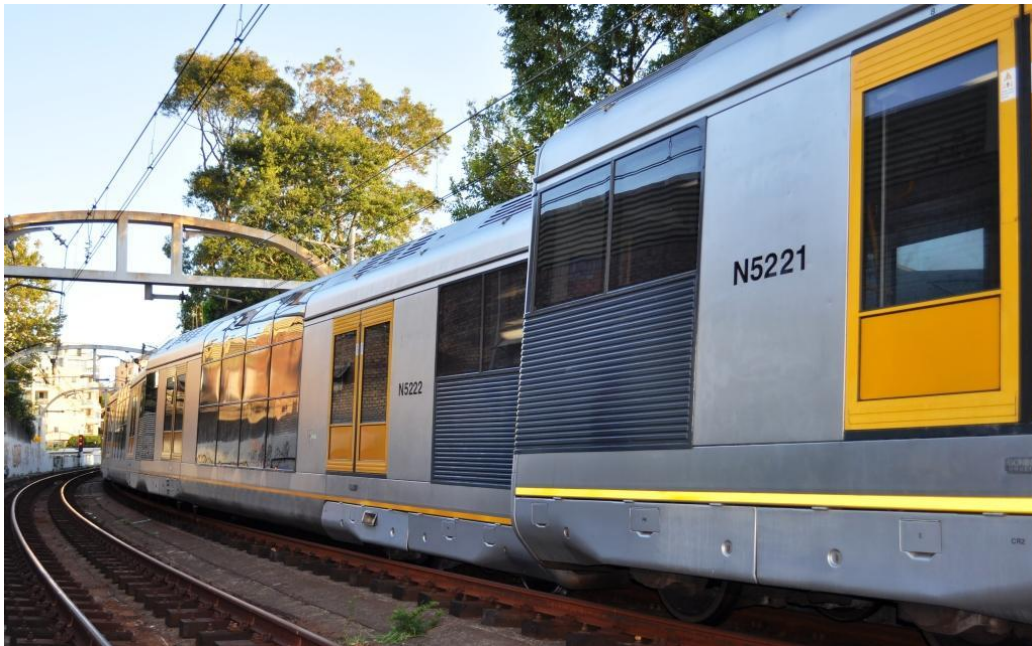
The management of the defective train from the first manifestation of the defect through to the response to the derailment revealed inadequacies in several areas including communications, training, command and control and culture. A lack of adherence to procedures and reporting lines led to the train continuing in service and subsequently derailing.

Figure 24: The train after derailing.

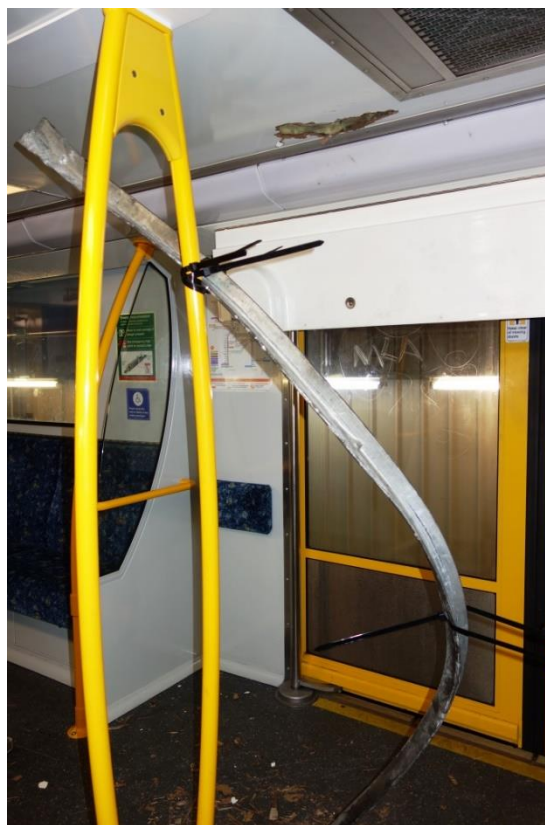
Figure 25: Angle iron secured inside the third carriage.

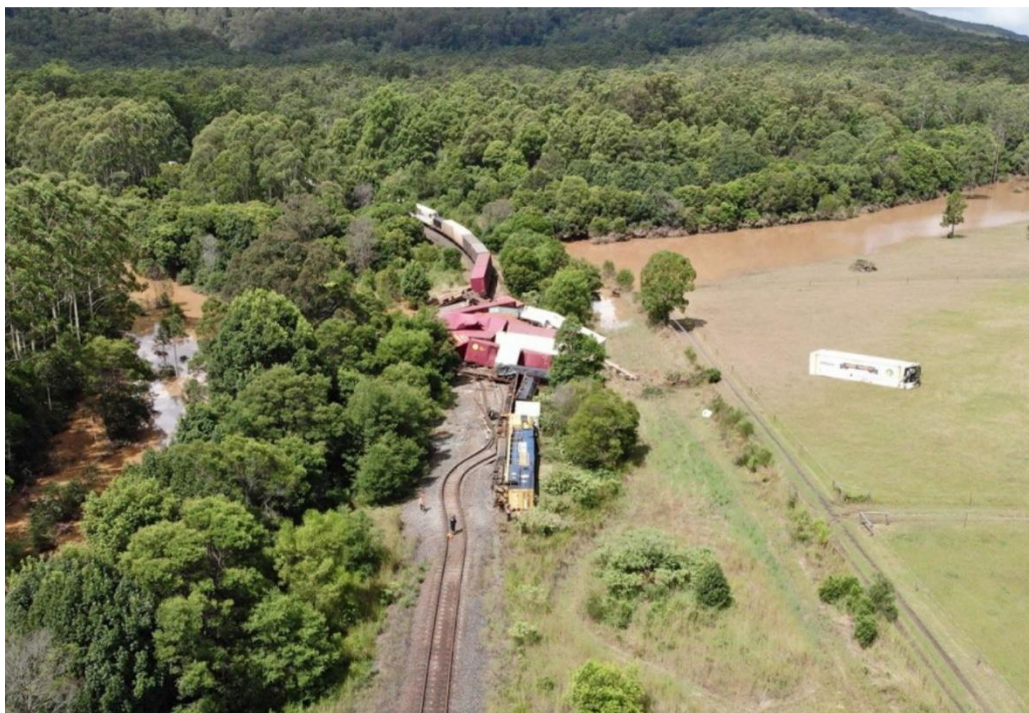
Figure 30: Post-derailment site.
