# Ferry Safety Investigation Report

Children overboard at Riverview College Ferry Wharf,  
Riverview, NSW, 16 February 2023

Published  
February 2025

Investigation Reference IO2038

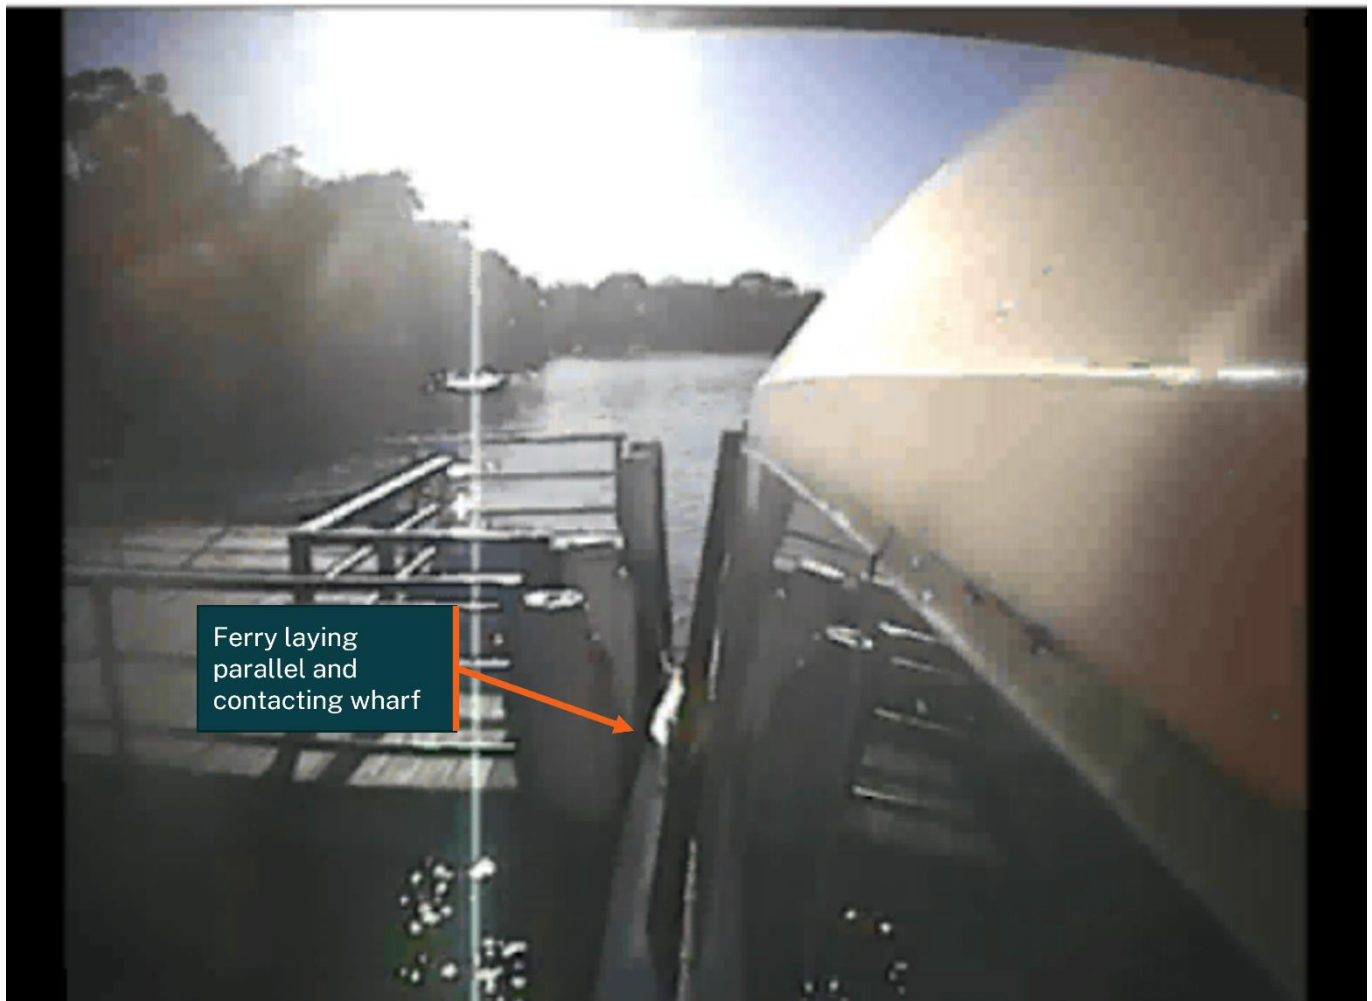
Figure 3: Onboard portside CCTV showing position of vessel alongside the wharf before the incident

- 1.9 Between 0809:36 and 0811:27, the Master and Deckhand made repeated attempts to safely position and secure the vessel, lining up the forward gangway door with the wharf's western platform. Each attempt resulted in the ferry stern (rear) drifting away from the wharf. On each occasion, the Deckhand loosened the mooring line and readjusted its length before refastening it once the Master repositioned the vessel.

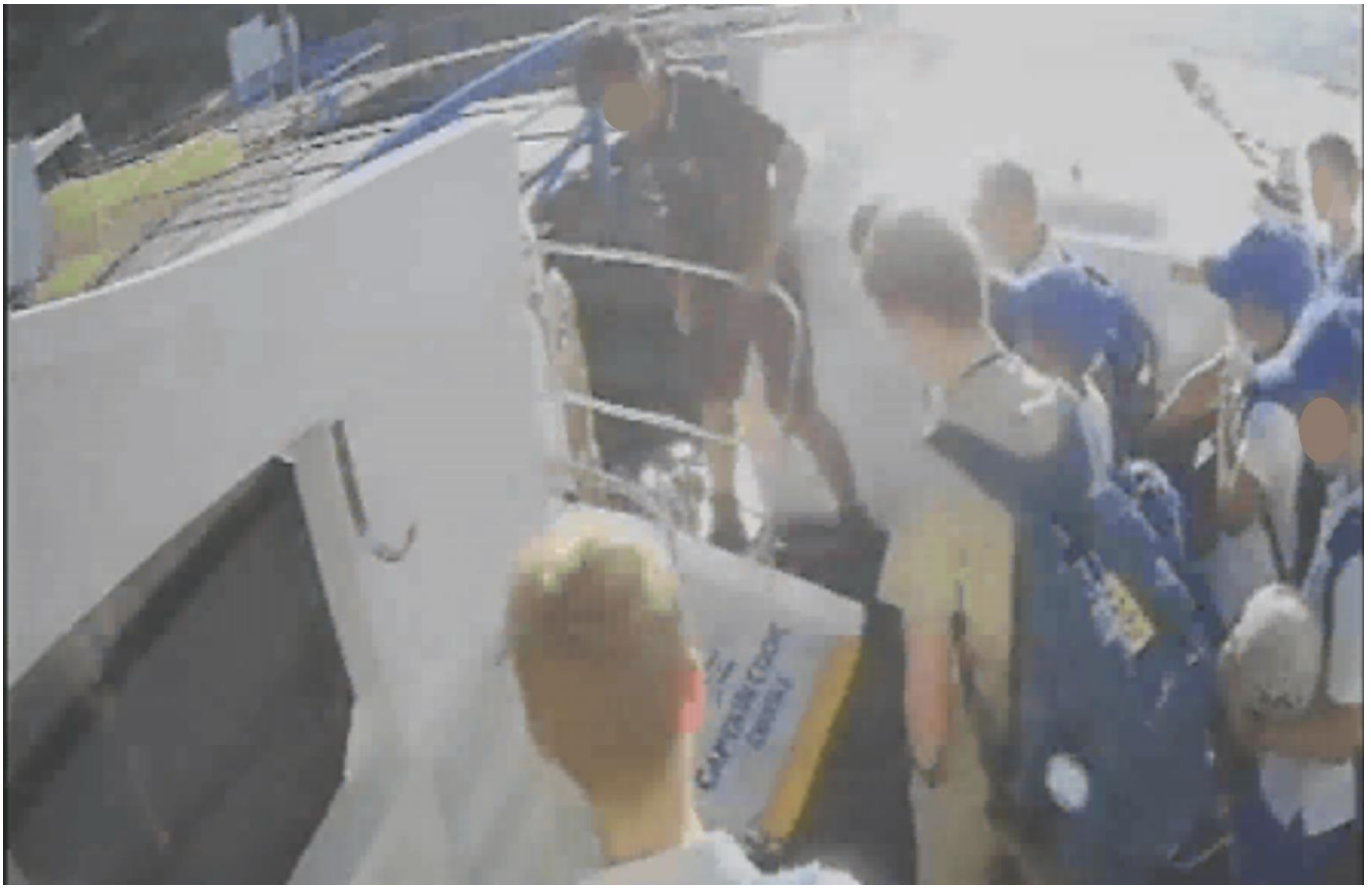
Figure 4: Onboard forward deck CCTV showing students crowding around the gangway at 0811:29

- 1.10 At 0811:29, the Deckhand secured the mooring line and deployed the gangway<sup>6</sup> onto the western platform (Figure 4). The chain on the gangway was not secured to the vessel as was documented practice. Students quickly moved forward from the foredeck, as a group, to disembark.
- 1.11 During disembarkation, students crowded onto the gangway closely behind each other, with up to five students on the gangway at one time. The students crossed the gangway in a continuous flow, at times in pairs side by side, carrying a school backpack over their shoulders, and often with an accompanying sports bag and/or sporting equipment.

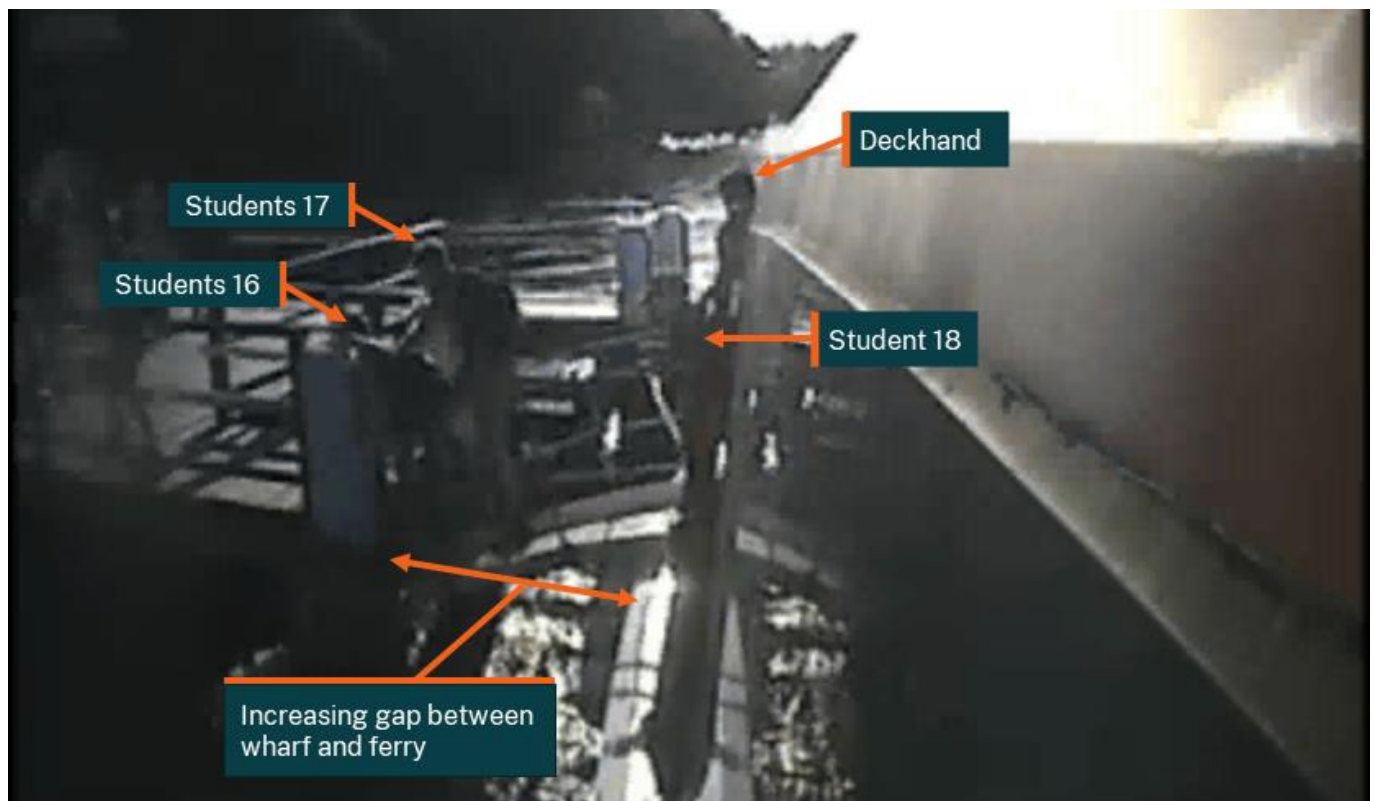
Figure 5: Onboard portside CCTV of gangway separating from wharf at 0811:46

- 1.12 Shortly after disembarkation commenced, the Deckhand was observed to look down towards their hand, then up towards shore, to count those passengers that had disembarked. It was an operator procedure for the Deckhand to count the number of passengers during disembarkation. As the students continued to disembark, the vessel's stern started to drift away from the wharf, resulting in an increasing gap between the wharf and vessel.

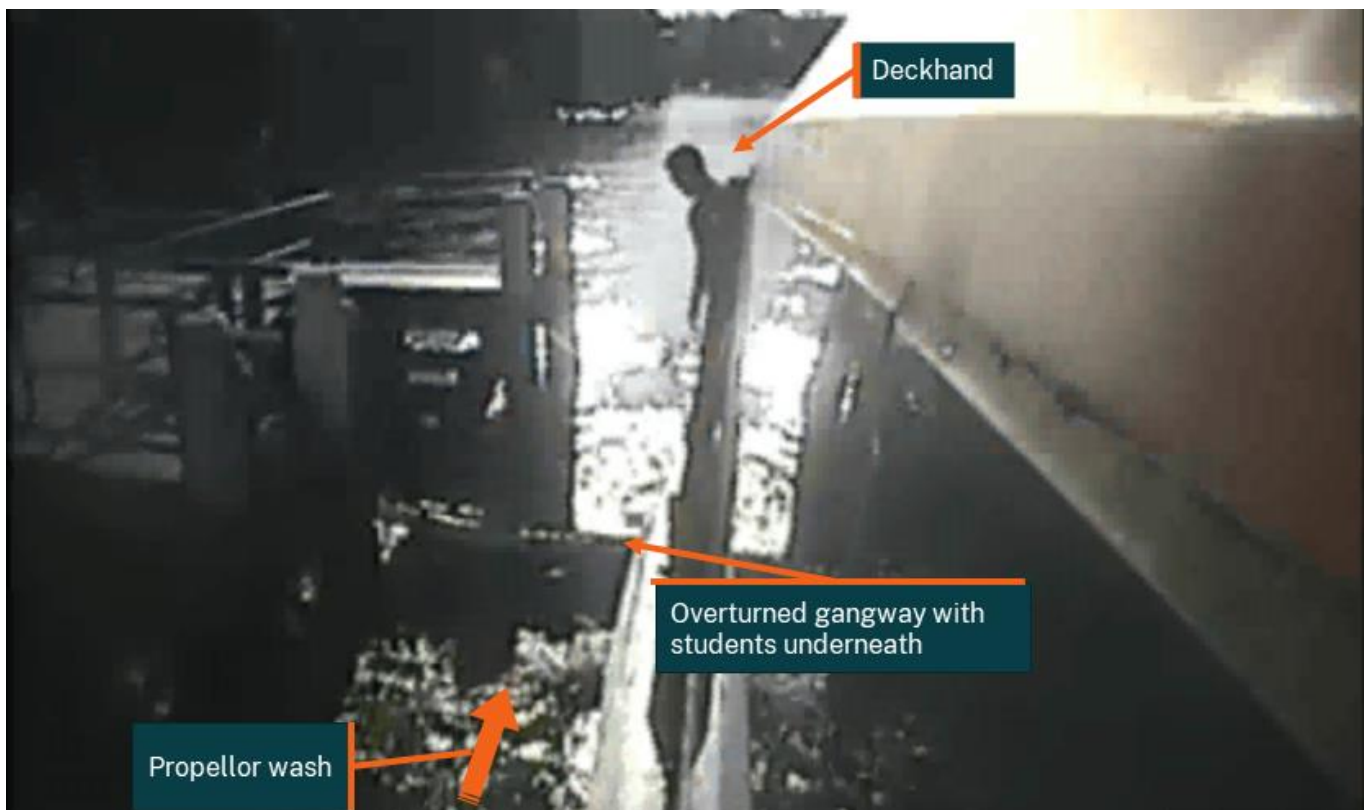
Figure 6: Onboard portside CCTV showing overturned gangway with two students underneath at 0811:51

- 1.14 At that time, two students at the front of the gangway (Students 16 and 17) fell forward, into the side of the wharf. Student 17, who was in Year 8, caught the edge of the wharf and held on until assisted onto the platform by a nearby student. Student 16, who was in Year 5, fell into the water, after momentarily holding onto the wharf's edge. The wash, created by the vessel's propeller, pushed this student under the falling gangway.

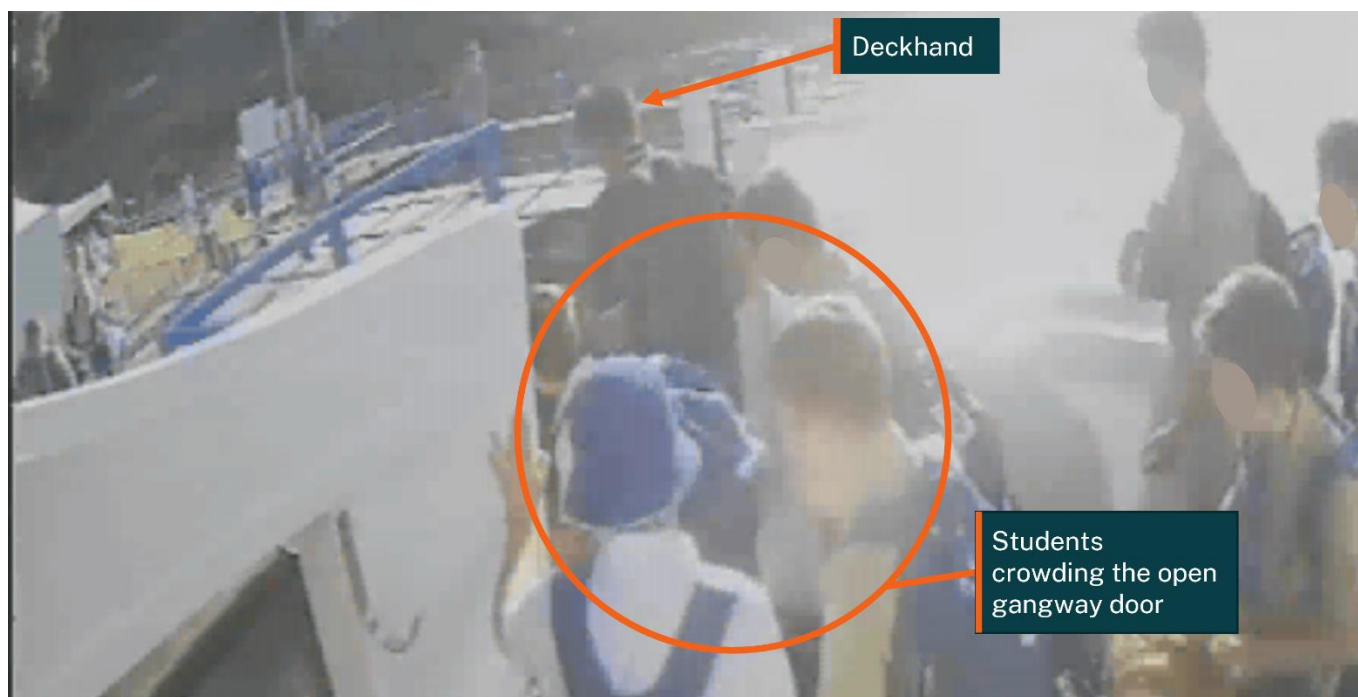
Figure 7: Onboard forward deck CCTV showing students crowding into open door at 0811:51

- 1.16 As the propellor wash pushed the students and gangway towards the narrow gap, student 18, moved through one of the handrails and climbed up onto the upturned gangway. Student 16 remained under the gangway, reporting that they struggled to free themselves from their backpack, with straps over both their shoulders and caught in the gangway handrails.
- 1.17 As the two students were washed forward, away from the vessel, the Deckhand stood in the open doorway, surrounded by a group of students trying to see what was happening in the water (Figure 7). At 0811:53, the Deckhand signalled the Master, pointing out the direction of the students in the water.

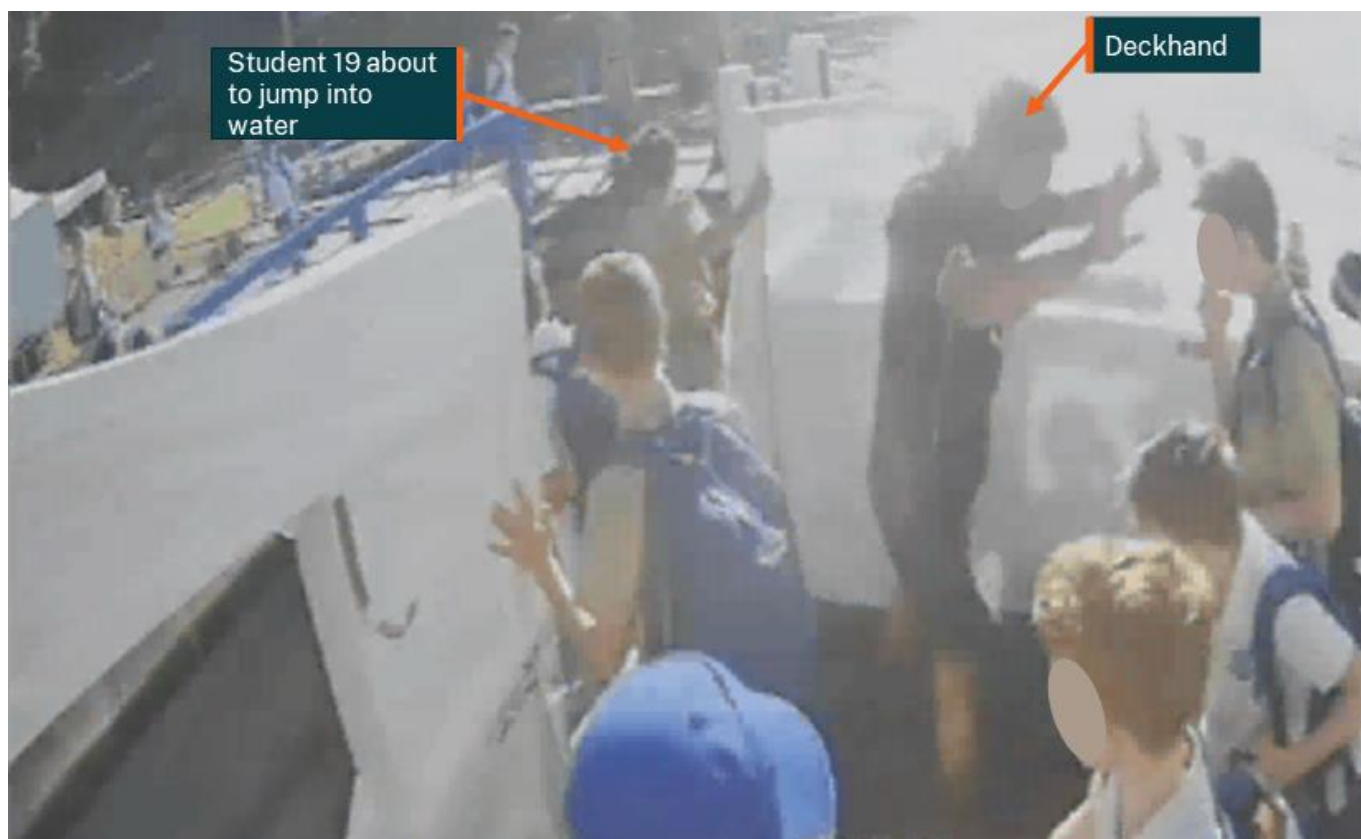
Figure 8: Onboard forward deck CCTV showing the Deckhand motioning for students to clear the area at 0811:57

- 1.18 At 0811:55, the Deckhand turned around and stepped away from the door to retrieve the Person Overboard (POB) ladder. At that time, a student (Student 19), whose sibling fell into the water, moved past the Deckhand into the open doorway. At 0811:57, the Deckhand motioned for students to clear the area (Figure 8).

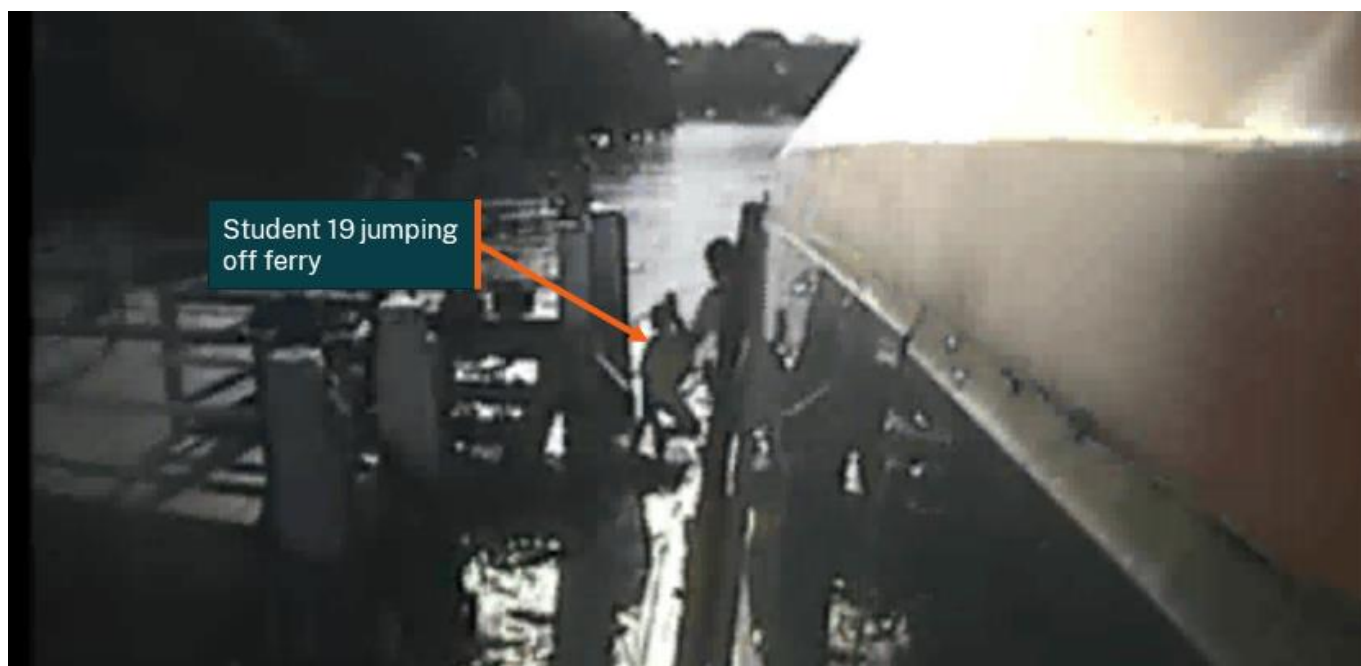
Figure 9: Onboard portside CCTV showing a student jumping into water from unattended door at 0811:57

1.19 When the Deckhand moved from the open doorway, Student 19 jumped into the water, between the ferry and wharf (Figure 9).

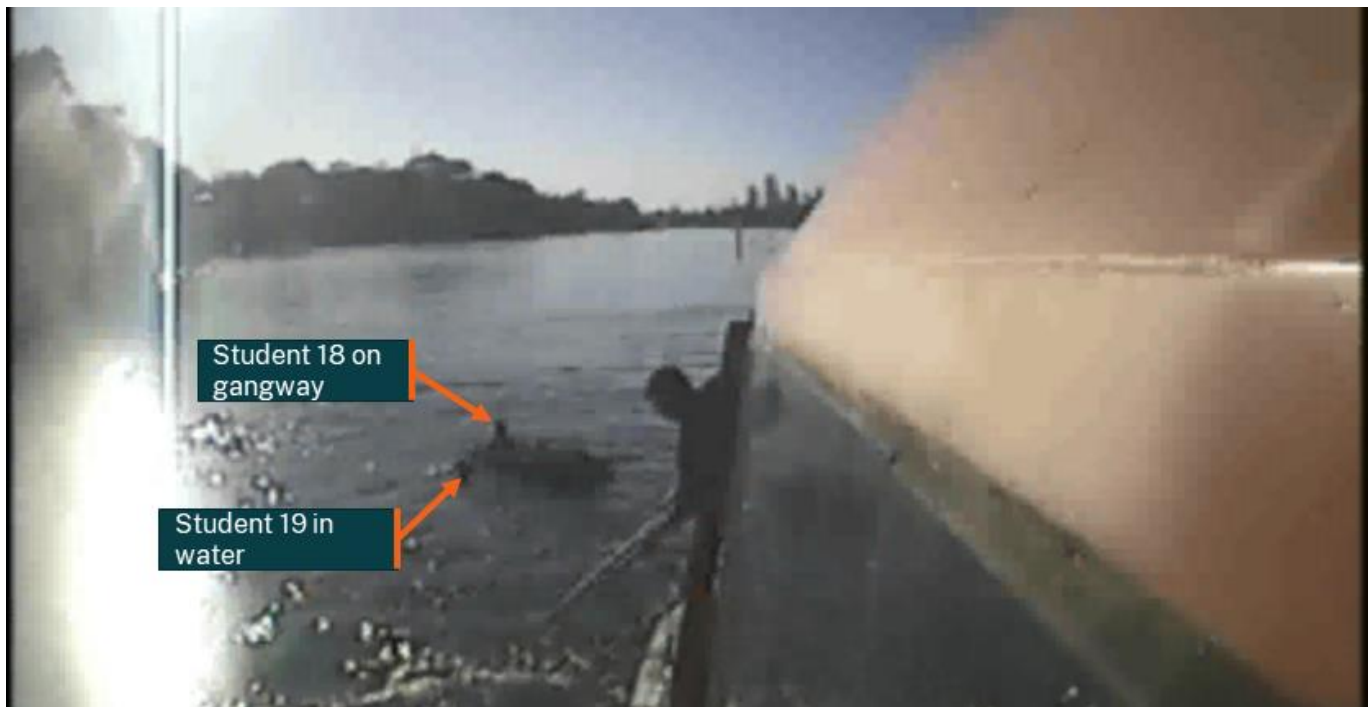
Figure 11: Onboard portside CCTV showing the vessel manoeuvring towards students and gangway at 0812:33

- 1.21 At 0812:28, the Master manoeuvred the vessel away from the wharf and towards the three students in the water, who had drifted downstream to the east. The movement of the vessel away from the wharf caused the attached mooring line to break.
- 1.22 At 0812:33, as the Master positioned the vessel towards the students in the water, Student 18 was on the upturned gangway with Student 19 in the water next to it (Figure 11). At that time, Student 16 was reported trapped underneath the gangway, with their backpack, positioned with the straps over their shoulders, lodged between the submerged gangway handrails. Student 19 swam underwater to free Student 16 from under the gangway, reported to have taken several attempts. Student 16 subsequently surfaced free of the gangway, with the assistance of Student 19.

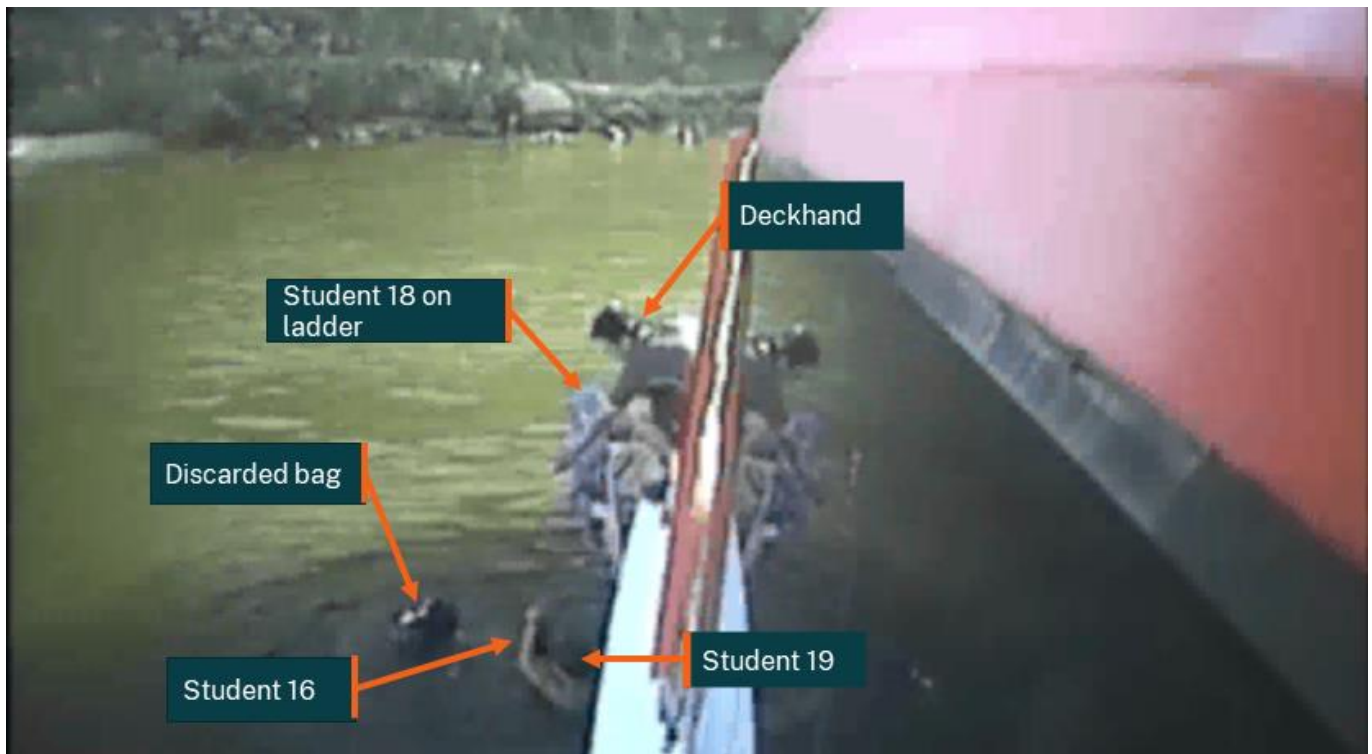
Figure 12: Onboard portside CCTV showing students climbing the ladder at 0813:45

- 1.23 At 0812:43 the Deckhand finished setting the POB ladder and began to give bearings to the Master for the position of the students in the water, via hand signals. The Master manoeuvred the vessel to the students' position.
- 1.24 At 0812:53, the vessel overshot the students in the water. The Deckhand again used hand signals to direct the Master back towards the three students. At 0813:15, the students were close to the base of the ladder when the Deckhand left the doorway to get a life ring, which was deployed at 0813:23.
- 1.25 At 0813:41, all three students swam to the base of the ladder and began to climb up onto the vessel. Student 18 went first, after discarding their backpack which had become waterlogged, impeding their climb (Figure 12).

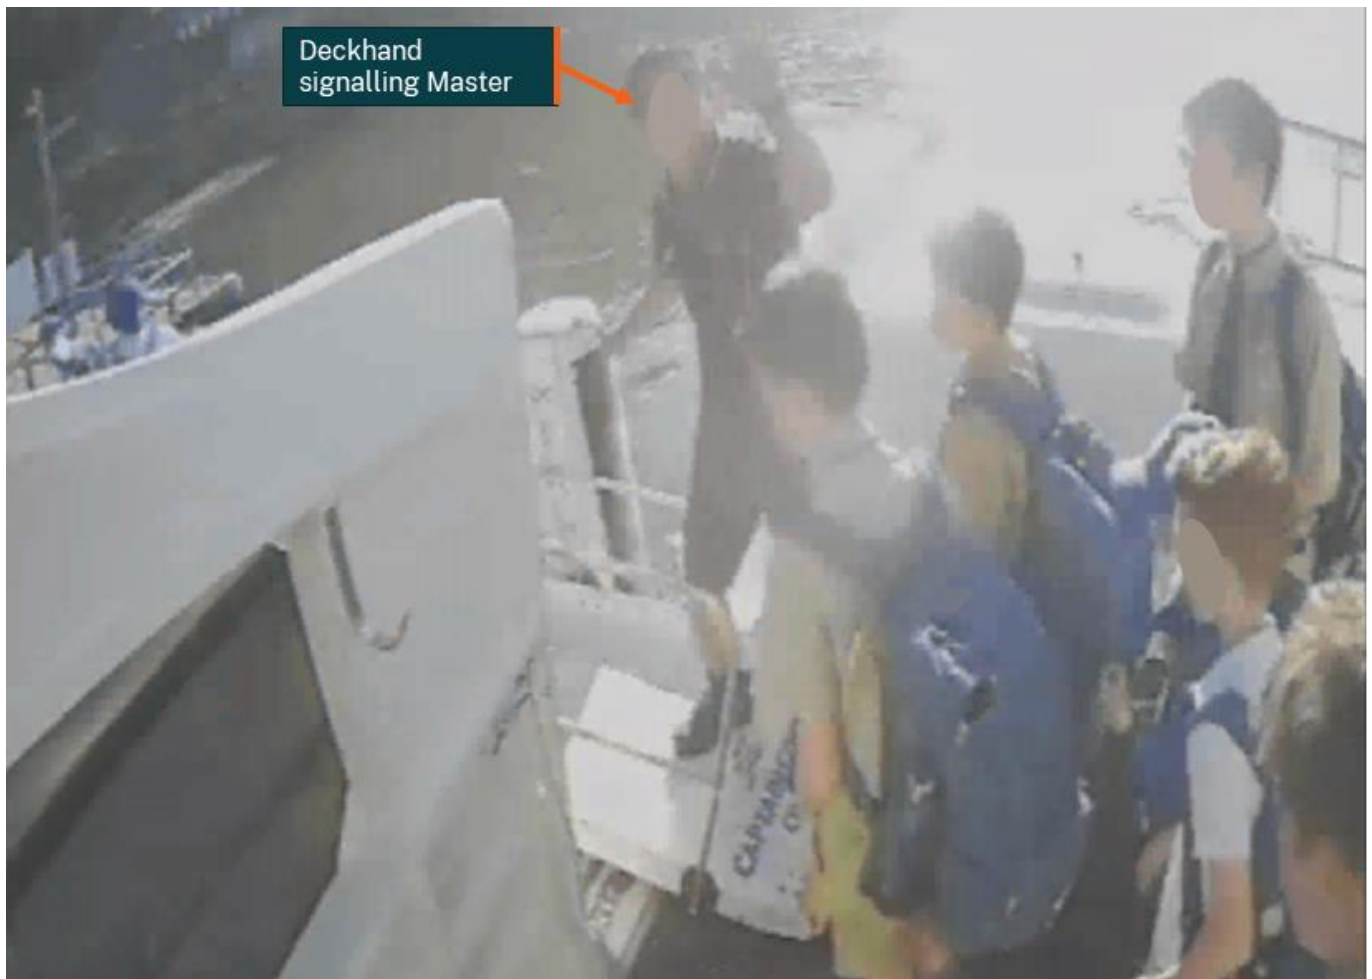
Figure 14: Onboard forward deck CCTV showing the Deckhand signalling the Master and stopping disembarkation

- 1.28 The crew later recovered the life ring before the Master manoeuvred the vessel back to the wharf. At 0818:47, the Master approached the wharf again. The Master instructed the Deckhand to secure the mooring line to the western side of the wharf so that they could secure the vessel and engage ahead (forward) propulsion, rather than laying astern (in reverse), as before.

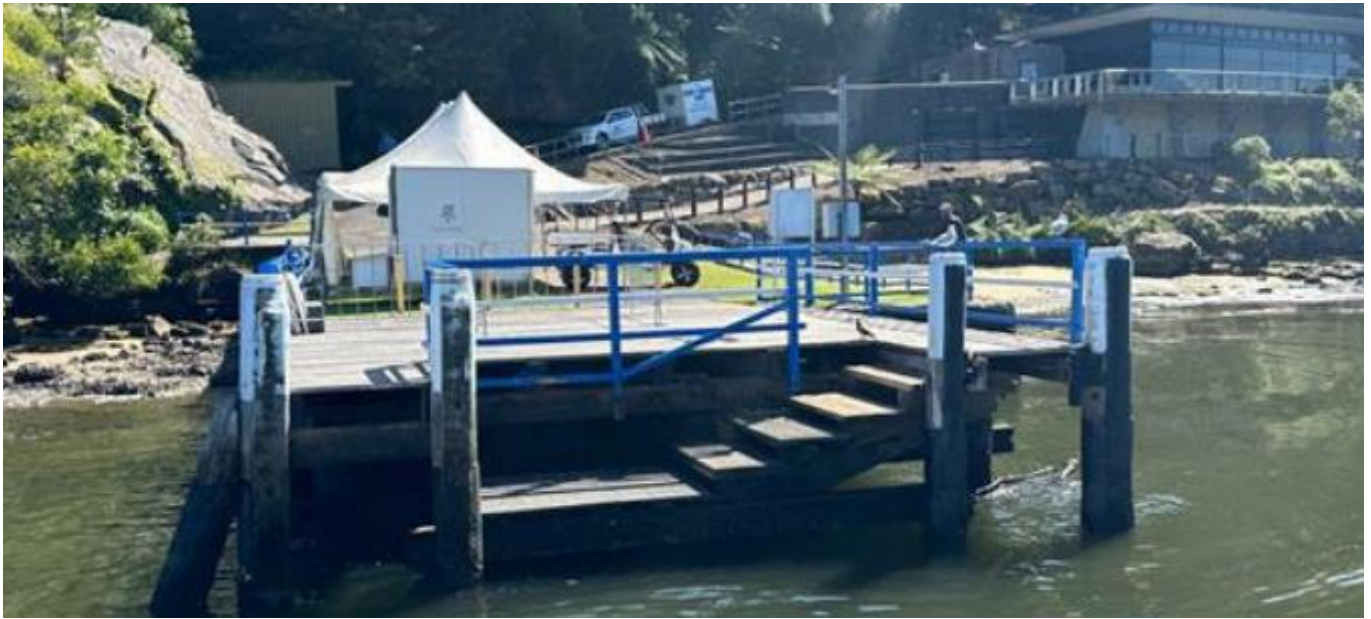
**Figure 18: Riverview College Wharf profile at low tide**

1.42 There were four wooden steps, the first approximately 450 mm wide with the remaining three 670 mm wide, leading down to a wooden landing that was approximately 2 m wide (Figure 18). The landing and lower two steps were covered with a Fibre Reinforced Plastic nonslip surface. The steps and lower landing were utilised by ferry crew during lower tidal periods when transferring passengers to and from the vessel. At the time of the incident, the wharf had no nonslip paint, edge markings, person overboard retrieval ladder or lighting at the wharf face.
