Safety Alert SAL01/25

Track mounted bus seat anchorage design and inspection

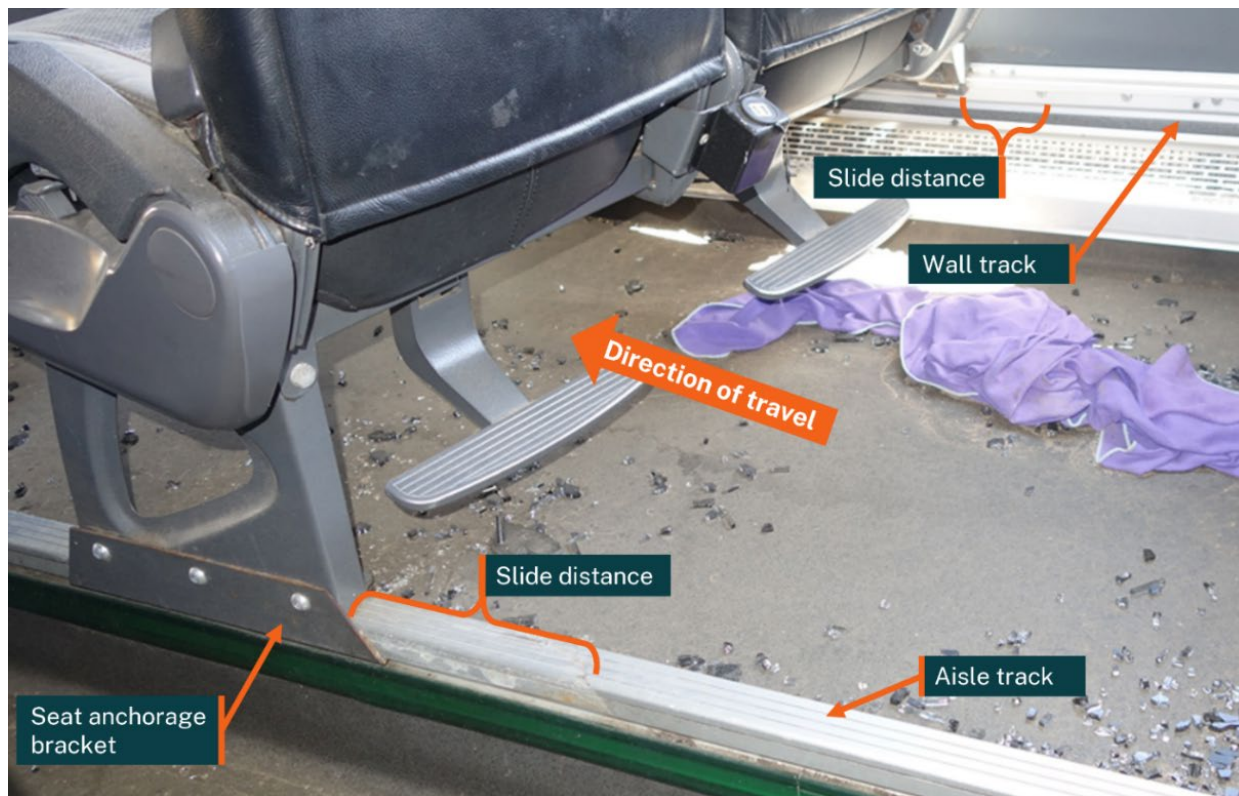
Figure 1: Seat slide and track mounting details

A 2013 coach was involved in a frontal crash with several seats sliding forward as a result (Figure 1). The seats were installed using a track mounting (rail) system that did not require drilling into the floor or track to install the seats. The seating position was retained using brackets and a clamping system (Figure 2):

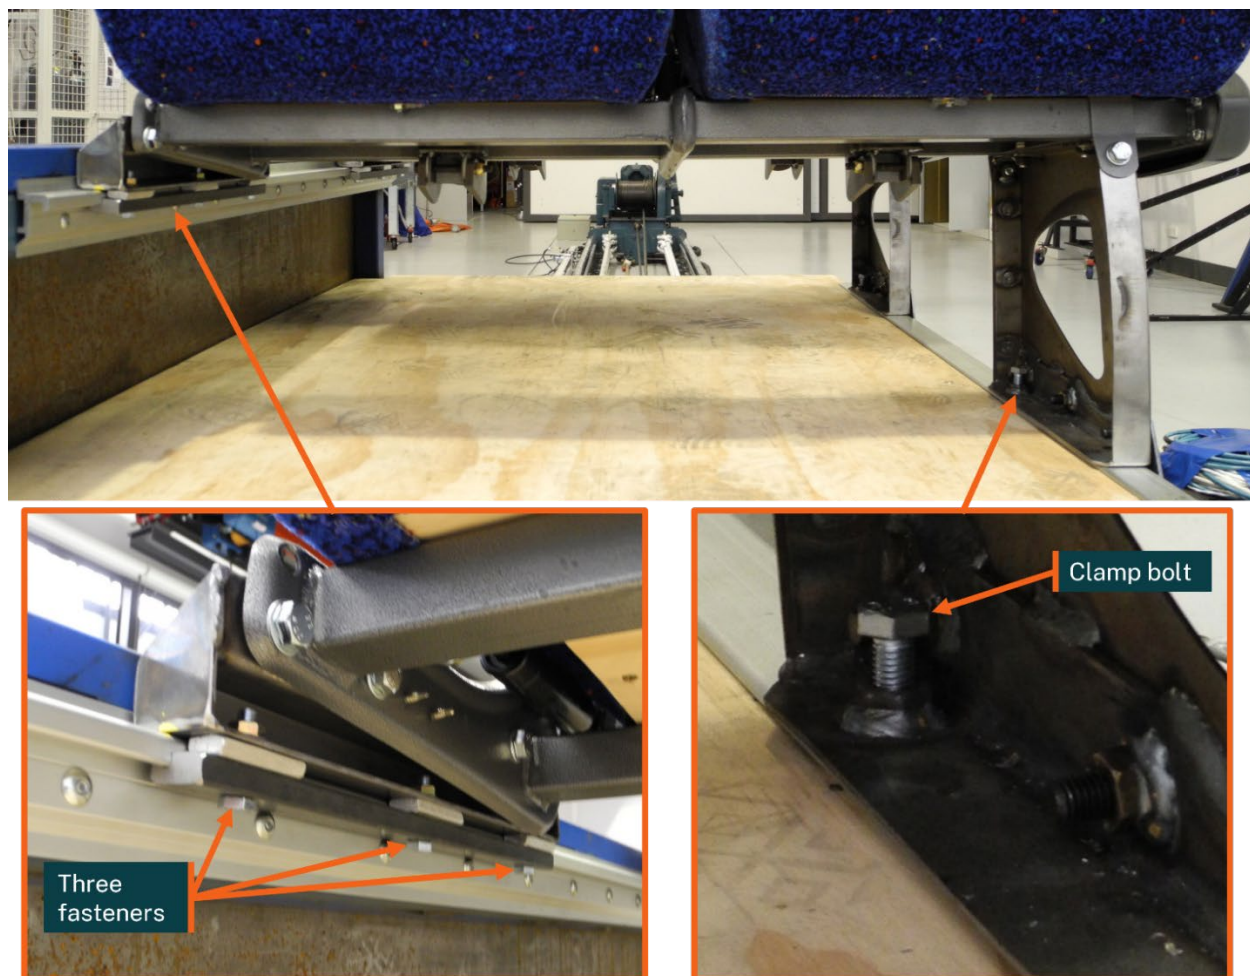
Figure 2: Mounting track securing arrangement

- The outboard side (window) of the seat frame was retained with three fasteners fixed to a clamping arrangement that was located on a continuous rail affixed to the coach side frame. This arrangement included serrated flange nuts (whiz nut)¹ to prevent the fasteners loosening.
- The inboard side (aisle) was attached to the floor rail with an angle bracket bolted to the seat in three places and retained with a single bolt that passed through a nut welded to the

seat frame which clamped to the aluminium track. There was no secondary securing mechanism to prevent the fastener from loosening.

If the clamping bolts become loose due to vibration, there were no secondary mechanisms to prevent the seat from sliding on the tracking when subjected to forces in a crash.

The outboard mounting clamp was secured with three bolts fitted with serrated flange type nuts. The inboard mounting clamp had a single bolt secured to a nut welded to the seat frame.

The OEM of the seats developed a service bulletin to instruct operators to inspect and torque the fasteners. This included that it was best practice to apply thread-lock compound to the fasteners to limit the likelihood that a fastener would loosen, and using a paint marker to witness mark the fasteners for ongoing visual inspections.
