Light Rail Safety Investigation Report

Fractures of Urbos 3 LRV underframes — Sydney Inner
West Light Rail Line, 27 October 2021

Fractures of Urbos 3 light rail vehicle underframes Sydney Inner West Light Rail Line

Investigation Reference I02011

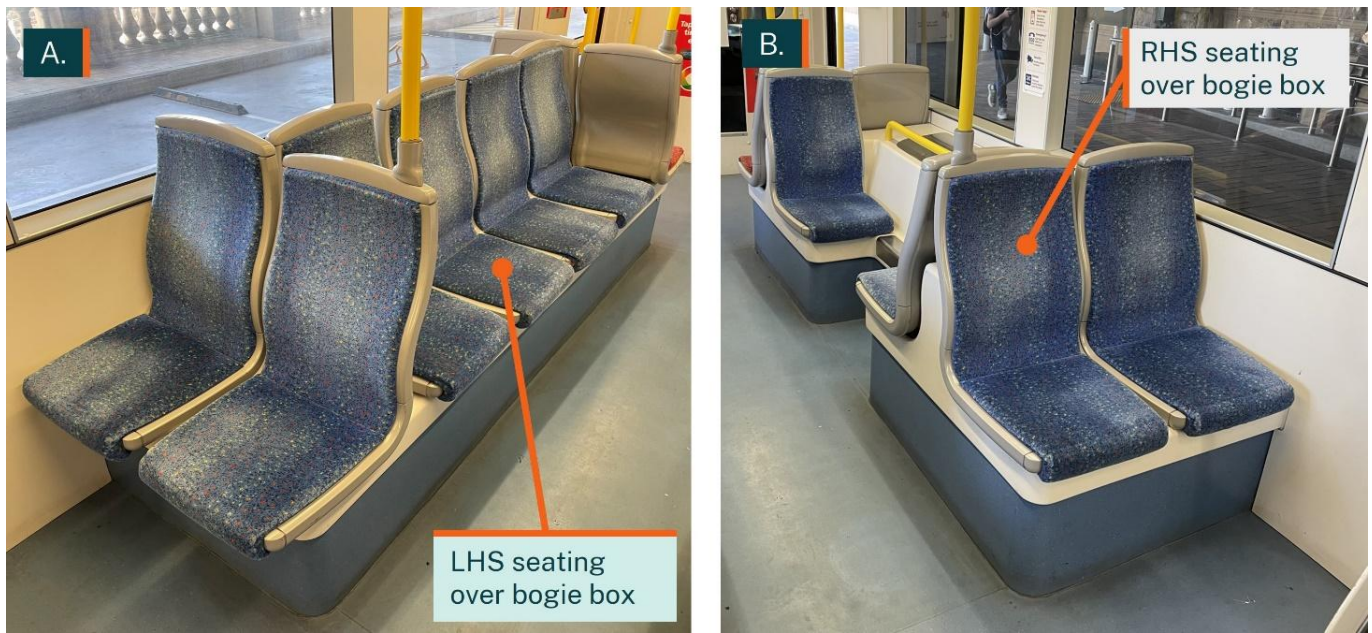
Figure 3: Urbos 3 C module carbody seating arrangements over bogie box

1.12 The underframe fractures which led to LRV services being suspended were found on the C module bogie boxes under the passenger seating arrangements (Figure 3).

Urbos 3 C module carbody seating arrangements. Image A: left-hand side (LHS) seating over LHS bogie box. Image B: right-hand side (RHS) seating over RHS bogie box. Fractures were identified in both LHS and RHS bogie box locations following removal of the seating. Source: OTSI

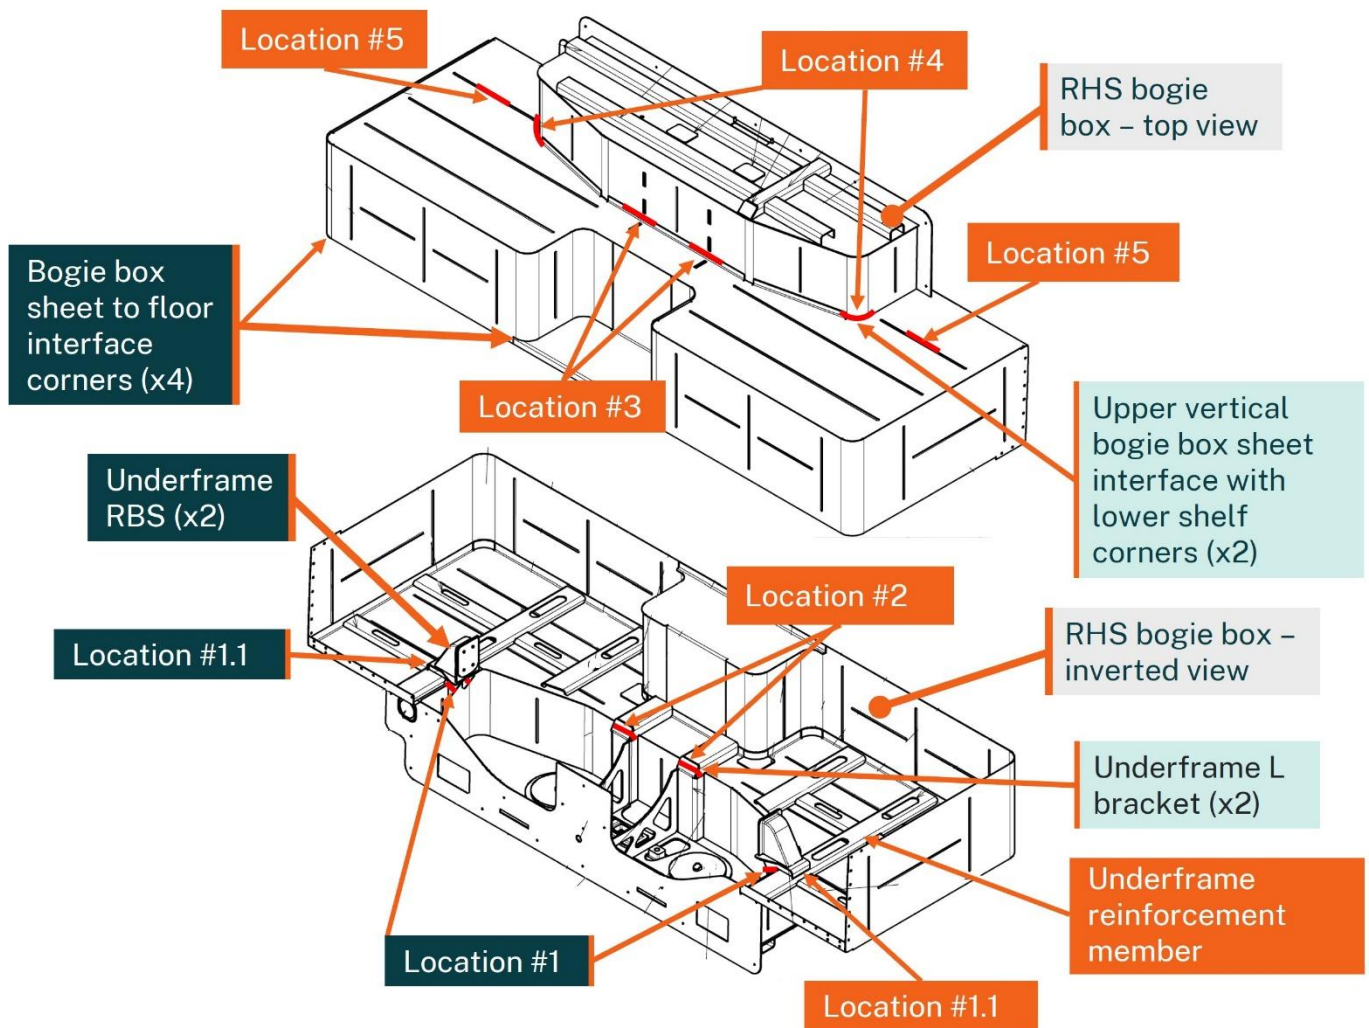
Figure 4: Underframe right-hand side bogie box fracture locations

- 1.13 Underframe fractures were found in 5 common areas on the C module through visual and non-destructive inspections⁸ (Figure 4).
- 1.14 As shown in Figure 4, the location of fracture location #1 in the underframe RBS was close to fracture location #4 in the top side bogie box sheeting. In addition, fracture location #2 in the L bracket⁹ structure was adjacent the top side bogie box sheeting at fracture location #3.

Top and inverted view of the RHS underframe bogie box assembly depicting typical fracture locations of both RHS and LHS bogie boxes identified during visual and non-destructive testing. Fractures underneath the bogie box structure of the underframe were identified at Location #1 in the underframe RBS gusset, and Location #2 in the L bracket corner. Fractures on the top side of the bogie box structure were identified at; Location #3 in the bogie box sheeting interface between the upper vertical sheet and lower shelf, Location #4 in the upper vertical bogie box sheet with lower shelf corners, and Location #5 along the lower bogie box shelf sheeting. No fractures were identified in the horizontal welding of the RBS structure to the underframe reinforcement members at Location #1.1. Location #1.1 provided a reference location for the TfNSW design assessment review.

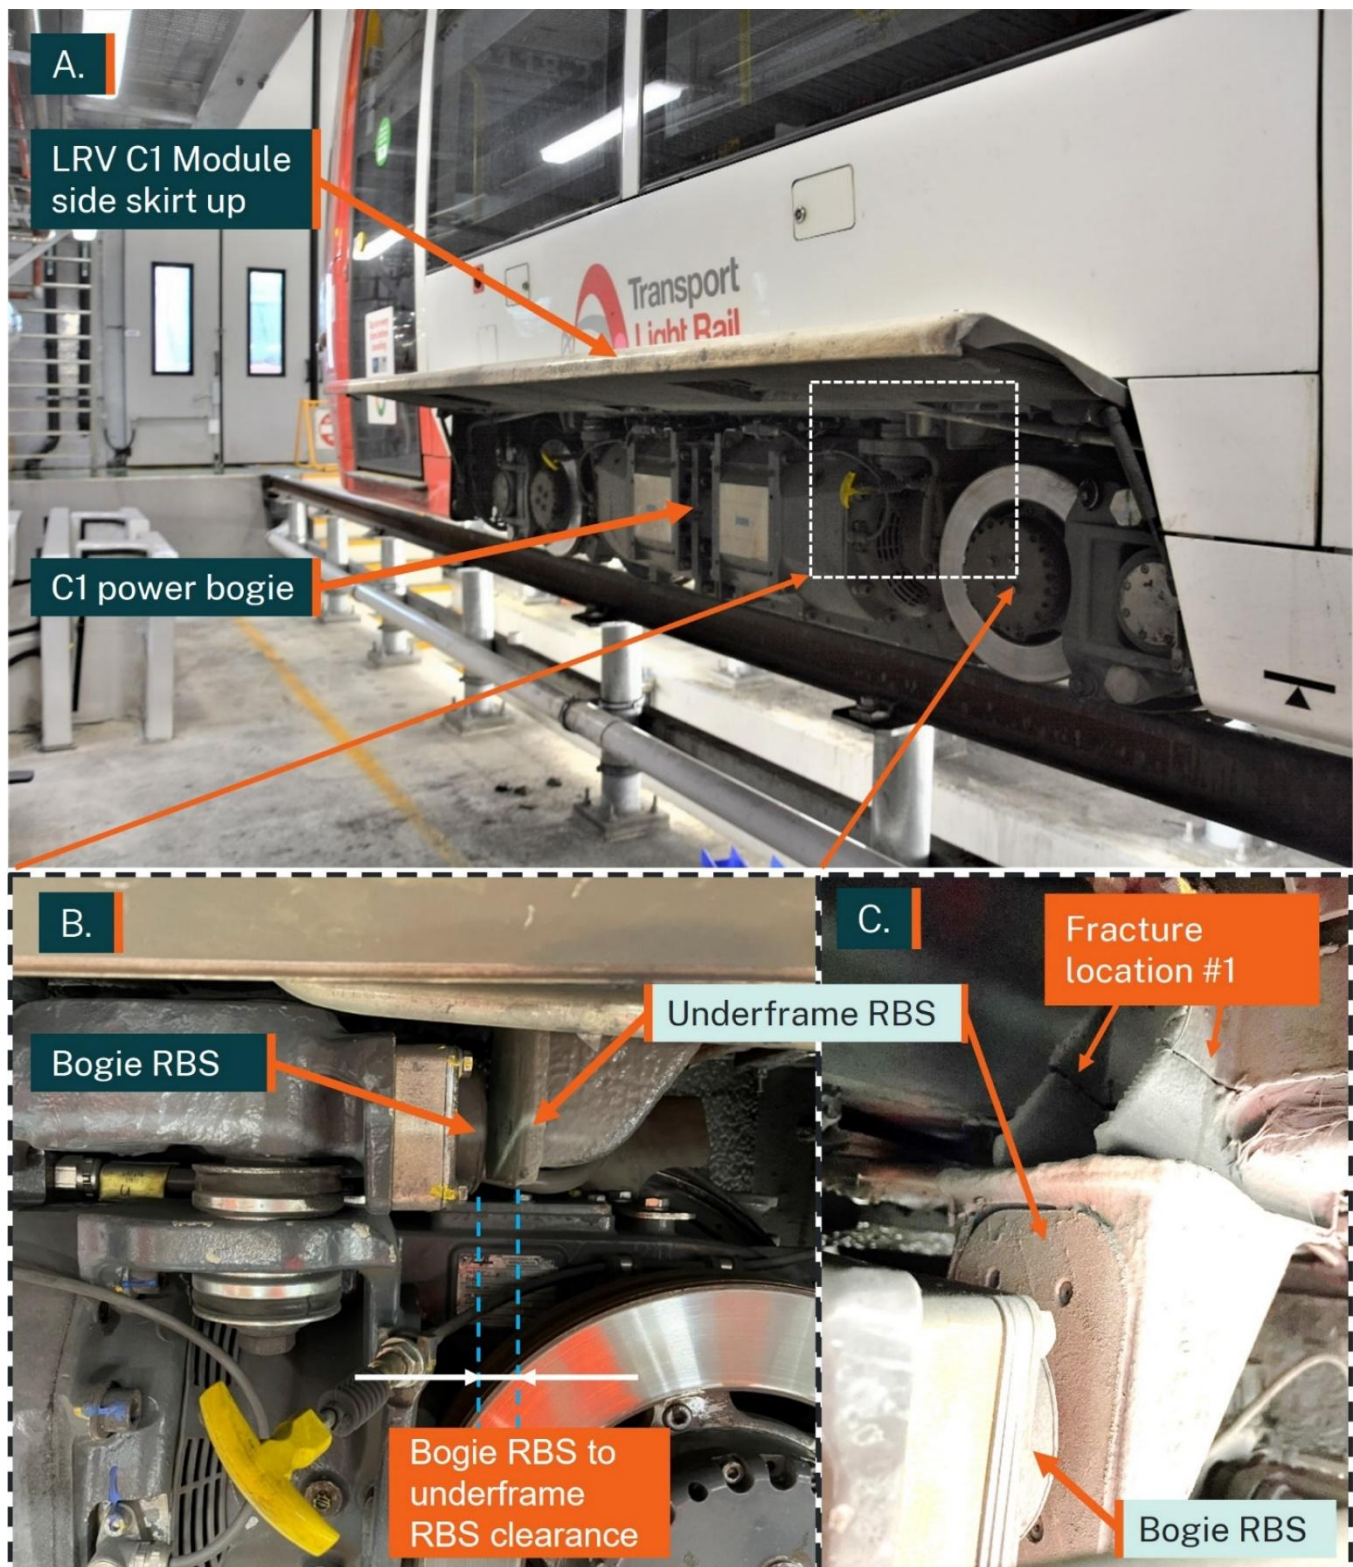
Figure 5: Underframe RBS fracture location relative to LRV carbody and bogie

- 1.15 Fractures were initially found in the LRV underframe at the RBS – Location #1 (Figure 5 and Figure 6). Fracture of the LRV underframe at the RBS location was observed to have extended into the underframe bogie box sheeting, and in some cases underframe reinforcement member (Figure 6).

Underframe fracture location #1 relative to LRV carbody and bogie. Image A: LRV C1 module on an inspection road (depicting view outside of inspection pit) with side skirt raised showing C1 motor bogie. Image B: Close up view of bogie RBS and underframe RBS with clearance between the two surfaces that could have made contact when an LRV traversed a curve. Image C: Close up view of the bogie RBS, underframe RBS and fracture location #1 in both RBS triangular gussets.

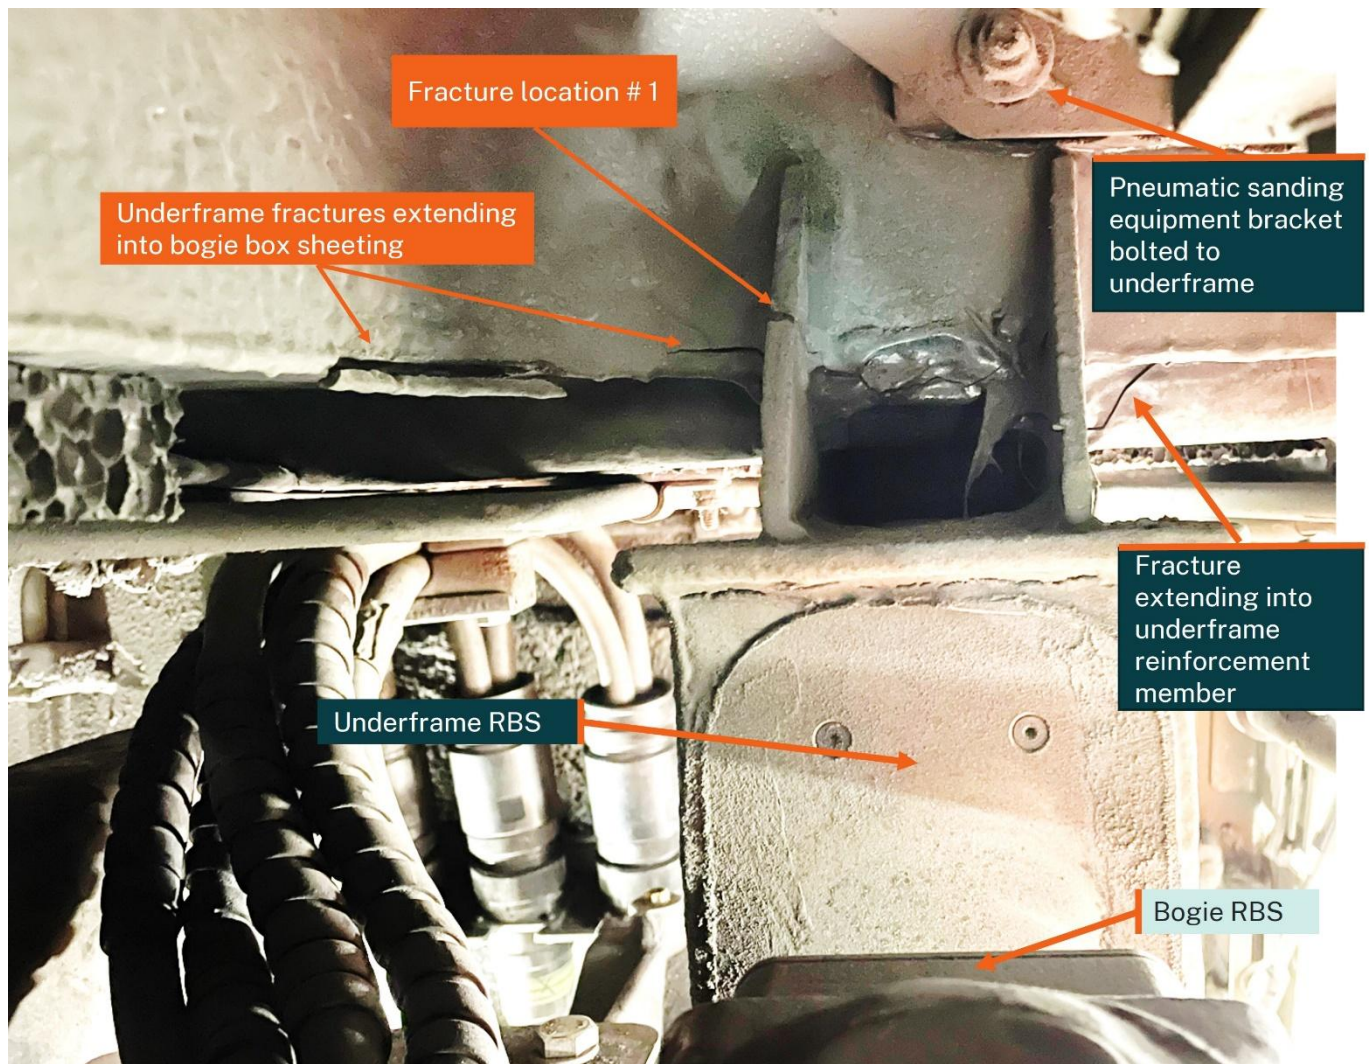
Figure 6: Underside view of bogie box and underframe RBS fractures

Image depicts bogie box sheeting fractures, single gusset fracture at location #1 and fracture extending into underframe reinforcement member. Image also depicts pneumatic sanding equipment bracket bolted to the underframe. Underframe RBS and bogie RBS visible in foreground. Image taken with LRV on an inspection pit, LRV side skirt raised, with view from outside of inspection pit. Source: OTSI

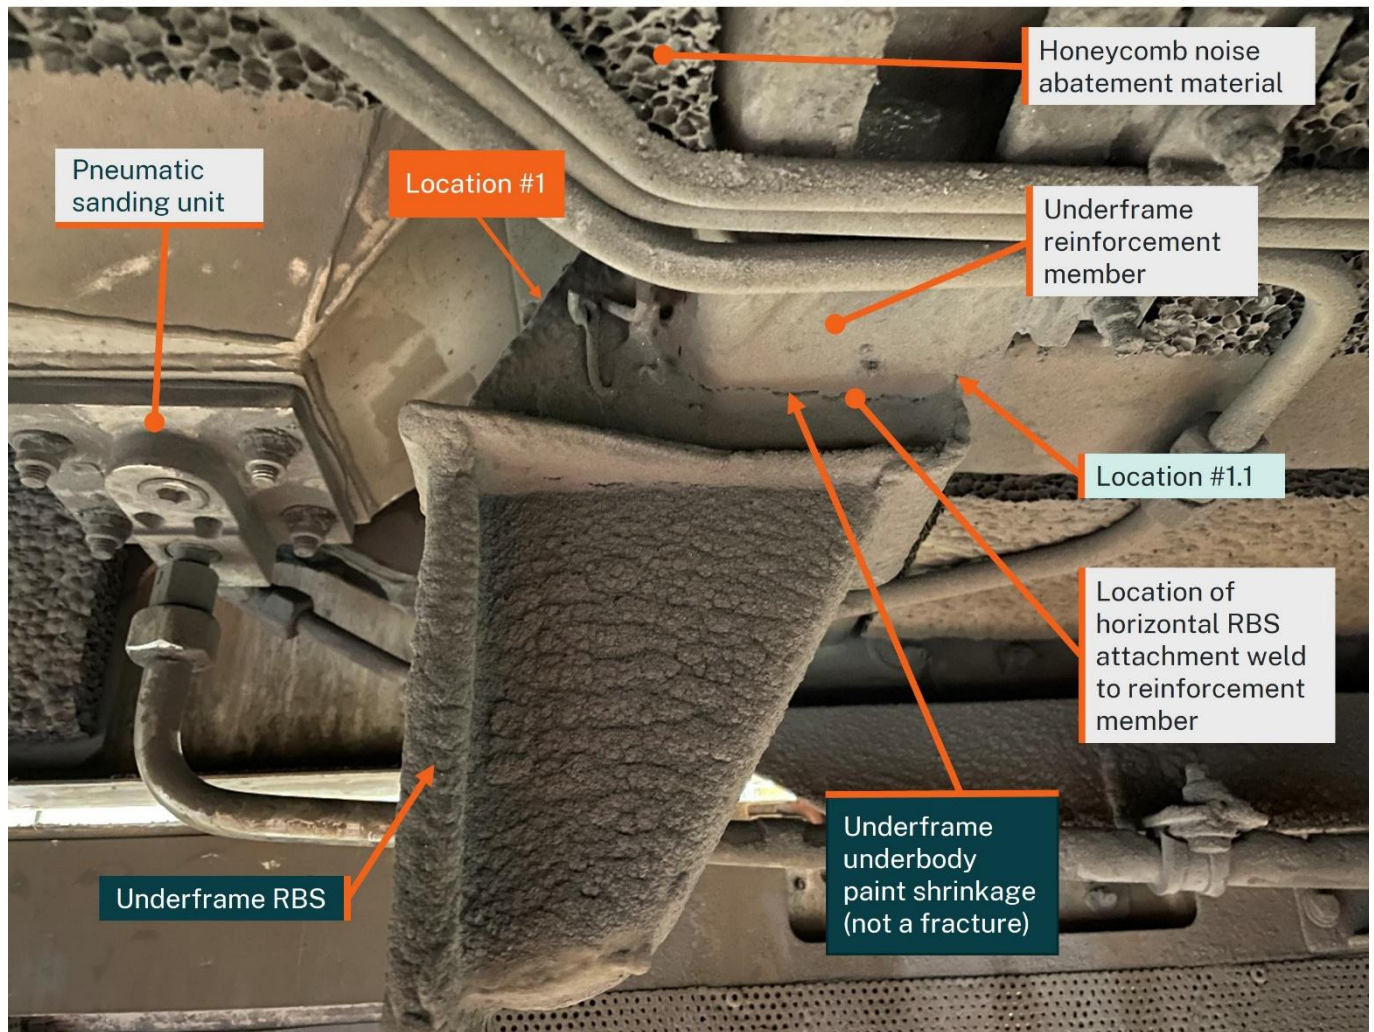
Figure 7: Side view of underframe RBS and components

- 1.16 The underframe RBS was welded to a reinforcement member with vertical and horizontal fillet welds. The surface of both the underframe RBS and reinforcement member were covered with thick protective layers of paint (Figure 7). Underframe underbody paint was noted on the RBS structure with paint shrinkage (appearing as fractures in the paint surface only) along the horizontal RBS attachment weld to the reinforcement member. The underframe RBS was also located near the LRV pneumatic sanding equipment that was bolted to the underframe via an attaching bracket arrangement (Figure 6 and Figure 7). Noise abatement material (honeycomb structure) was also affixed to the underframe at various locations (Figure 7).

Side view of the underframe RBS facing towards the outside of the carbody with the motor bogie removed and LRV placed on lifting stands. Underframe pneumatic sanding equipment was located near the RBS structure. Underframe underbody paint was noted on the RBS structure with paint shrinkage (appearing as fractures in the paint surface only but not a fracture in the RBS) along the horizontal RBS attachment weld to the reinforcement member. Honeycomb noise abatement material was also visible covering some of the surface area of the bogie box structure.

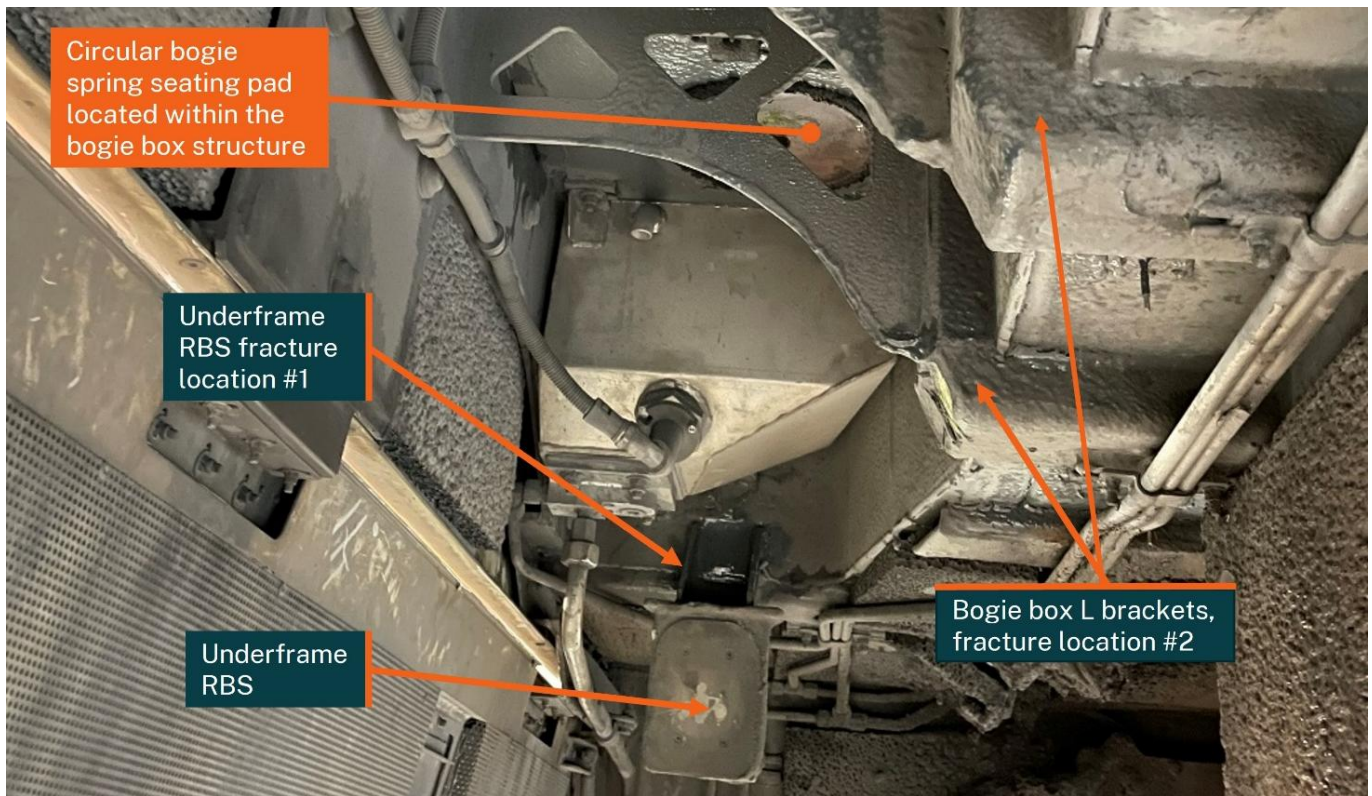
Figure 8: Left-side bogie box RBS fracture location #1 and L brackets fracture location #2

1.17 Fractures of the LRV underframe at the L bracket were found during non-destructive visual inspection and testing following removal of underbody paint. The underframe bogie box structure, including the L bracket location is depicted in Figure 8, with the location of an L bracket fracture depicted in Figure 9.

Left-side underframe bogie box area facing towards the C module front with the motor bogie removed and LRV placed on lifting stands. Underframe RBS fracture location #1 and bogie box L brackets fracture location #2 indicated. Circular bogie spring pad where a bogie spring seated into the bogie box frame also indicated.

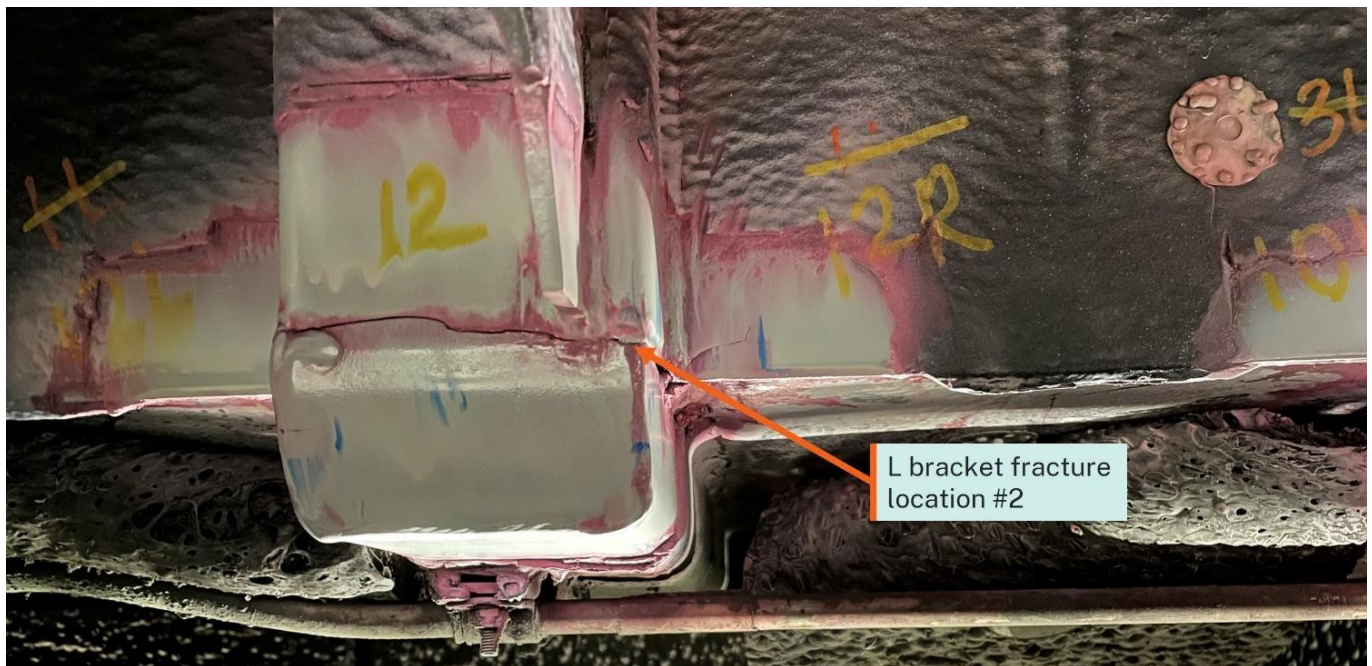
Figure 9: L bracket fracture location #2

L bracket fracture location #2 following removal of thick protective paint and application of dye penetrant testing to highlight fracture line (black line through pink dye).

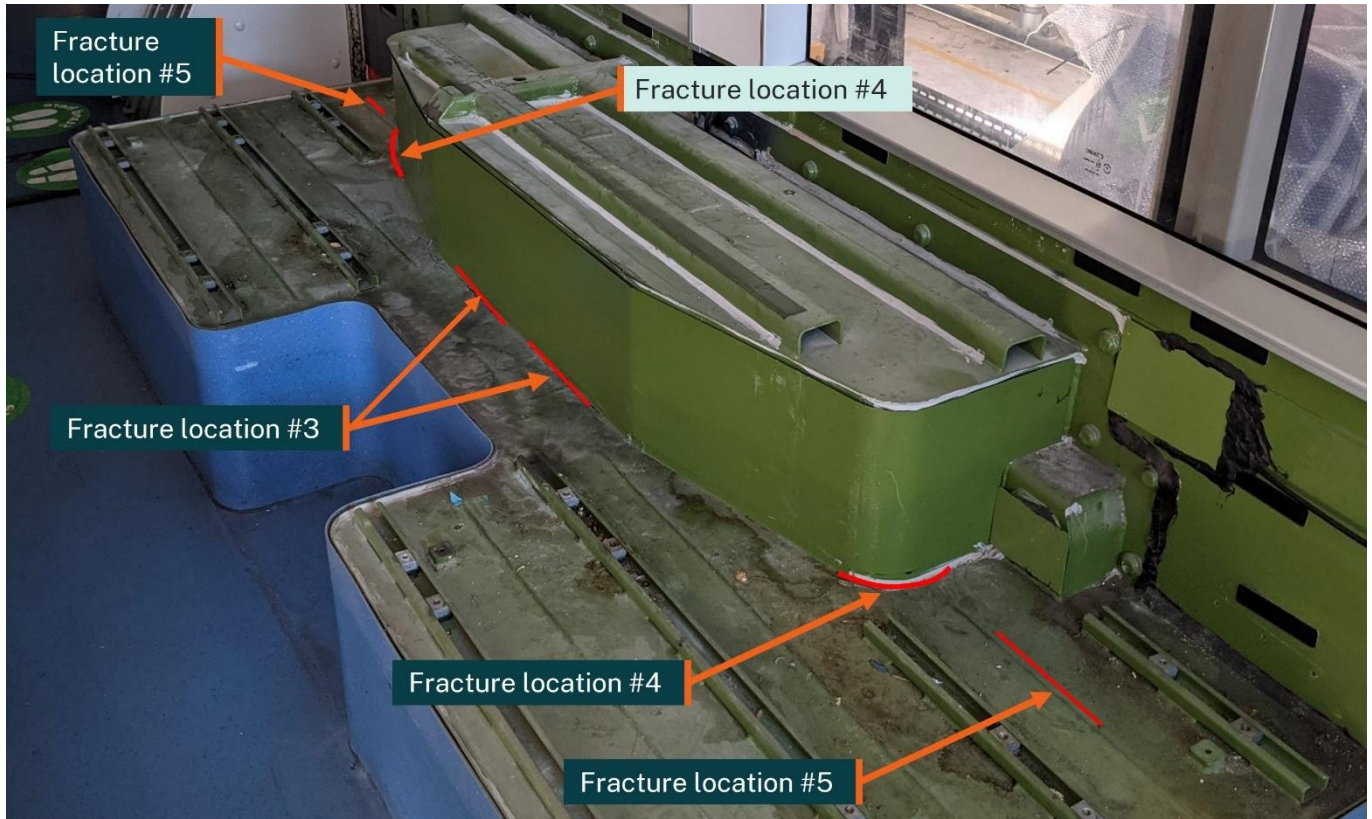
Figure 10: Top left hand side bogie box fracture locations #3, #4 and #5

1.18 Fractures of the LRV bogie box structure were found following removal of the passenger seating and fibreglass moulding depicted in Figure 3 on page 13. The location of fractures were identified as locations #3, #4 and #5 (Figure 10) with some examples shown in Figure 11.

Top side of bogie box structure (right side) with fracture locations #3, #4 and #5 identified with red lines.
Source: OTSI

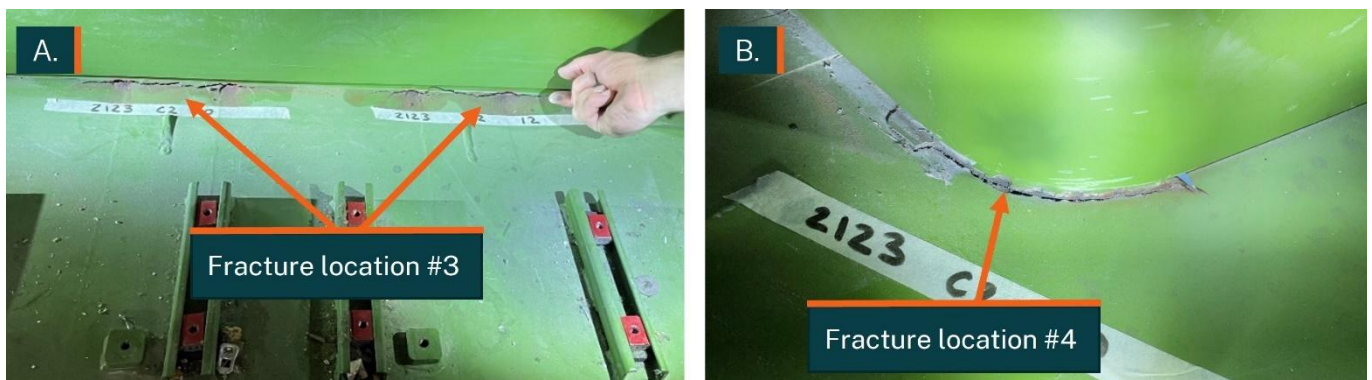
Figure 11: Examples of top side bogie box fracture locations #3 and #4

Examples of top side bogie box fracture locations #3 and #4 from U2123 C2 module.
Source: OTSI

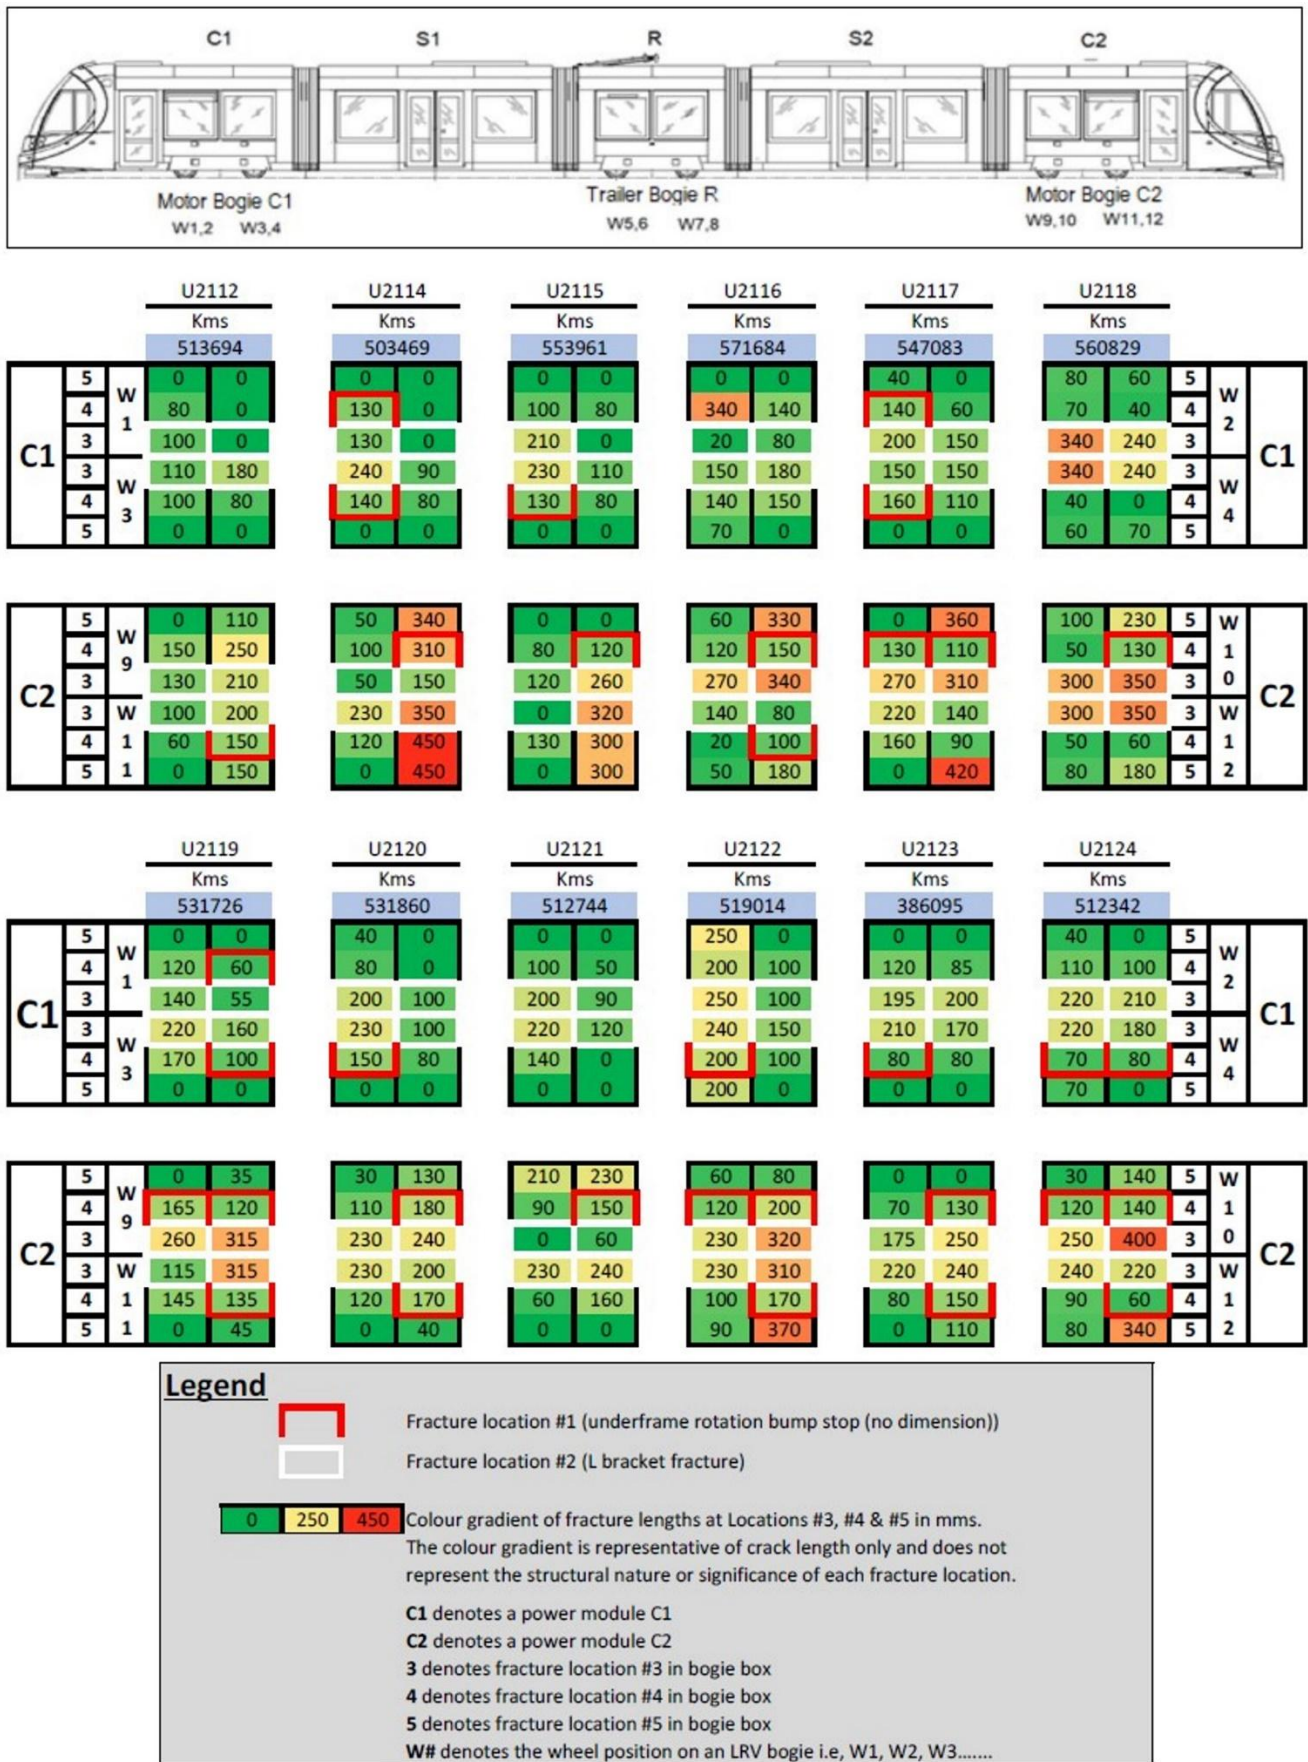
Figure 12: Urbos 3 unit fracture locations, measurements and LRV kms travelled

- 1.19 Fracture lengths at the fracture locations were recorded, except for the underframe RBS fracture measurements. A summary of the fracture locations is detailed below and depicted in Figure 12.

- a. All C module underframe bogie boxes of the LRV fleet (48 in total) were identified with fractures in the L bracket location #2 (96 L brackets).
 - b. Not all underframe RBS had fractures in the gussets at fracture location #1, i.e. 35 per cent of C module underframe RBS gussets were identified with fractures at location #1.

- c. Some examples existed of LRV units with no underframe RBS fractures in a C module (U2112, U2116, U2118, U2121 C1 modules). However, those C modules had fractures at location #4, near the underframe RBS attachment at location #1.

- e. No fractures of the underframe RBS attachment to the underframe reinforcement member were detected at the horizontal and rear welds (Location #1.1).

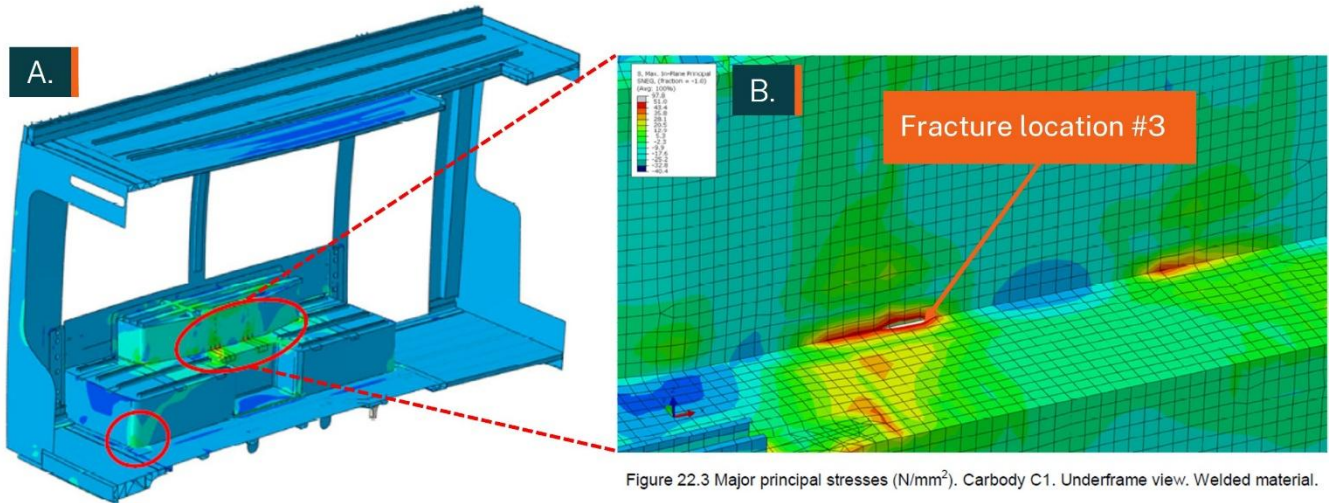
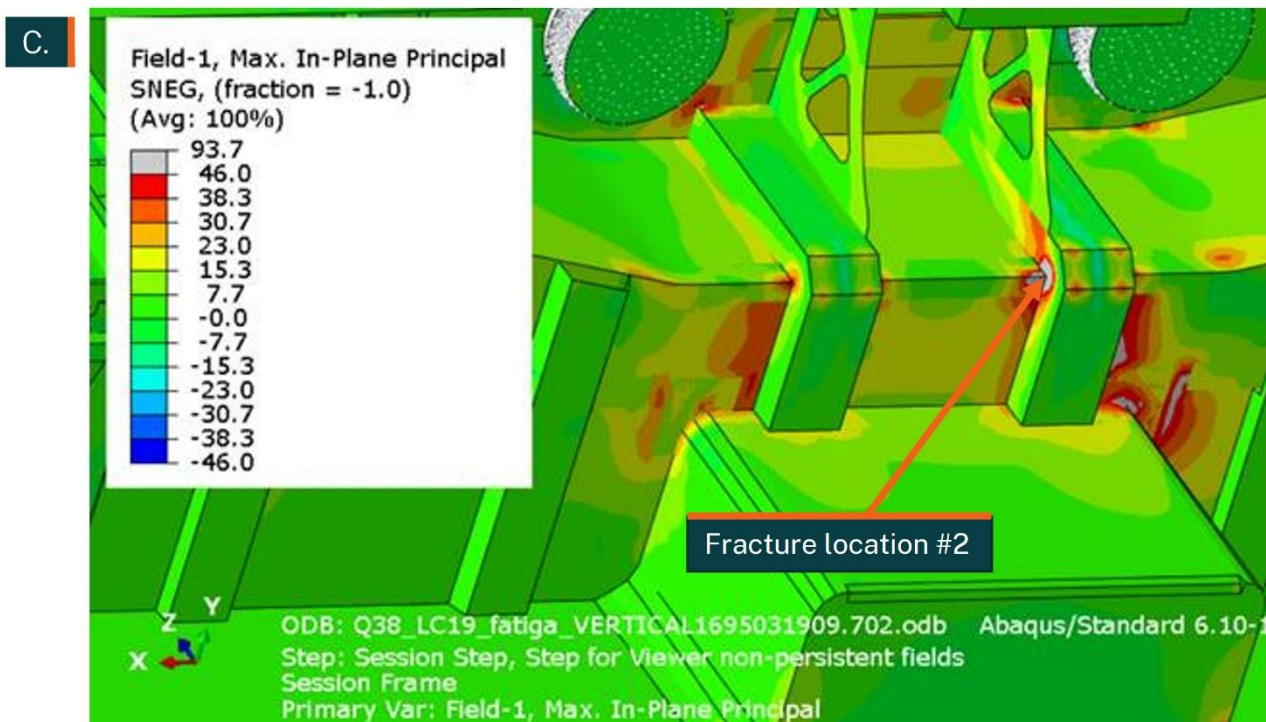
Figure 13: CAF FEA major principal stresses plots of welded material in carbody C1

CAF FEA major fatigue principal stress plots in welded material for the vertical fatigue load case. The plots provided an indication of where the major principal stress resided in the underframe welded structure. Image A: RHS view of Carbody C1 major principal stresses plot in welded material noting the ellipse area where the major principal stress was located in proximity to fracture location #3. Image B: Enlarged view of the stress plot ellipse section with grey shaded area being the major principal stress location in the bogie box structure and its proximity to fracture location #3. Image C: Inverted enlarged view of bogie box area showing section of stress plot where the major fatigue principal stress was located in the vicinity of fracture location #2.

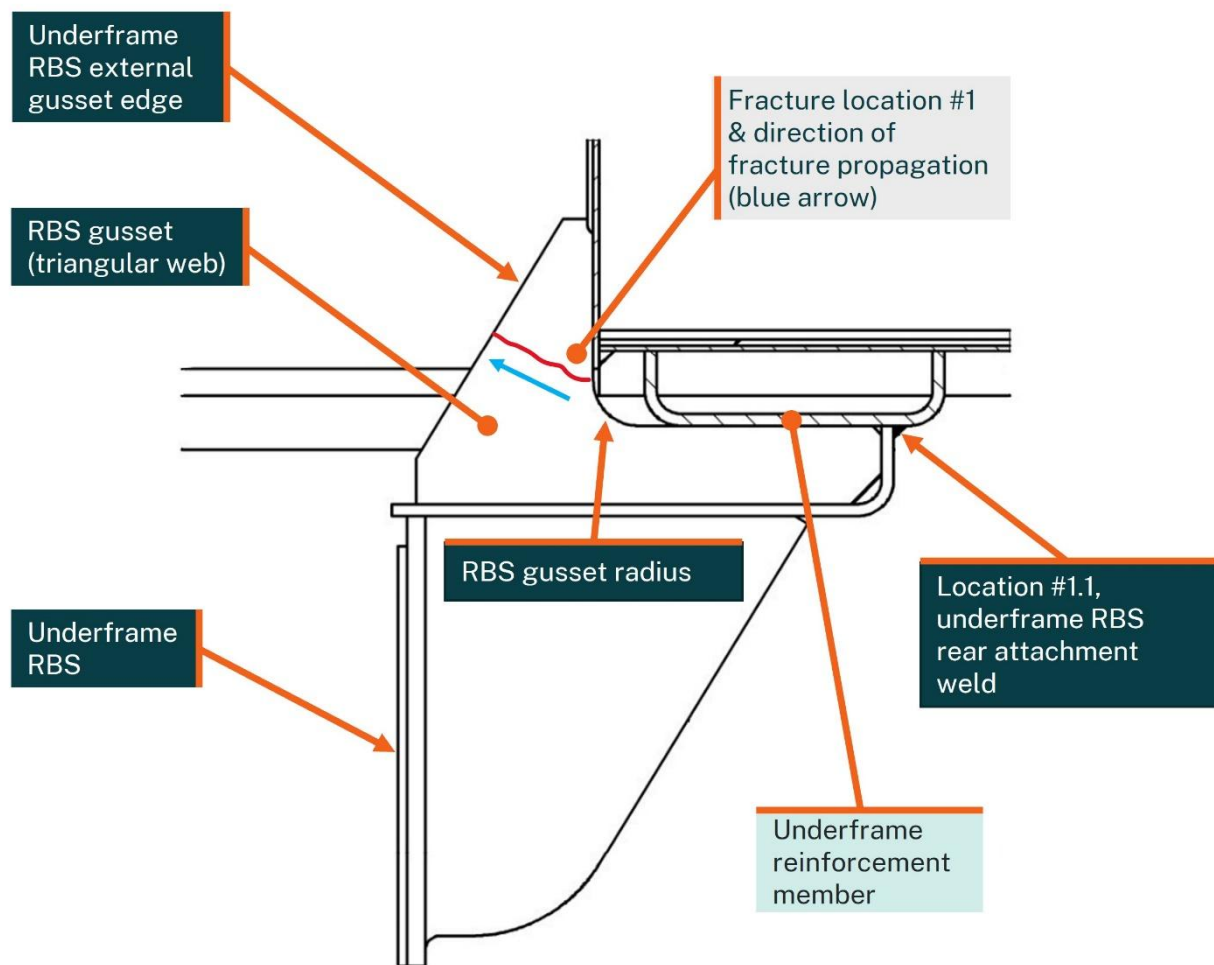
Figure 22: Fracture location #1 propagation direction in underframe RBS gusset

Side view of RBS structure depicting fracture location #1 and the direction of fracture propagation (shown as a blue arrow) in the RBS triangular gusset.

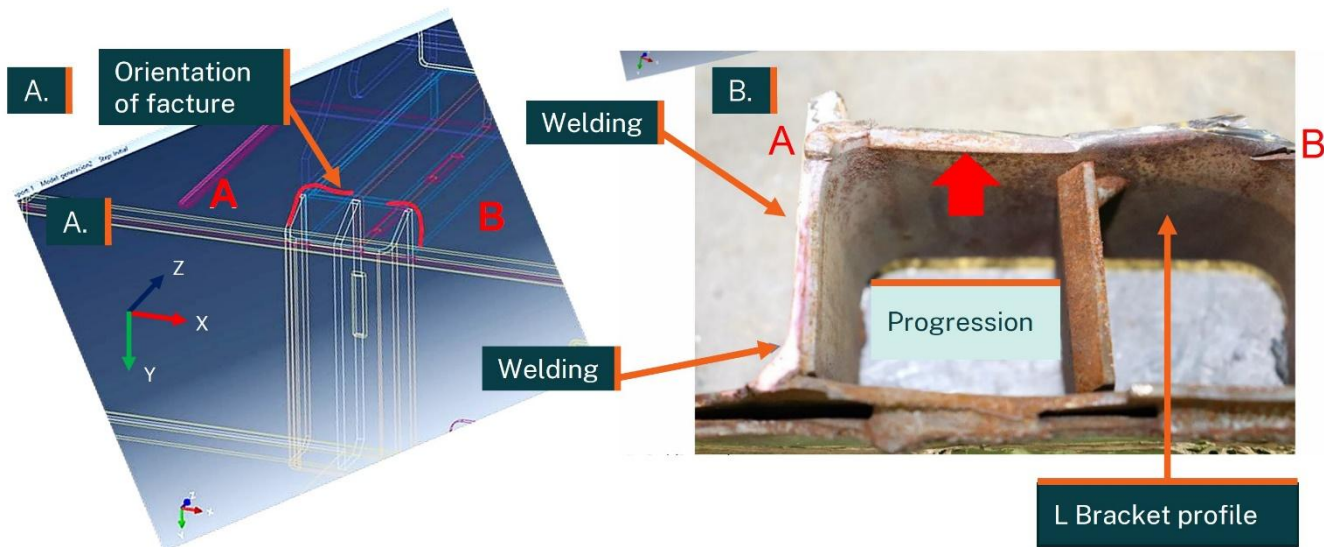
Figure 23: Fracture location #2 – CAF metallurgical examination of L bracket

Section of L bracket (fracture location #2) removed for metallurgical examination.

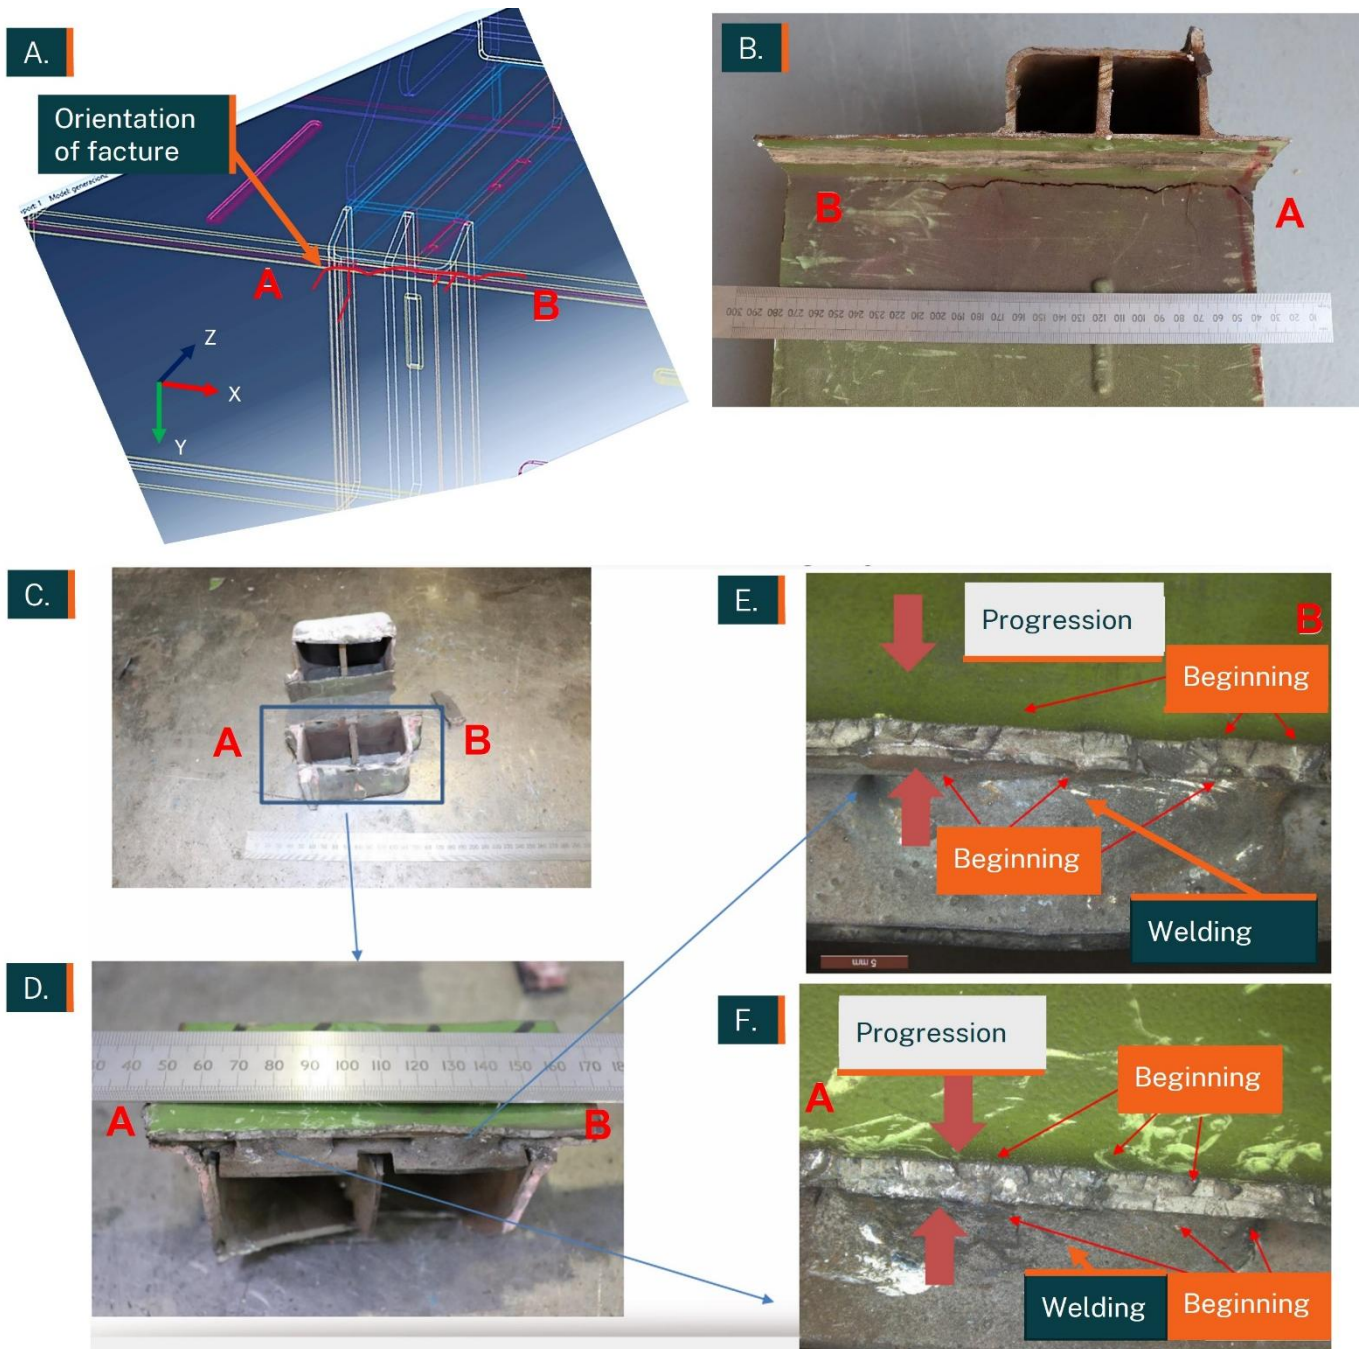
Figure 24: Fracture location #3 – CAF metallurgical examination of bogie box sheeting

Section of L bracket (fracture location #2) and bogie box vertical and horizontal sheeting (fracture location #3).

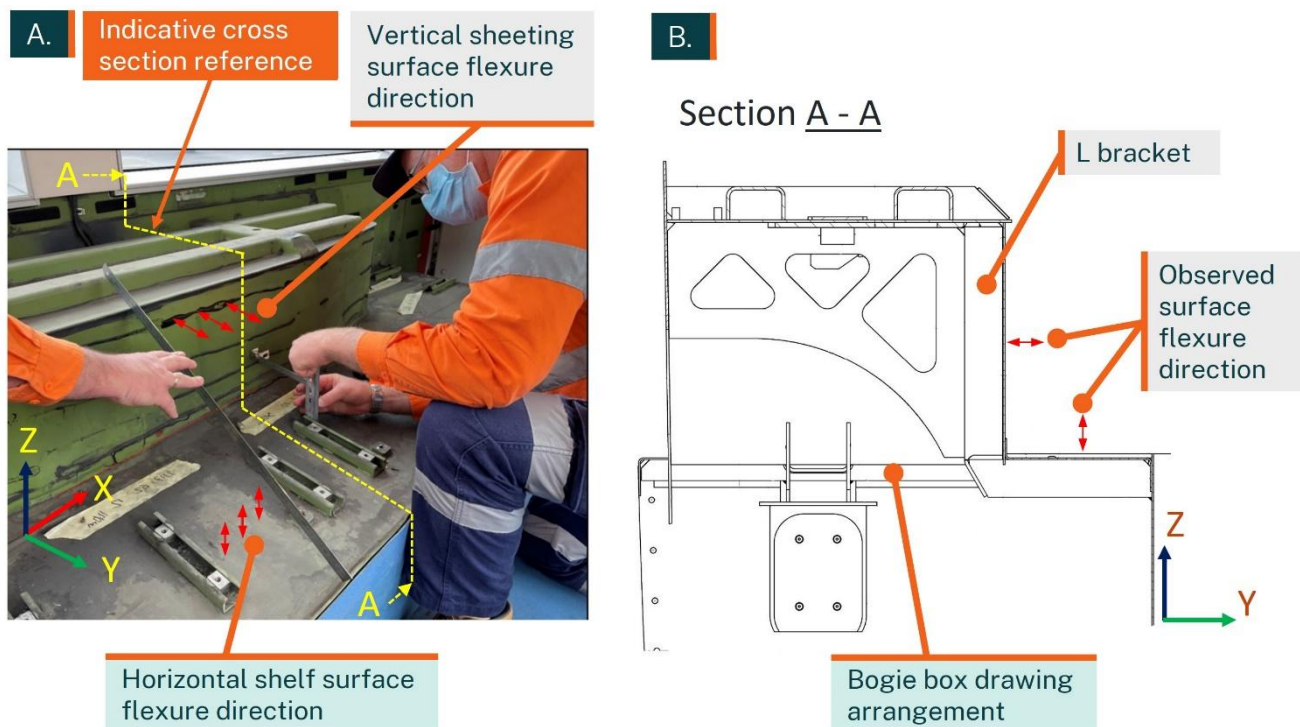
Figure 25: Urbos 3 original design – bogie box observations during dynamic operation

Image A: Small red arrows indicating surface flexure direction of bogie box on U2117 that was operated with fractures. Photograph mirrored vertically to align with orientation of the adjacent drawing in Image B. Image B: Small red arrows indicate movement of bogie box surface flexure. Photograph and drawing not to scale.

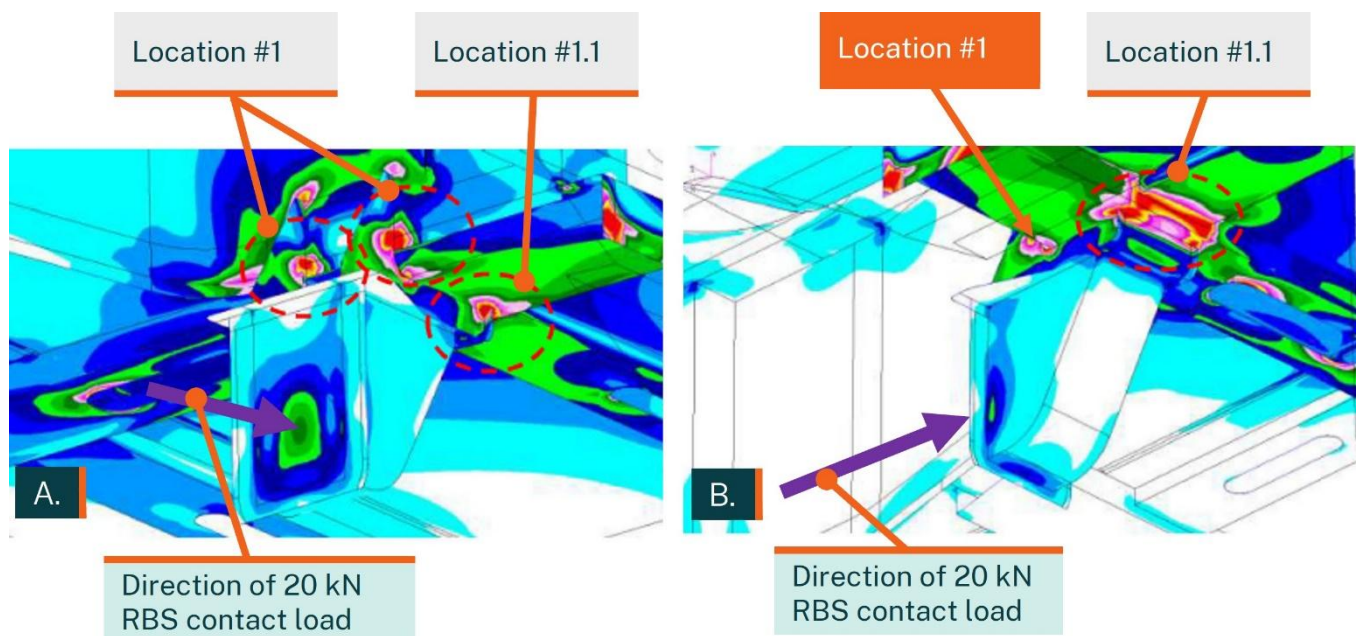
Figure 28: TfNSW RBS FEA plot subject to 20kN RBS loading

Image A: Front view of RBS loading with Location #1 and Location #1.1 non-compliant areas circled. Image B: Rear view of RBS loading with Location #1 identified and Location #1.1 circled.
