Light Rail Safety Investigation Report

Fractures of Urbos 3 LRV underframes — Sydney Inner
West Light Rail Line, 27 October 2021

Fractures of Urbos 3 light rail vehicle underframes Sydney Inner West Light Rail Line

Investigation Reference I02011

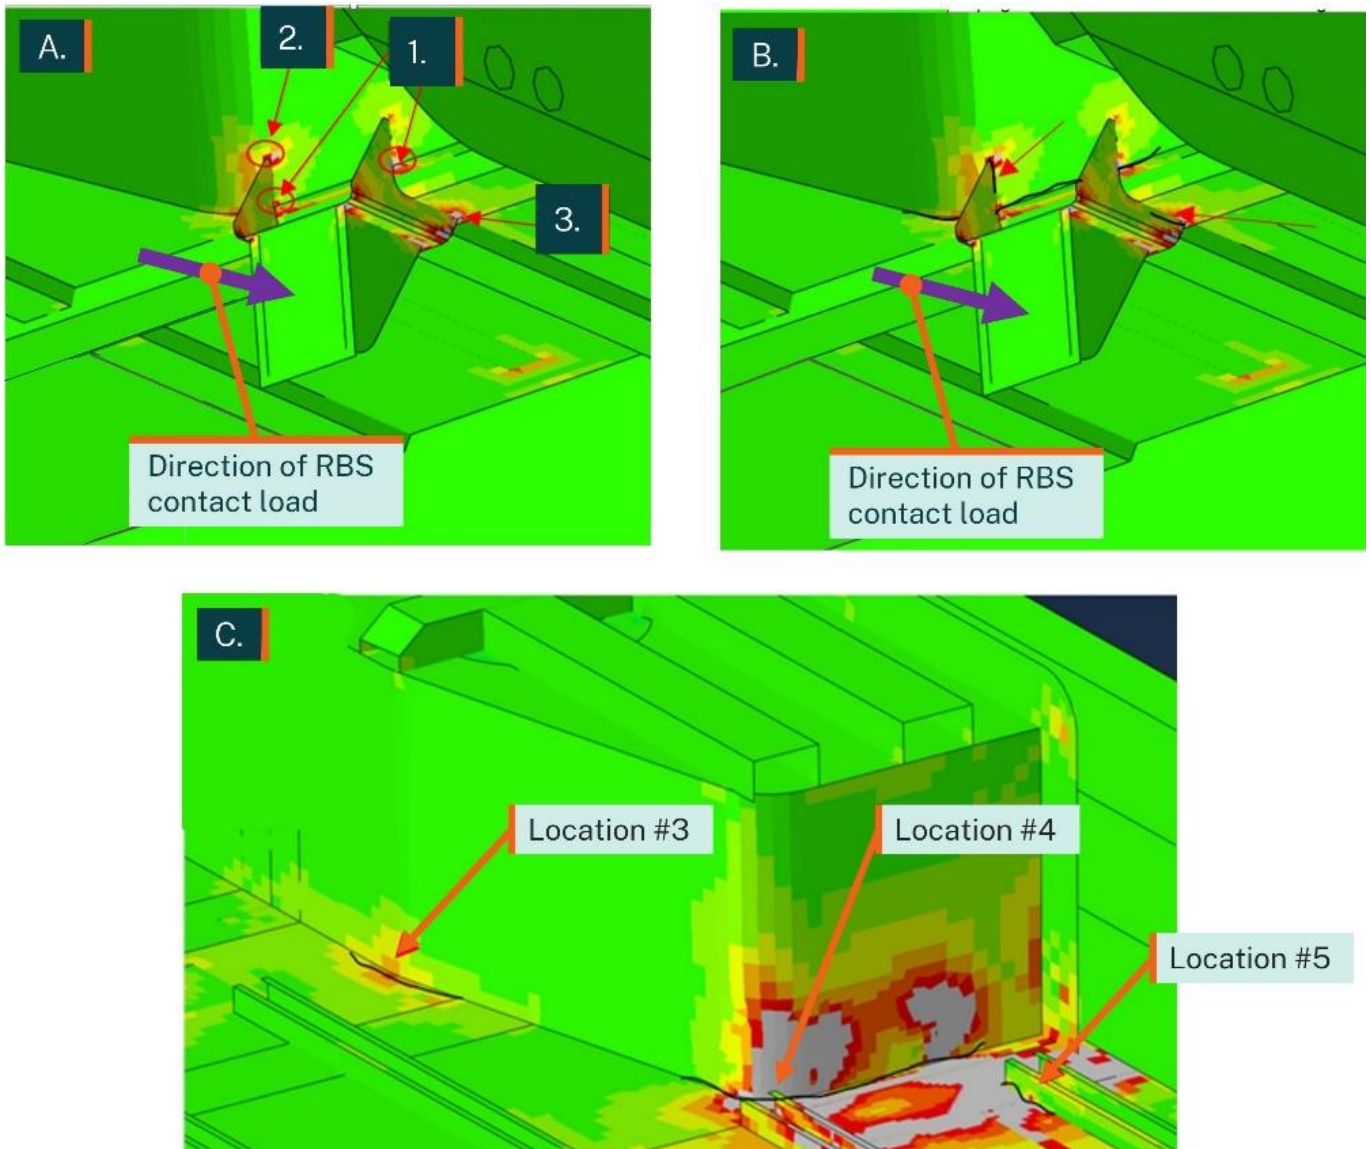
Figure 29: Bogie box fracture initiation locations identified by CAF

Image A: RBS contact load (purple arrow) generated fracture initiation locations starting at point 1 then likely to generate at points 2 and 3. Image B depicts fractures progressing at the RBS bracket weld locations (fracture location #1 and #1.1) and the bogie box sheeting along discontinuous fillet welds at the vertical and horizontal shelf interface. Image C depicts fractures progressing into other welds of the bogie box structure (fracture locations #3, #4 and #5).

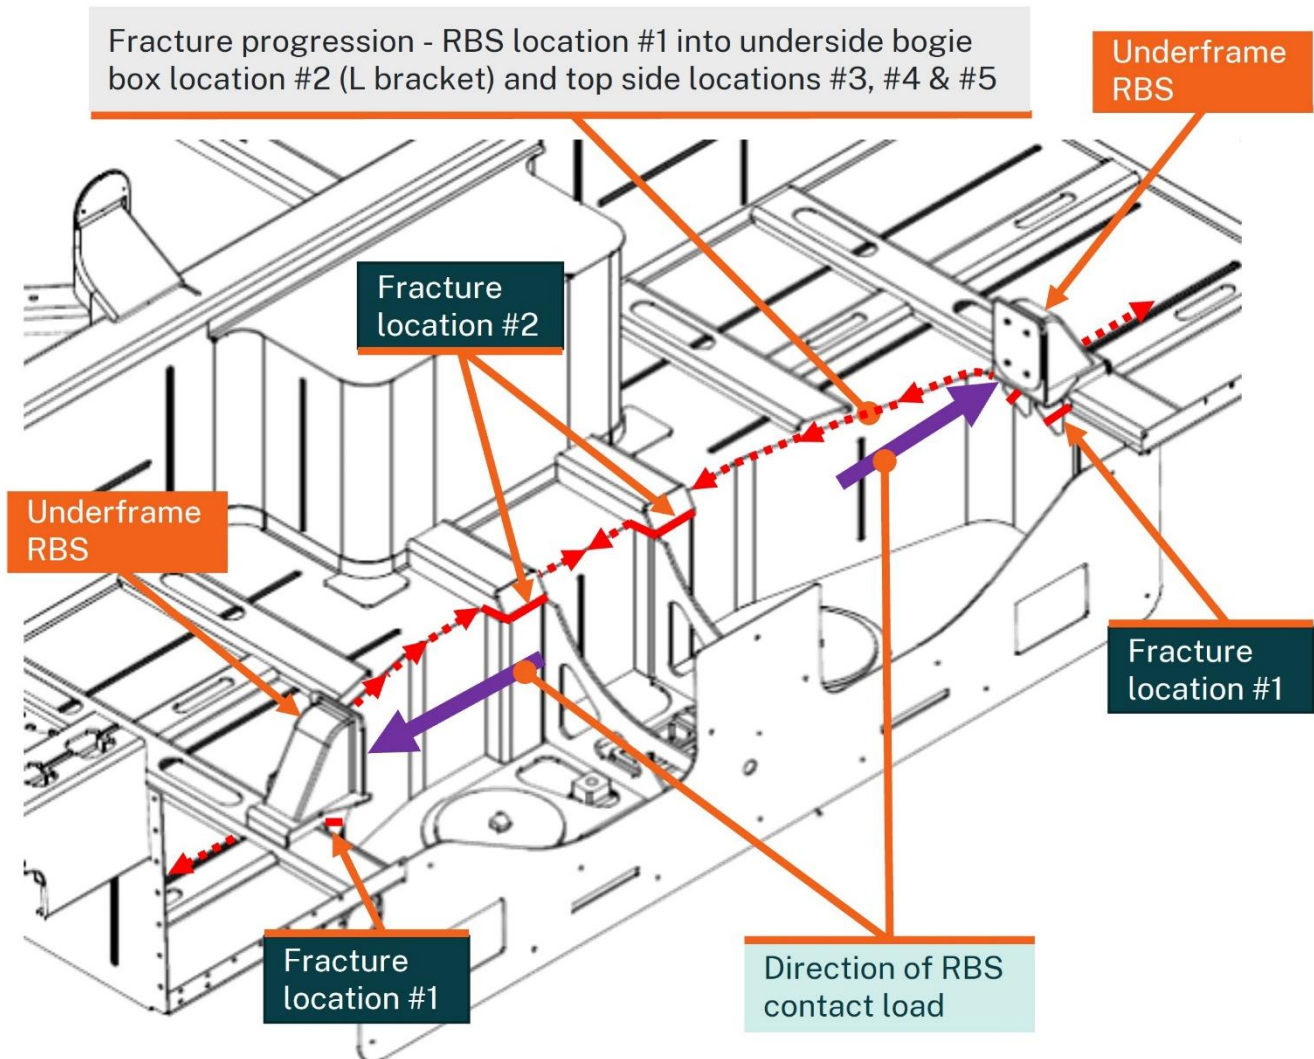
Figure 30: CAF assessment of bogie box fracture progression from fracture location #1

Inverted view of RHS bogie box depicting RBS contact load (purple arrow) with fractures initiating at the RBS bracket fracture location #1, progressing into the bogie box with other parts of the structure becoming overstressed generating fractures in the L bracket location #2 and bogie box weld and sheeting locations #3, #4 and #5.

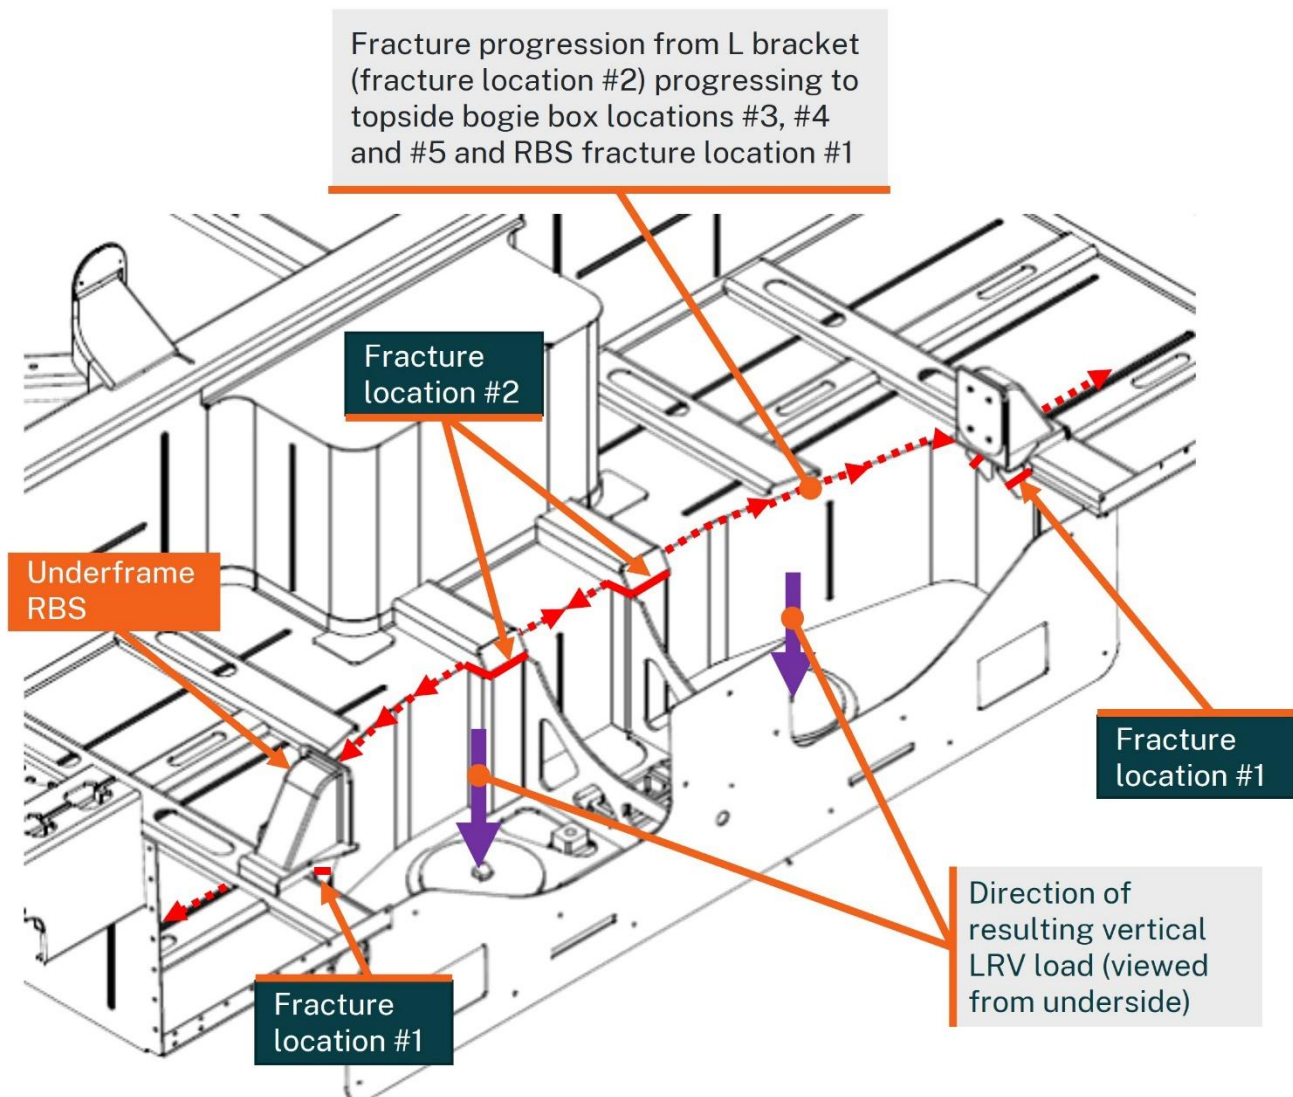
Figure 31: TfNSW assessment of bogie box fracture progression from fracture location #2

Inverted view of RHS bogie box depicting LRV vertical load (purple arrow) on underframe with fractures initiating at the L bracket (fracture location #2) and progressing into the bogie box with other parts of the structure becoming overstressed generating fractures in the bogie box locations at fracture locations #3, #4 #5 (top side of bogie box) and #1.

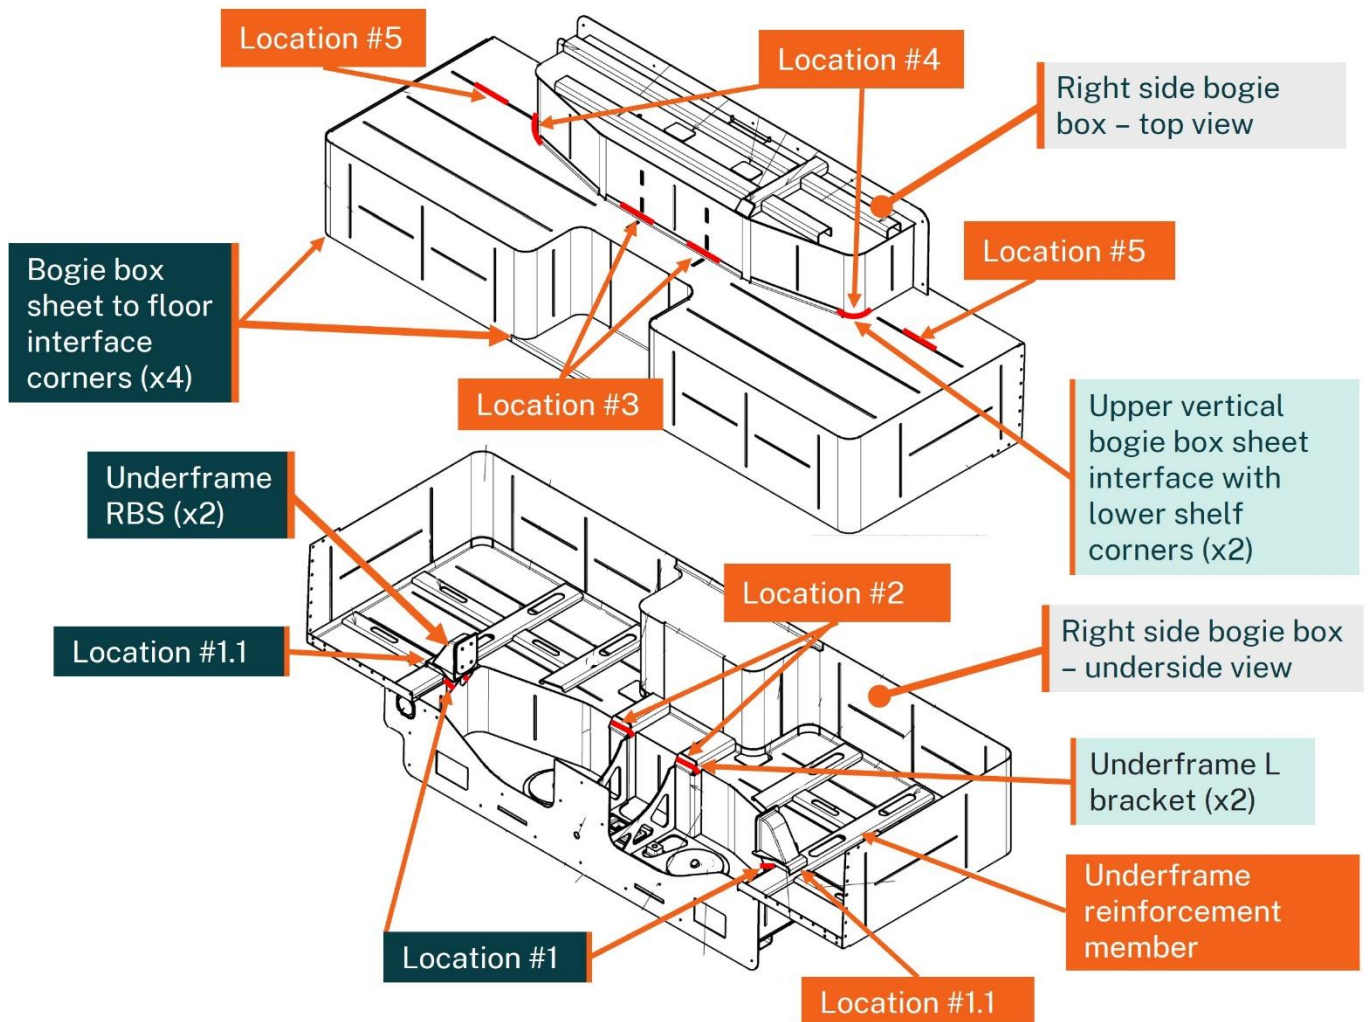
Figure 34: Underframe bogie box fracture locations

Top and inverted view of the right-side underframe bogie box assembly depicting typical fracture locations identified during visual and non-destructive testing. Fractures underneath the bogie box structure of the underframe were identified at Location #1 in the underframe RBS gusset, and Location #2 in the L bracket corner. Fractures on the top side of the bogie box structure were identified at; Location #3 in the bogie box sheeting interface between the upper vertical sheet and lower shelf, Location #4 in the upper vertical bogie box sheet with lower shelf corners, and Location #5 along the lower bogie box shelf sheeting. No fractures were identified in the horizontal welding of the RBS structure to the underframe reinforcement members at Location #1.1. Location #1.1 provided a reference location for the TfNSW design assessment review.
