# Rolling stock irregularity on train 3YN2

Kiacatoo, New South Wales, on 6 January 2021

**ATSB Transport Safety Report**

RO-2021-001

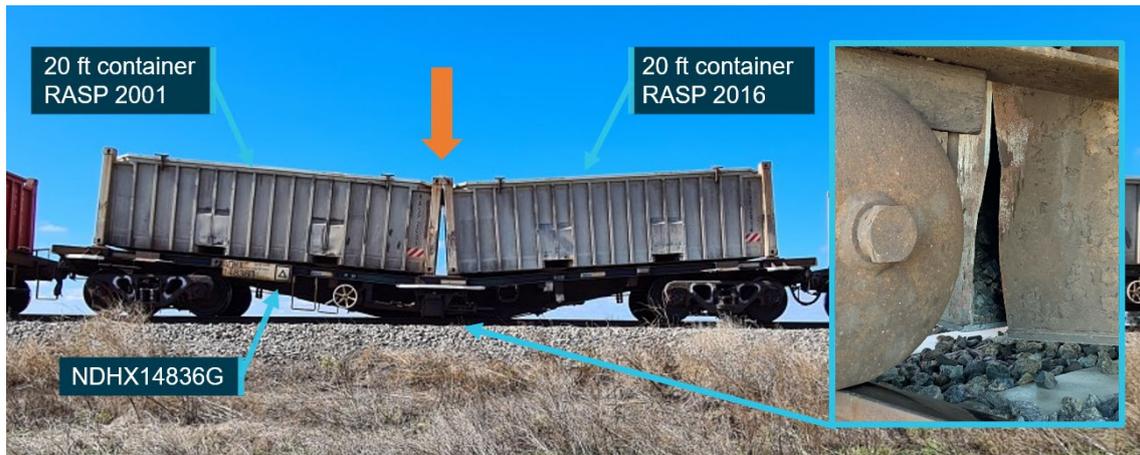
**Figure 2: Rolling stock irregularity**

The crew stopped to inspect the train between Euabalong West and Kiacatoo. The crew identified that the wagon frame on the 32nd wagon (NDHX14836G) had failed and the air tank was resting on the rail near 583.900 km<sup>3</sup> (Figure 1 and Figure 2). The wagon was loaded with two containers carrying zinc (Zn) concentrate at the time which remained secured to the wagon.

Wagon NDHX14836G shown with centre of the wagon sagging under the load of the 20 ft containers. Inset image shows the fracture in the underframe and an air tank resting on the rail.

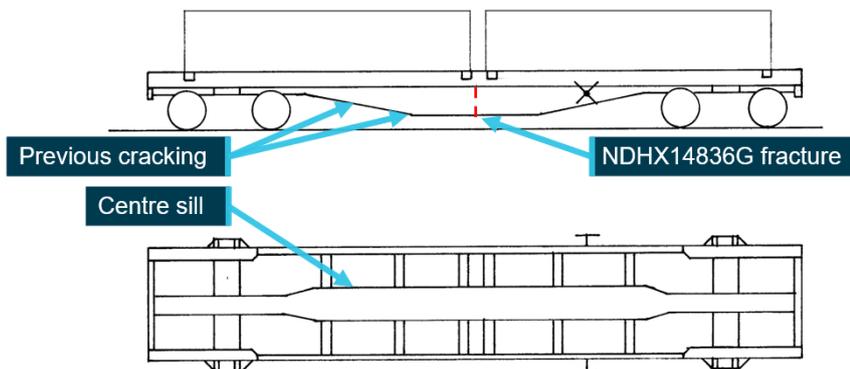
**Figure 3: ICX class wagon underframe and cracking locations**

Historically, cracking had been detected on some ICX class wagons at butt welds along the centre sill lower flange at a change in material thickness (Figure 3). Repair procedures had been developed with doubler plates<sup>5</sup> fitted if cracking was detected.<sup>6</sup> The location of the previous cracking was along the centre sill but not at the location of the fracture on NDHX14836G.

The design and construction of the ICX class wagons varied with some wagons having a centre sill transverse weld at the mid-point on the lower edge of the sill. Design drawing provided as part of the investigation did not indicate the presence of the weld or provide details for the original weld

specification. A weld at this location of high stress increases the risk of fatigue cracking and presented different risk profiles within the same wagon class.

On the day of the occurrence, Pacific National issued a Rolling Stock Notice (RSN E 21-002) requiring an underframe crack inspection on NDHX, NQHX and NQIX wagons. The visual inspection required:

- checking if there was a butt weld at the midpoint of centre sill
- checking for cracks on the underside of the centre sill at the location of the butt weld
- checking the vertical web plate for the presence of crack propagation
- confirming the presence of doubler plates and any cracking associated with the doubler plates.

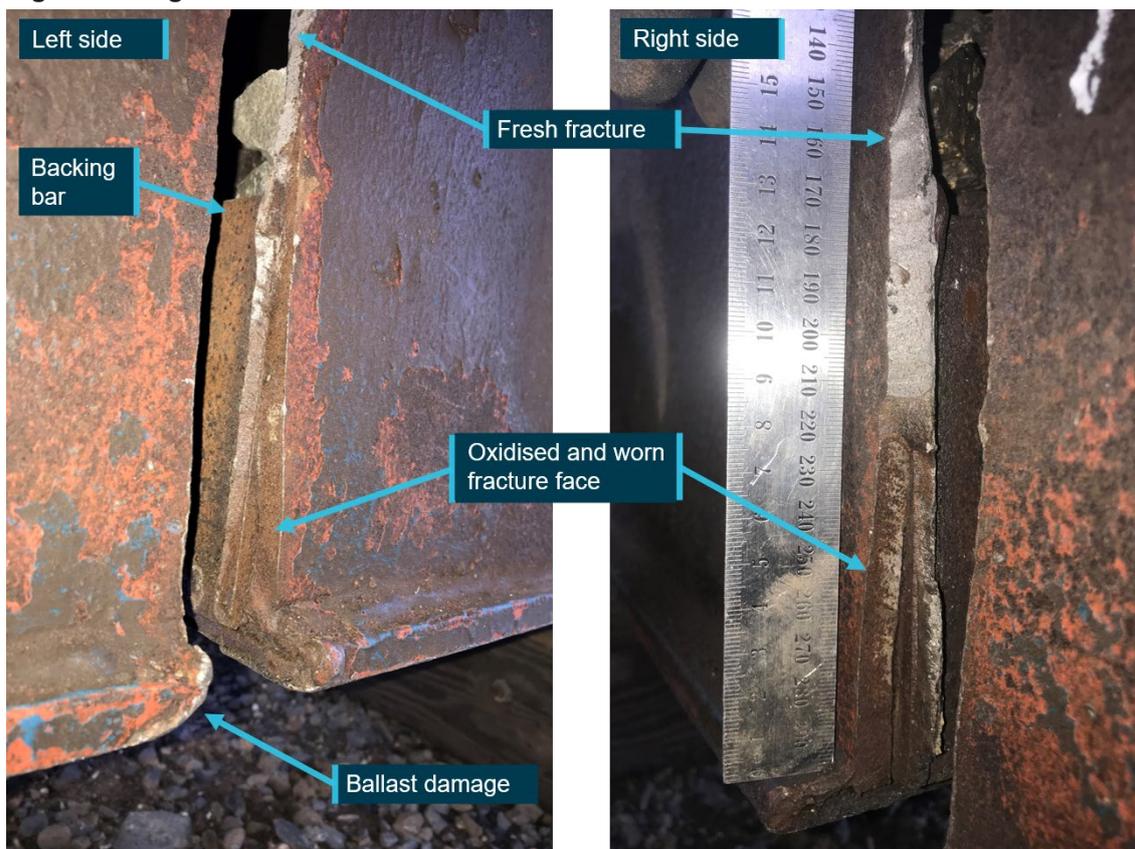
Figure 4: Wagon NDHX14836G fracture

The wagon was found with a fracture extending across the bottom flange (underside) and up both vertical plates (web) at the mid-point of the centre sill. The lower portion of the fracture face was damaged by ballast strikes, particularly on the trailing edge (in the direction of travel) of the fracture.

Assessment of the fracture indicated that the fracture was at the mid-point of the centre sill transverse weld. A backing bar<sup>8</sup> was present along the length of the weld although there was no obvious weld penetration. Oxidation was visible on the lower section of both vertical plates and the fracture face was worn (Figure 4). The presence of both oxidation and wear is consistent with fatigue cracking however there were no beach marks<sup>9</sup> observed in this region. The remaining fracture face was free from oxidation and likely progressed quickly.

The GX inspection scope was limited although the partial fracture would likely have been visible during close inspection of the centre sill vertical plates (web). The investigation was unable to determine when the frame was partially fractured, the oxidation indicates a fracture was almost certainly present during numerous GX and roll-by inspections.
