## **BUS SAFETY INVESTIGATION REPORT**

### **SERIOUS INJURING OF YOUNG CYCLIST AFTER BEING STRUCK BY A BUS**

**PARKLEA**

**12 NOVEMBER 2007**

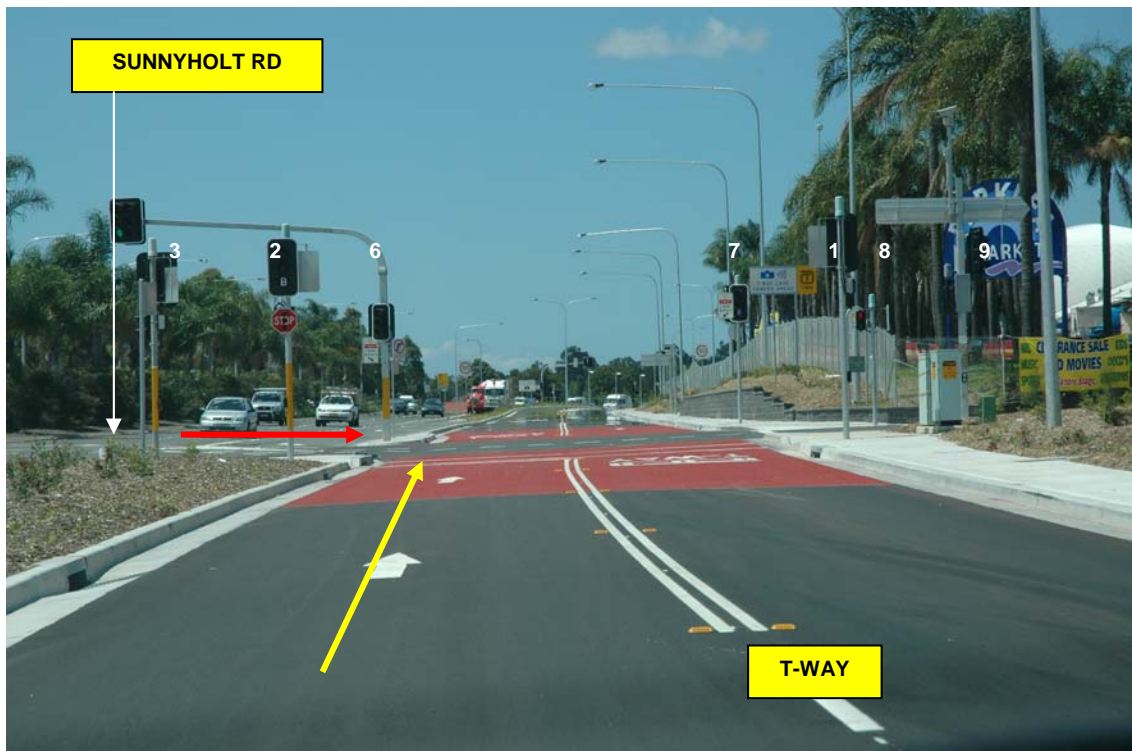
**Photo 1:** Traffic arrangements, as seen from the direction in which the bus driver was travelling, with the direction of his bus and the young cyclist indicated by yellow and red arrows respectively

- 1.4 Sunnyholt Road is a major arterial road with high volumes of traffic during the morning and afternoon peak periods. The T-Way is dedicated for the use of buses only. Parts of the T-Way's road surface are pigmented red (as indicated in *Figure 1* and other photos appearing later in this report) to alert car drivers to the fact that the related lanes are dedicated for the use of buses only.

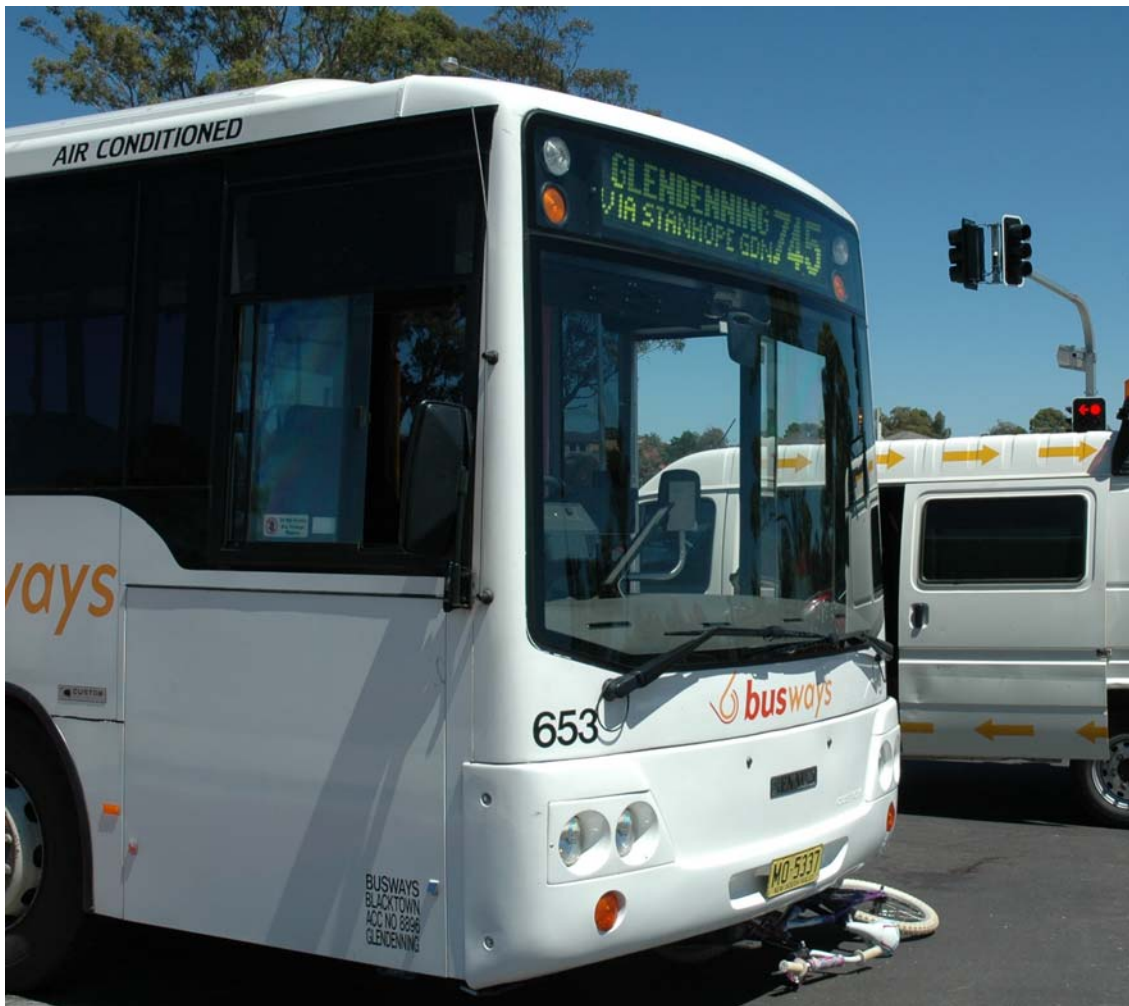
**Photo 2: Resting place of the bus and cycle after the collision**

- 1.5 The bus, a 2001 model Renault operated by Busways Pty. Ltd, was being operated on a scheduled service over Route No. 745 from Glendenning via Stanhope Gardens. The bus is licensed to carry 57 seated and 9 standing passengers, but at the time of the collision there were three passengers onboard. The bus is shown at the scene in *Photo 2*.

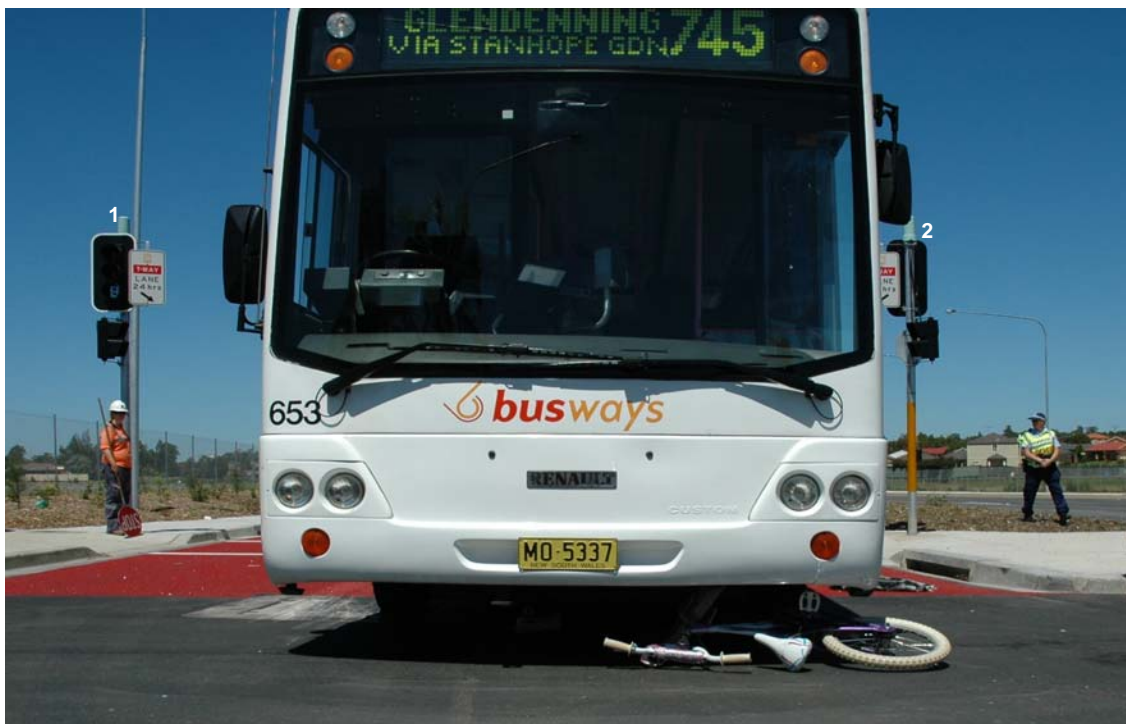
**Photo 3: Front of bus where it came to rest after the accident, with the bicycle underneath**

1.16 OTSI Investigators arrived at the scene after the cyclist had been conveyed to hospital but the bus and bicycle remained unmoved (see *Photo 3*). Significantly, it was apparent that the bicycle had been dragged, from the point of impact, under the near side of the bus until the bus became stationary. Once the bicycle was removed from this position it was examined and its tyres were found to be in good condition and its back pedal brake to be well adjusted and operable.

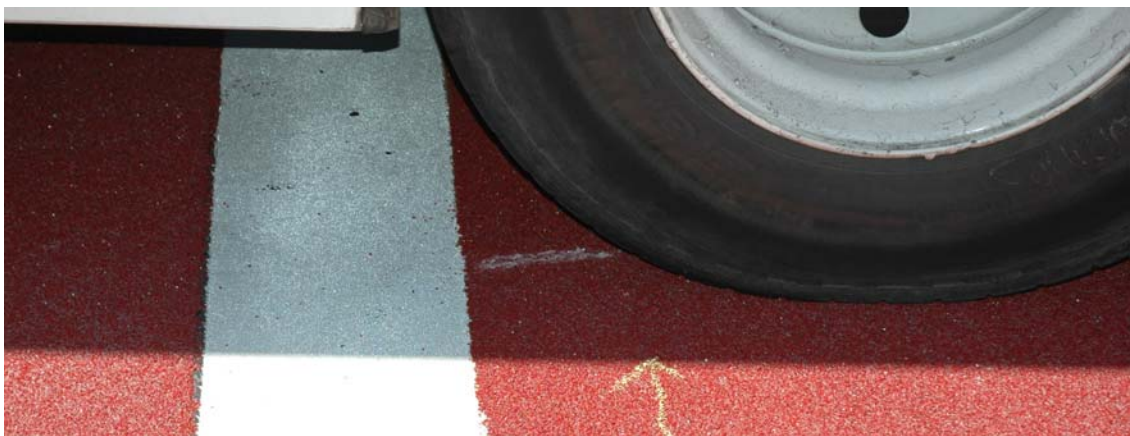
**Photo 4: Marking on roadway at the point of impact**

- 1.17 New markings on the surface of the T-Way at the pedestrian crossing were determined to have been caused by the bicycle's white pedals and handle bar grips and assisted in determining the point at which the collision occurred (See *Photos 4 and 5*). These markings and the resting place of the bus showed that the bus travelled a distance of 8.4m after the collision. This short distance and the absence of skid marks validated the driver's indication of the speed at which he was travelling immediately prior to the collision. The bus came to rest with its front offside, or the driver's side, protruding 0.9 metres into the South-Eastern bound lanes, which is consistent with his description of him having swerved to avoid the young cyclist.

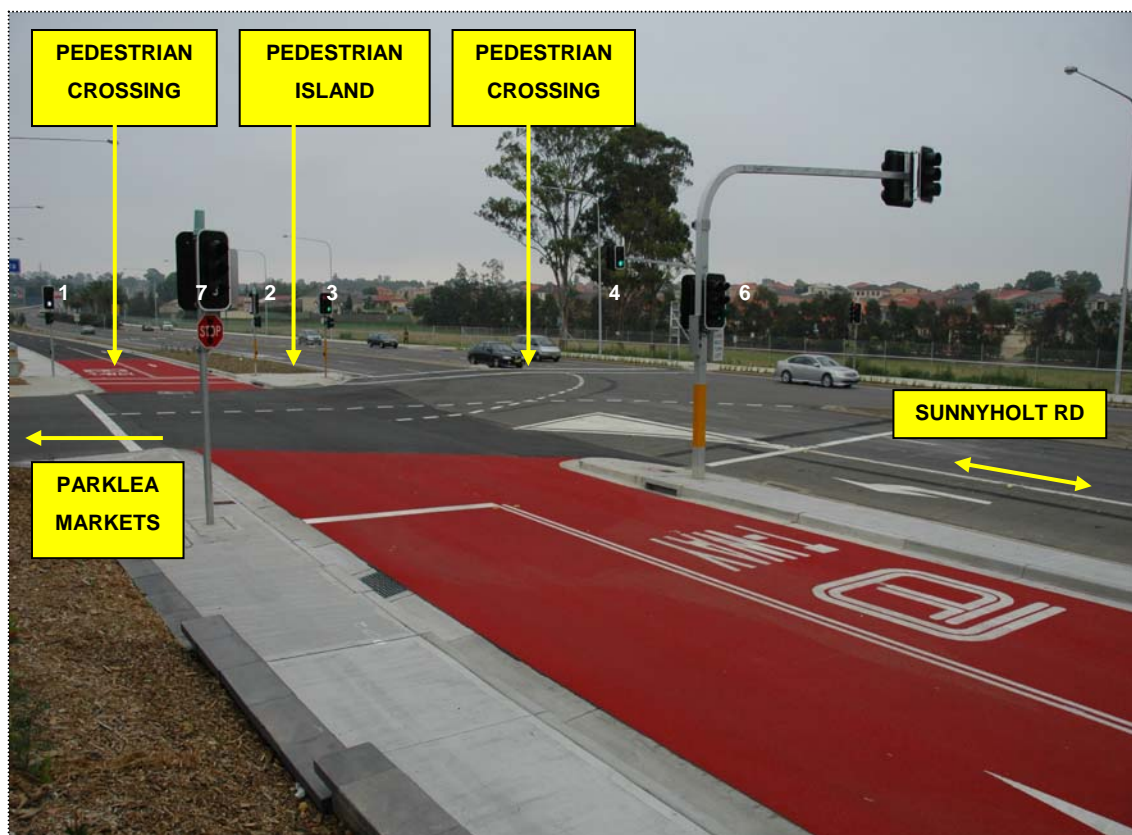
**Photo 6: Layout of intersection**

- 1.19 In the vicinity of the Parklea Markets, Sunnyholt Road has six lanes. Four lanes carry traffic in a North-Easterly direction but two of these lanes become turning lanes, into the Markets, as is indicated in *Figure 1*. There are also two lanes carrying traffic in a South-Westerly direction, plus a turning lane, and these are also indicated in *Figure 1*. In the adjacent T-Way, there are two lanes; one conveys traffic North-Eastwards and the other South-Westwards. On the North-Western and South-Eastern sides of Sunnyholt Road and the T-

- 1.20 To cross from the North-Western to the South-Eastern pathway, or vice versa, a pedestrian or a dismounted cyclist must traverse eight lanes and a traffic island separating Sunnyholt Road and the T-Way. The passage of vehicles along Sunnyholt Road and the T-Way in the area of the Parklea Market, and the passage of vehicles across the two carriageways, is regulated by the traffic lights indicated in *Figure 1* and in *Photo 6*.

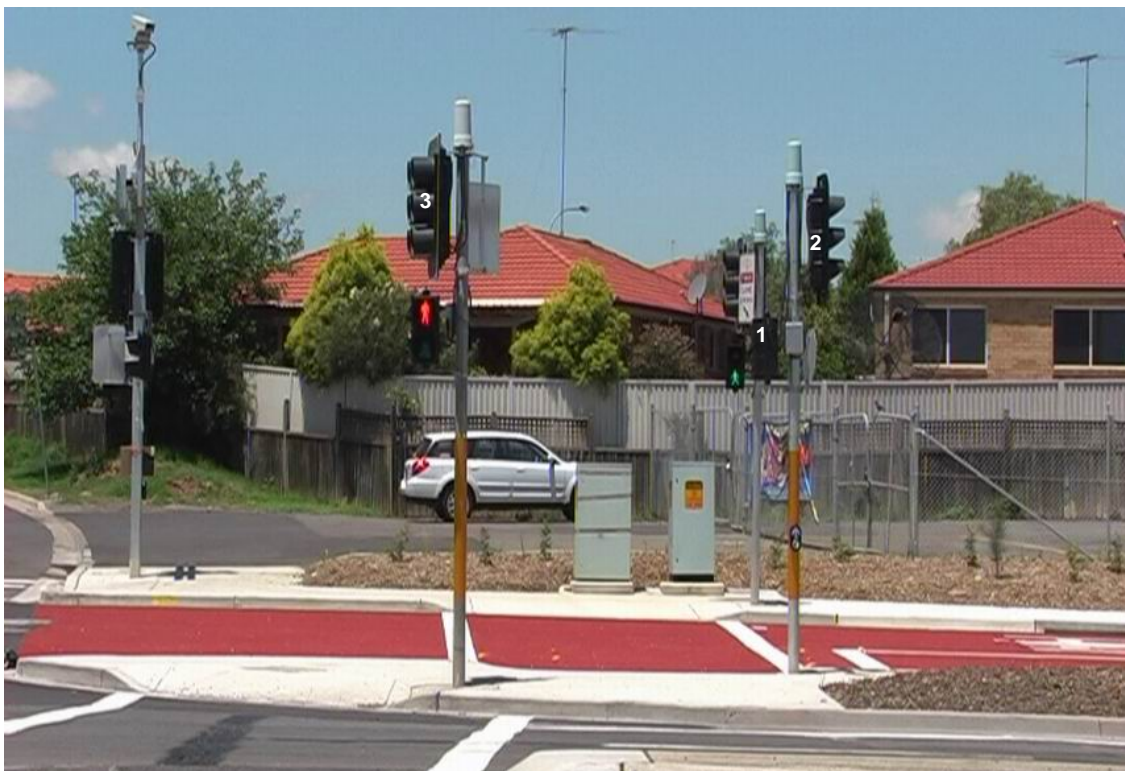
**Photo 7: Looking South-East across Sunnyholt Rd towards the T-Way**

- 1.23 Significantly, at the same time as pedestrian Signal 1 reverts to a fixed red indication, the traffic signals governing vehicle movement on Sunnyholt Road and the T-Way in a North-Easterly and South-Westerly direction respectively, i.e., traffic Signals 1, 2, 3, 4, 5 and 6, immediately turn green, which means there is no time margin for pedestrians who, for whatever reason, are still in the crossings, to reach safety before through traffic is released. In addition, OTSI considers that scope for confusion exists when pedestrians, particularly young children, cross from North-West to the South-East if they focus on pedestrian Signal 1 when it is green rather than pedestrian Signal 3 which will be at red. *Photo 7* indicates how such confusion might arise.

- iii. Review the phasing of the traffic control lights in the in the immediate vicinity of the Parklea Markets with a view to providing an interval between the time lights governing movement on the pedestrian crossing revert to red and the time those governing vehicle movement on Sunnyholt Road and the T-Way revert to green.

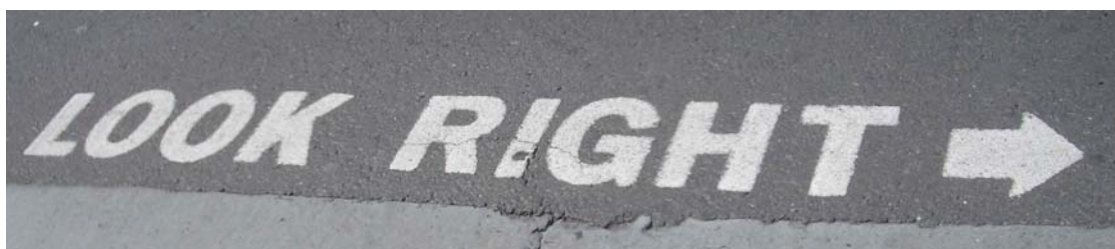
**Photo 8: Example of carriageway signage**

- 1.25 While pedestrians and cyclists are permitted to travel on the paths that are adjacent to Sunnyholt Road and the T-Way, OTSI noted that there are no signs requiring/reminding cyclists to dismount before they attempt to use the pedestrian crossing<sup>4</sup>. OTSI also noted that there are no signs on the surface of the carriageways to alert pedestrians to 'look both ways'. While the use of such carriageway signage is not required, it is becoming increasingly common (refer to *Photo 8* for an example of carriageway signage) and is considered by OTSI to serve a useful purpose.

- v. Install 'Look Both Ways' signs on the carriageway in the immediate vicinity of the pedestrian crossing opposite Parklea Markets.
- vii. Install 'Riders to dismount' signage adjacent to the pedestrian crossing in the immediate vicinity of the Parklea Markets and at all other locations in NSW where a pedestrian crossing that is not equipped with bicycle crossing lights is immediately preceded by a cycle path.

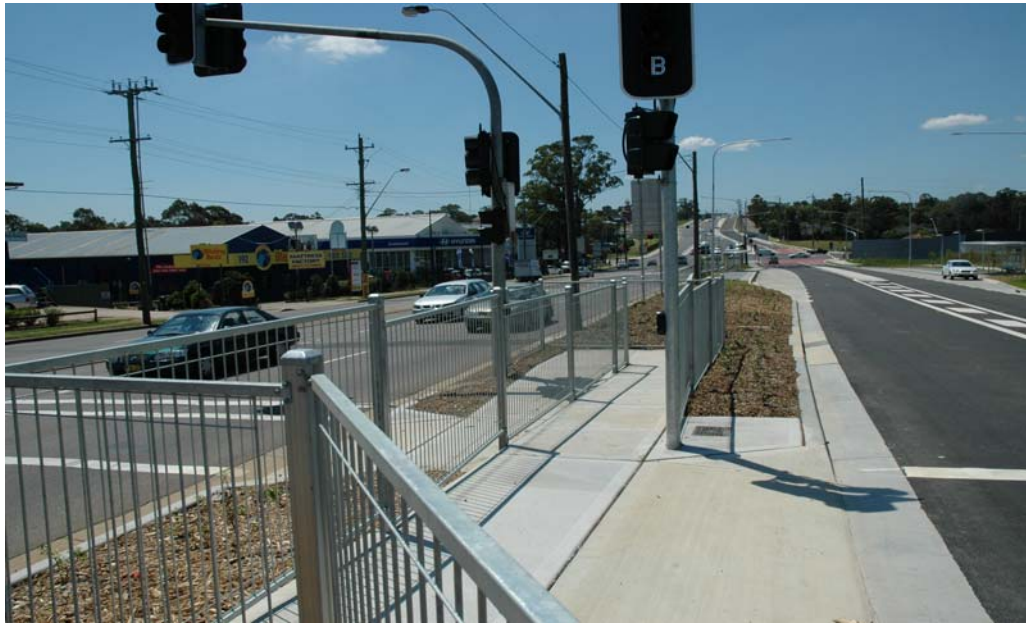
**Photo 9: Pedestrian barrier at another location on Sunnyholt Road**

- 1.26 Further, there is no barrier or fence on the traffic island, such as that depicted in *Photo 9*, to deter pedestrians from simply continuing onto the T-Way or Sunnyholt Road, depending on the direction of their movement, without regard to signal indications. However, such barriers are installed at similar locations elsewhere along Sunnyholt Road and the T-Way.

- iv. Install a safety barrier, similar to those that can be seen elsewhere along Sunnyholt Road, on the traffic island between Sunnyholt Road and the T-Way in the immediate vicinity of the Parklea Markets to prevent pedestrians from simply continuing to move straight across the island onto the T-Way.
