Office of Transport Safety Investigations

BUS SAFETY INVESTIGATION REPORT

**SCHOOL CHILD PEDESTRIAN FATALITY
ROCKY POINT, NSW**

26 APRIL 2017

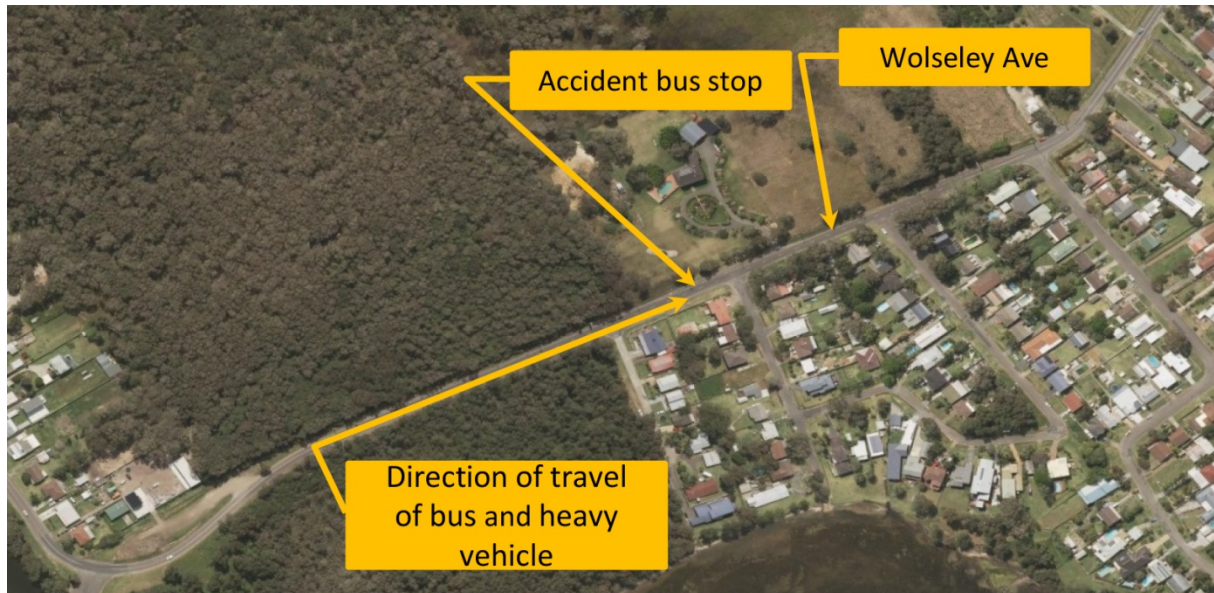
Figure 2: Wolseley Avenue and direction of travel

- 1.5 Wolseley Avenue has a straight stretch of road of approximately 250 m long leading up to the accident bus stop.
- 1.6 Wolseley Avenue has a bitumen surface with a lane in either direction. The lanes are separated by painted broken white lane markers and the edges are marked with continuous white lines.
- 1.7 The road is edged with a grass verge and does not have kerb and guttering, except for a short section adjacent to some designated bus stops.
- 1.8 The accident bus stop has a grass verge of approximately 3 m between the lane edge and the adjacent property fence.
- 1.9 At the time of the accident, the road was wet from localised rainfall and the rainfall continued to increase post the accident.
- 1.10 Central Coast Council is the road authority for this section of roadway.

- 1.4 Wolseley Avenue is a part of the main thoroughfare between the Central Coast suburbs of Wyong and Tuggerawong. (see Figure 2)

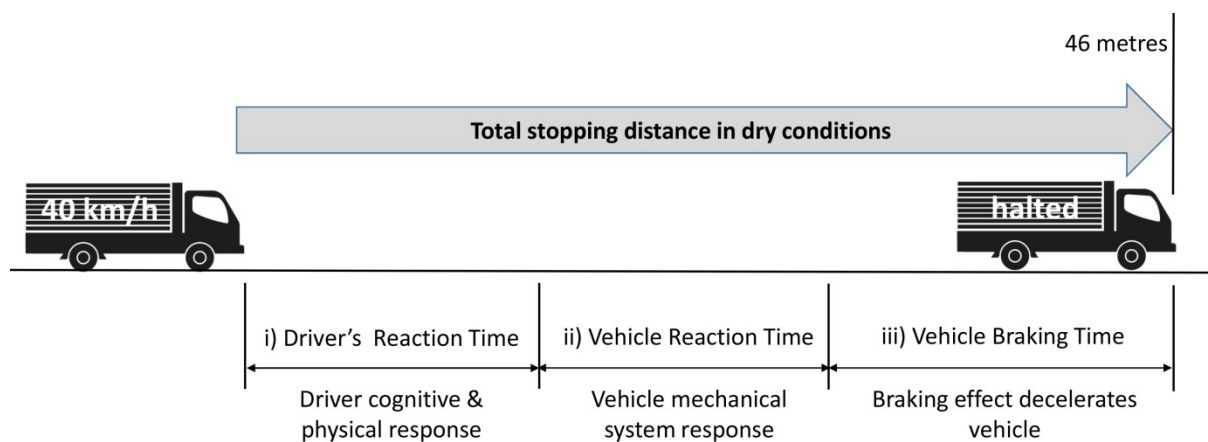
Figure 3: Stopping distance

- 2.10 A heavy vehicle of this type would need approximately 46 m to brake to a halt from 40 km/h⁶ in dry conditions. This total stopping distance incorporates the driver's cognitive and physical response to a possible collision, the time for the vehicle's braking system to react and the time for the vehicle to decelerate to a halt. (see Figure 3)

- 2.11 In this case, the driver would need a clear line of sight greater than the total stopping distance to avoid a collision. At the time of the accident, the wet road surface would have extended the total stopping distance.
- 2.12 Wolseley Avenue provides approximately 250 m of clear line of sight on the approach to the bus stop. However, the stationary bus had obstructed the clear line of sight between the child and the heavy vehicle driver.
- 2.13 In this accident, the heavy vehicle driver's view of the grass verge on the passenger side and the area in front of the bus was obstructed by the stationary bus. This situation prevented the driver and the child pedestrian from detecting the impending collision. (see Figure 4)

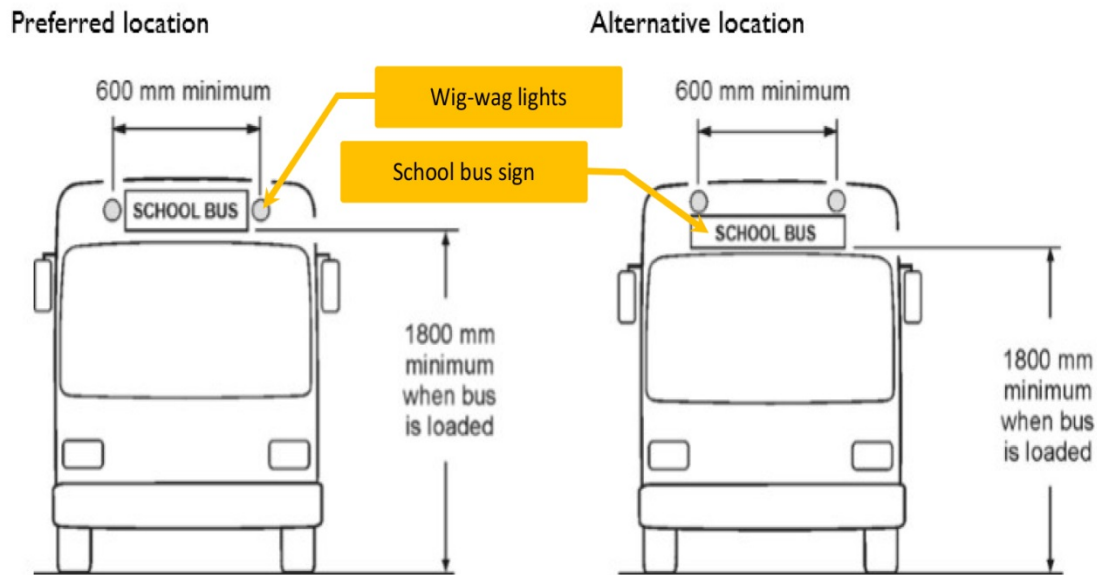
Figure 5: School bus front warning lights and signage

- 2.21 In 2000, the Roads and Traffic Authority (RTA), now RMS, introduced Technical Specification 142⁹ (TS142) as a standard for the installation of warning lights and signage on NSW designated school buses.
- 2.22 To comply with TS142, a bus utilised for school bus routes in NSW must display a 40 km/h speed sign on the rear of the bus. The bus must be equipped with alternating flashing amber lights on the front and the rear of the bus. The amber lights must be mounted on either side of the 40 km/h sign on the rear of the bus and the front headlights must flash alternately when the amber lights are activated. The front face of the bus must also carry signage to identify the service as a school bus. (see Figures 5 and 6)

2.23 The intention of the wig-wag lights, flashing headlights and speed sign is to warn drivers that school children may be boarding or disembarking the bus or

crossing the road in the vicinity, and to instruct drivers to reduce their speed to 40 km/h until they have passed the bus.

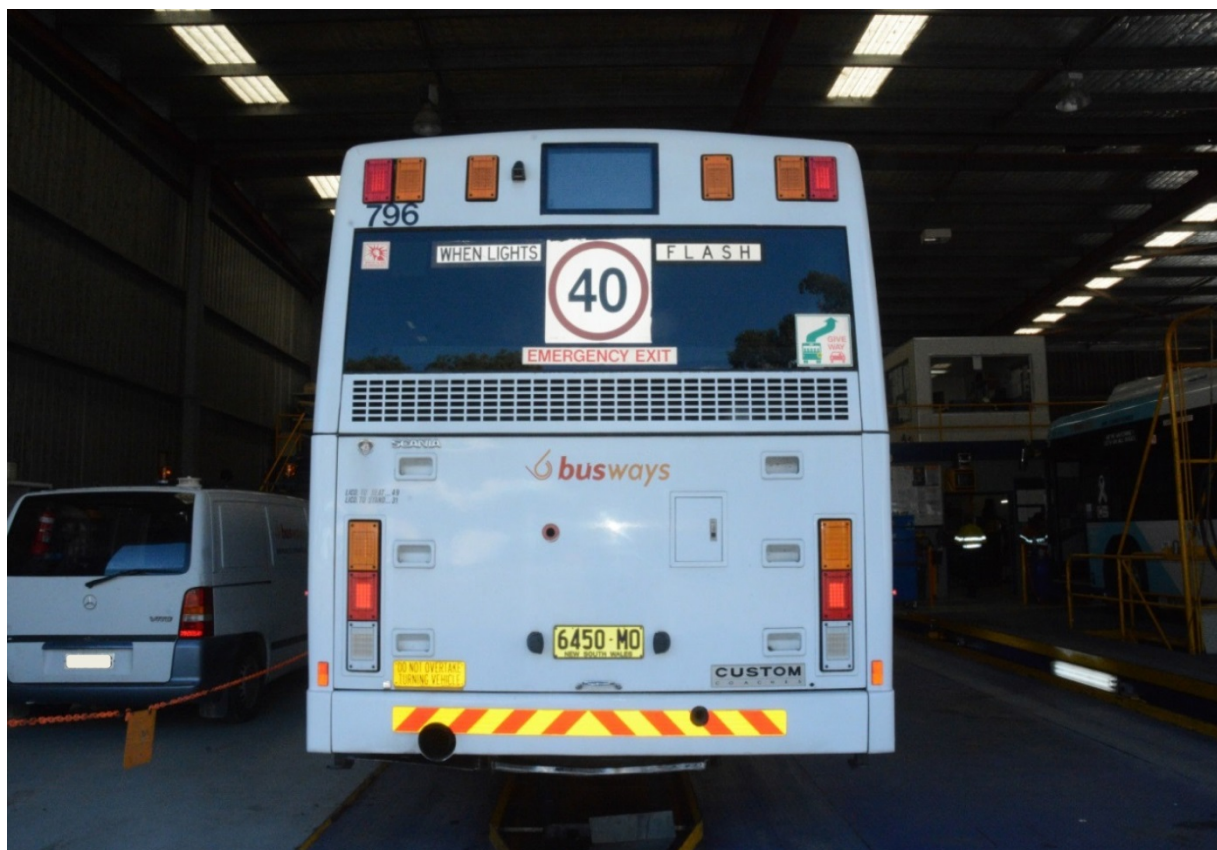
Figure 7: Rear view of bus 6450 MO

- 2.25 Bus 6450 MO was equipped with the necessary warning lights, signs and indicators. The warning and direction indicator lights operated as designed during OTSI's inspection of the bus.

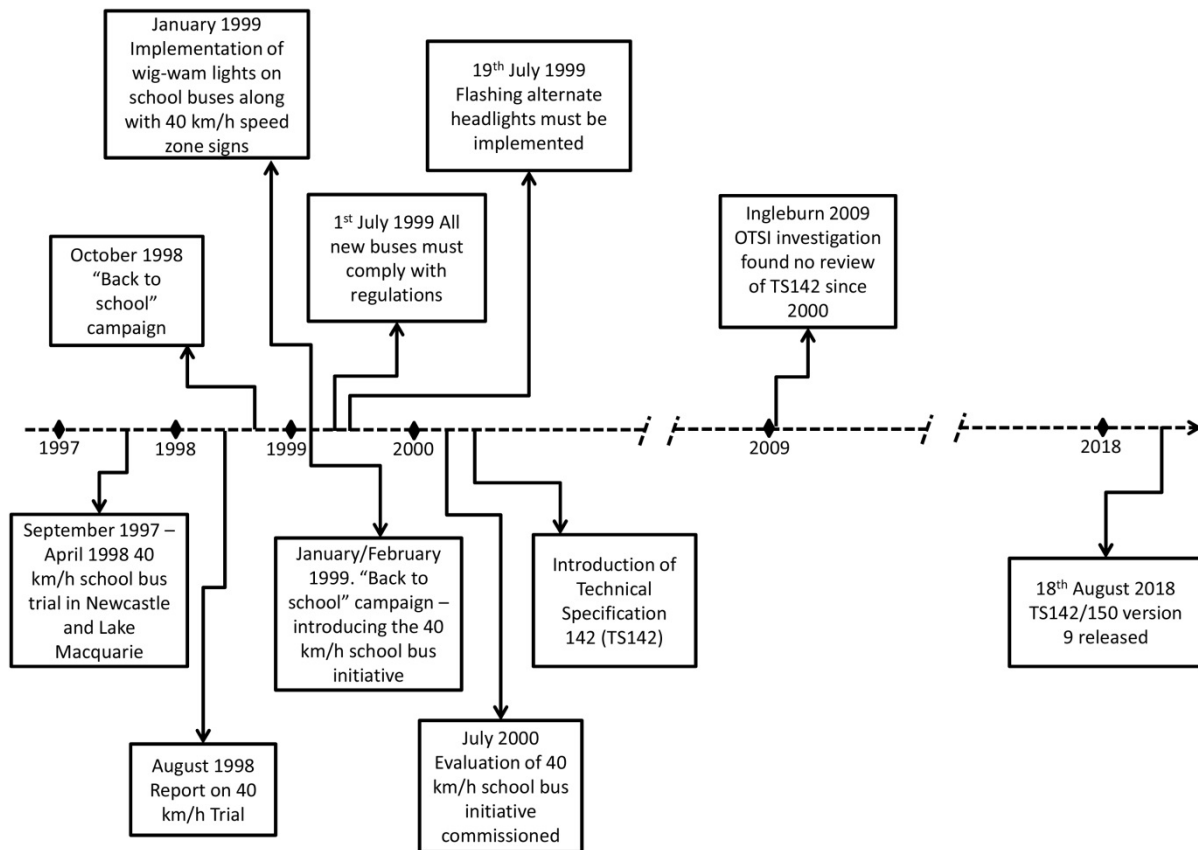
Figure 10: Timeline of school bus safety initiatives

- 2.45 To improve safety around school bus travel, in 2000 the NSW Government trialled the 40 km/h speed restriction around stationary school buses. The trial introduced wig-wag lights and 40 km/h speed signs mounted on the trial buses. The trial also introduced an enforceable 40 km/h speed restriction on traffic travelling in the same direction as the school bus. The trial expanded to other parts of NSW, and apart from a slight modification, the system is relatively unchanged.

- 2.46 In OTSI’s investigation into a child fatality at Ingleburn NSW in 2009, OTSI highlighted that TS142 had been enacted for 10 years without review. At the time, OTSI had recommended the RTA review the effectiveness of TS142.
- 2.47 The New Zealand Government has reduced speed limits around stationary school buses from 30 km/h to 20 km/h. The speed restriction is enforceable on all traffic in both directions. They cite the reduction in speed increases pedestrian survivability after a crash with a vehicle.
- 2.48 North America (USA and Canada) require all traffic (from both directions) to come to a halt on non-dual carriage ways when a stationary school bus has its warning lights set to red.
