RAIL SAFETY INVESTIGATION

HAWKESBURY RIVER RAILWAY BRIDGE

BROOKLYN

14 SEPTEMBER 2015

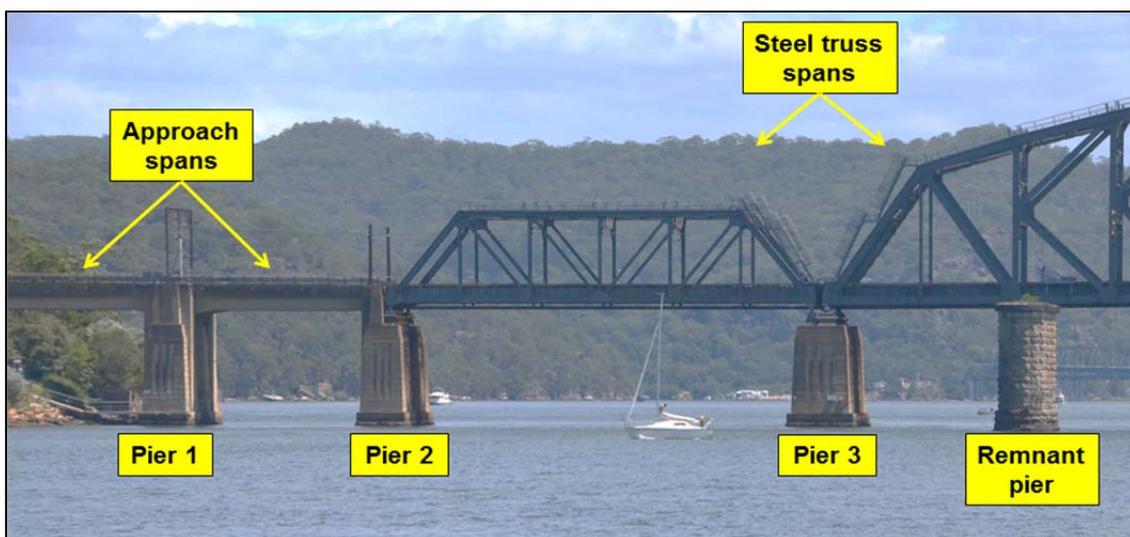
Photograph 2: Southern end of bridge showing piers and spans

- 1.4 The underbridge structure comprised of ten simply supported spans with a total length of approximately 842m.⁴ Spans 1 and 2, the southern approach spans, are constructed of continuous reinforced concrete T-girders. Spans 3 to 10 are steel through trusses.
- 1.5 The reinforced concrete substructure comprised abutments on shallow foundations and piers supported by caissons bedded in river soils or rock. Piers 1 and 2, located at the Southern end of the bridge, supported the concrete approach spans and have pairs of circular caissons. Piers 3 to 9 had single rectangular caisson structures. Design drawings indicated the circular caissons were filled with concrete and the rectangular caissons had internal steel cylinders filled with sand and water (refer to *Photograph 2*).

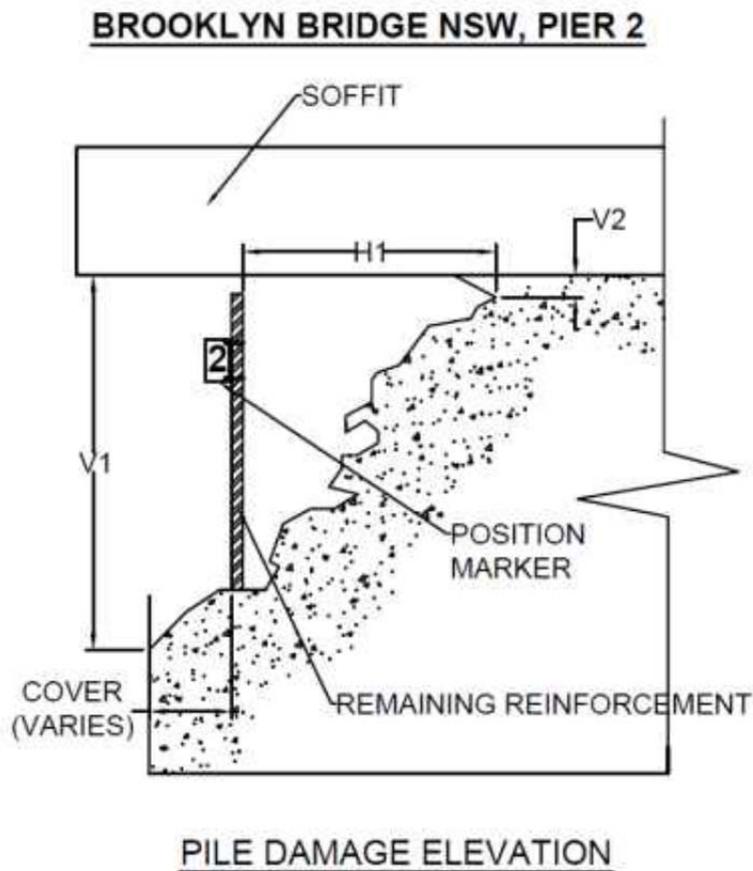
Figure 3.1 Measurements taken

Figure 3.1 shows the measurements taken These also show the extent of vertical deterioration from the soffit of the marrying slab/top of pile. The deterioration measurement was taken from the outer layer of reinforcement.

The cover to the outside reinforcement varies from 150mm to 200mm. As such, the maximum deterioration considered is the measured amount plus 200mm.

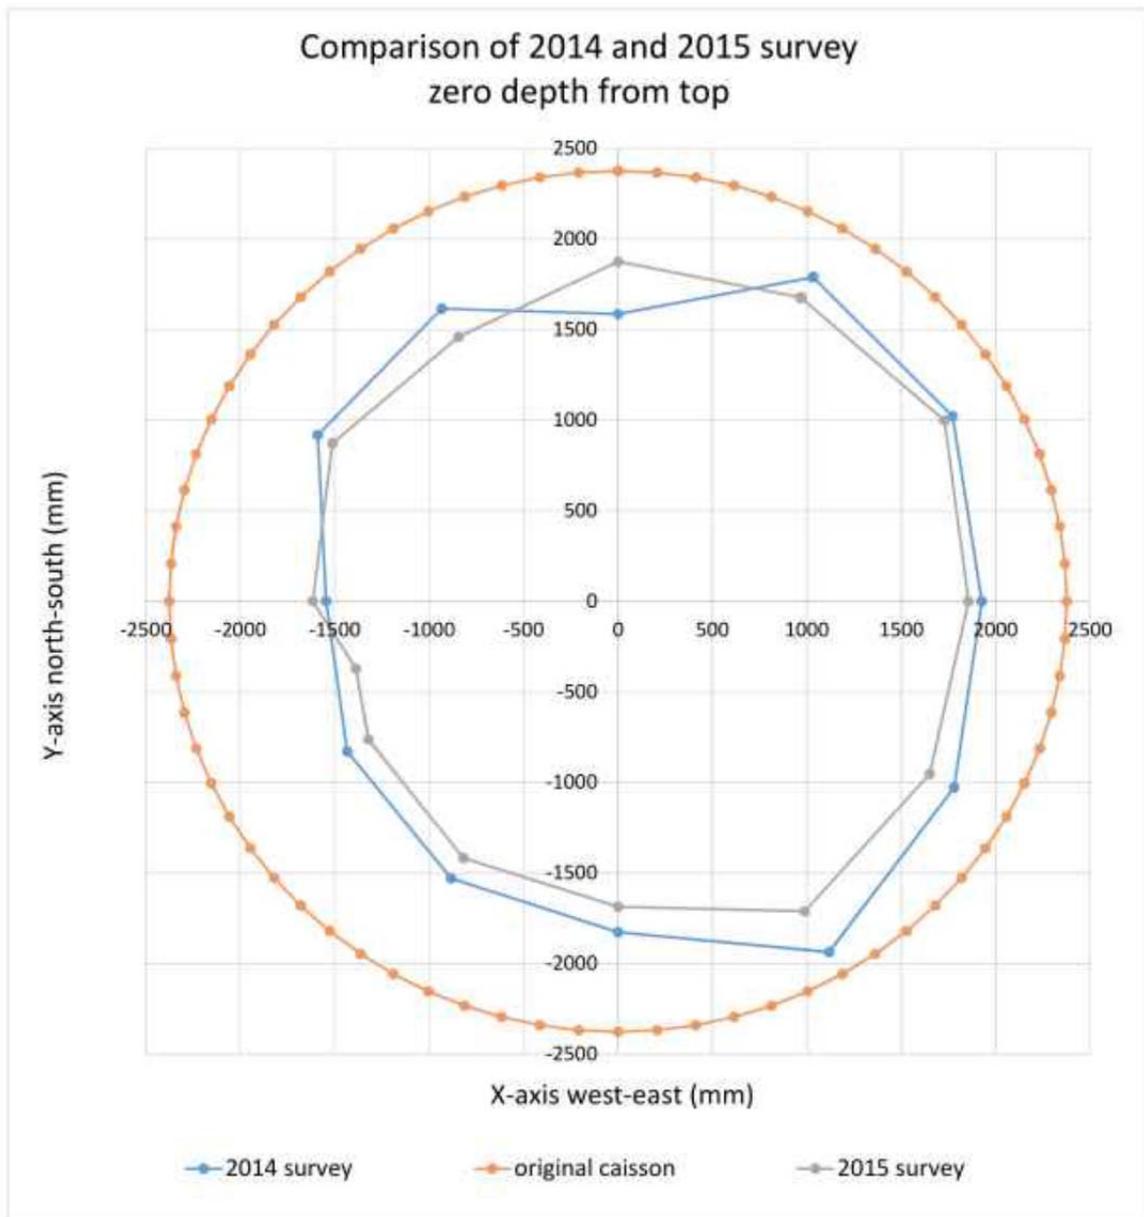
Figure 3.2 2015 measured loss of pile section

Figure 3.2 below shows the measured loss of section around each position (o'clock) of Pile No. 2, measured in October 2015. Also plotted on the graph is the measurement from 2014 for comparison, obtained from Document 4. Where the 2015 measurement indicates less concrete loss, this is likely due to the accuracy of measurement as there were no permanent reference marks for ease of measurement in 2014.

The rate of concrete loss from the 2014 and 2015 measurements ranges from 50mm to 260mm per year with the greatest loss occurring at the 5 o'clock location. The cross section area remaining, compared to the original design, is approximately 65% and 60% respectively for the 2014 and 2015 measurements.

Based on the measured rate of concrete loss at the respective pile positions, the cross section area of the pile remaining in 12 months' time would be approximately 50% of the original area. Based on the maximum measured rate of concrete loss applied to all pile positions, the cross section area of the pile remaining in 6 months' time would be approximately 50%.
