8.0 APPENDICES

Derailment at 88.878 km, Unanderra.

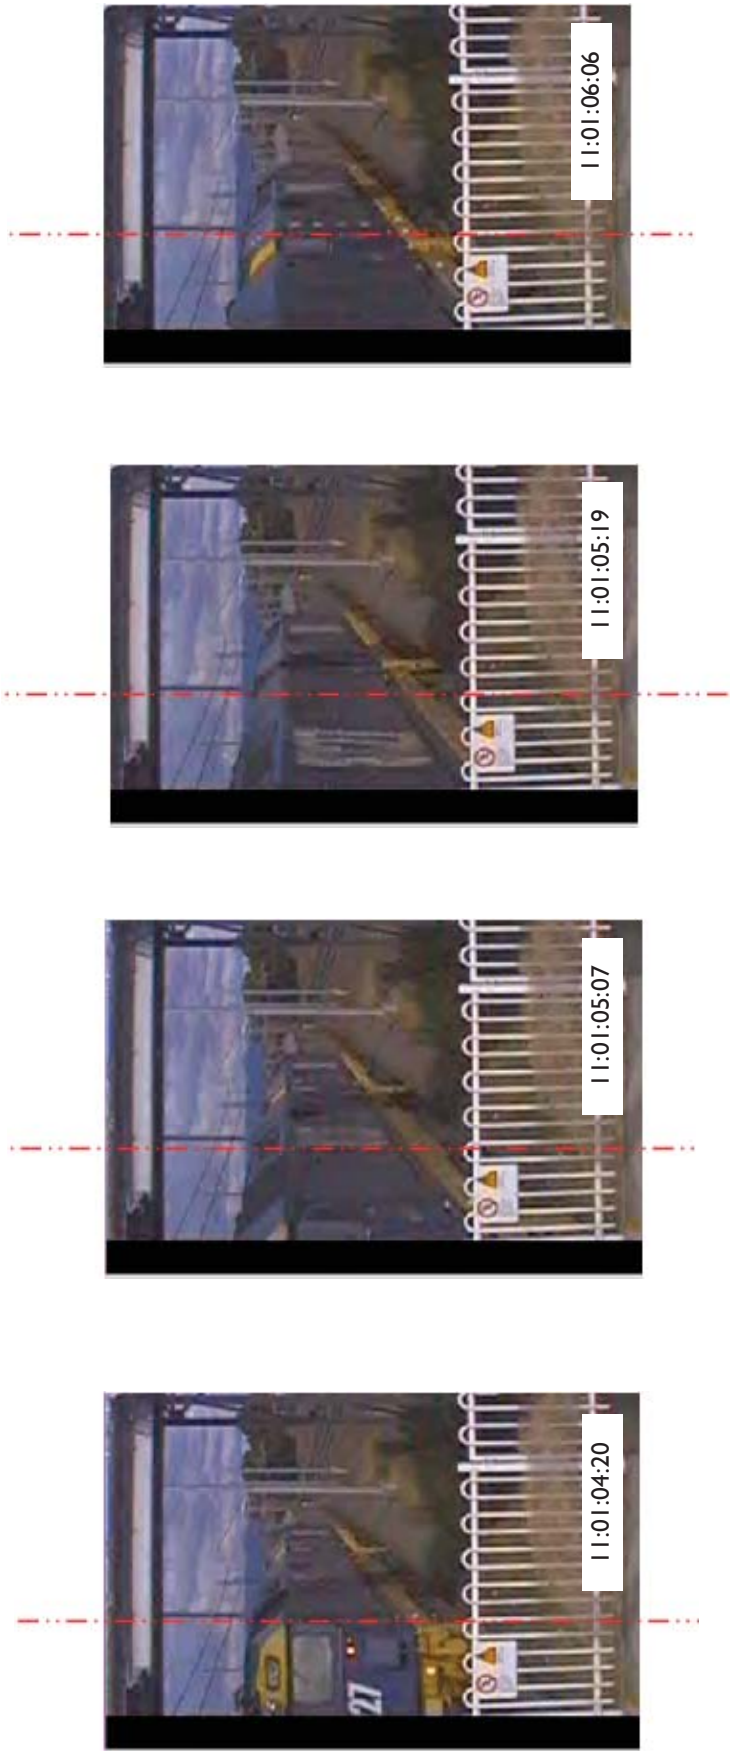
8.3 CCTV Speed check of B9162

Distance = Leading face of 8127 to leading face of 8148
= 21.156 metres

Time between CCTV frames = 1.86s

Approximate Speed = $(21.156/1.86) \times (3600/1000)$
~ 41km/h – confirming those results extrapolated from the Hasler tape at the start of Unanderra Platform from the POR.

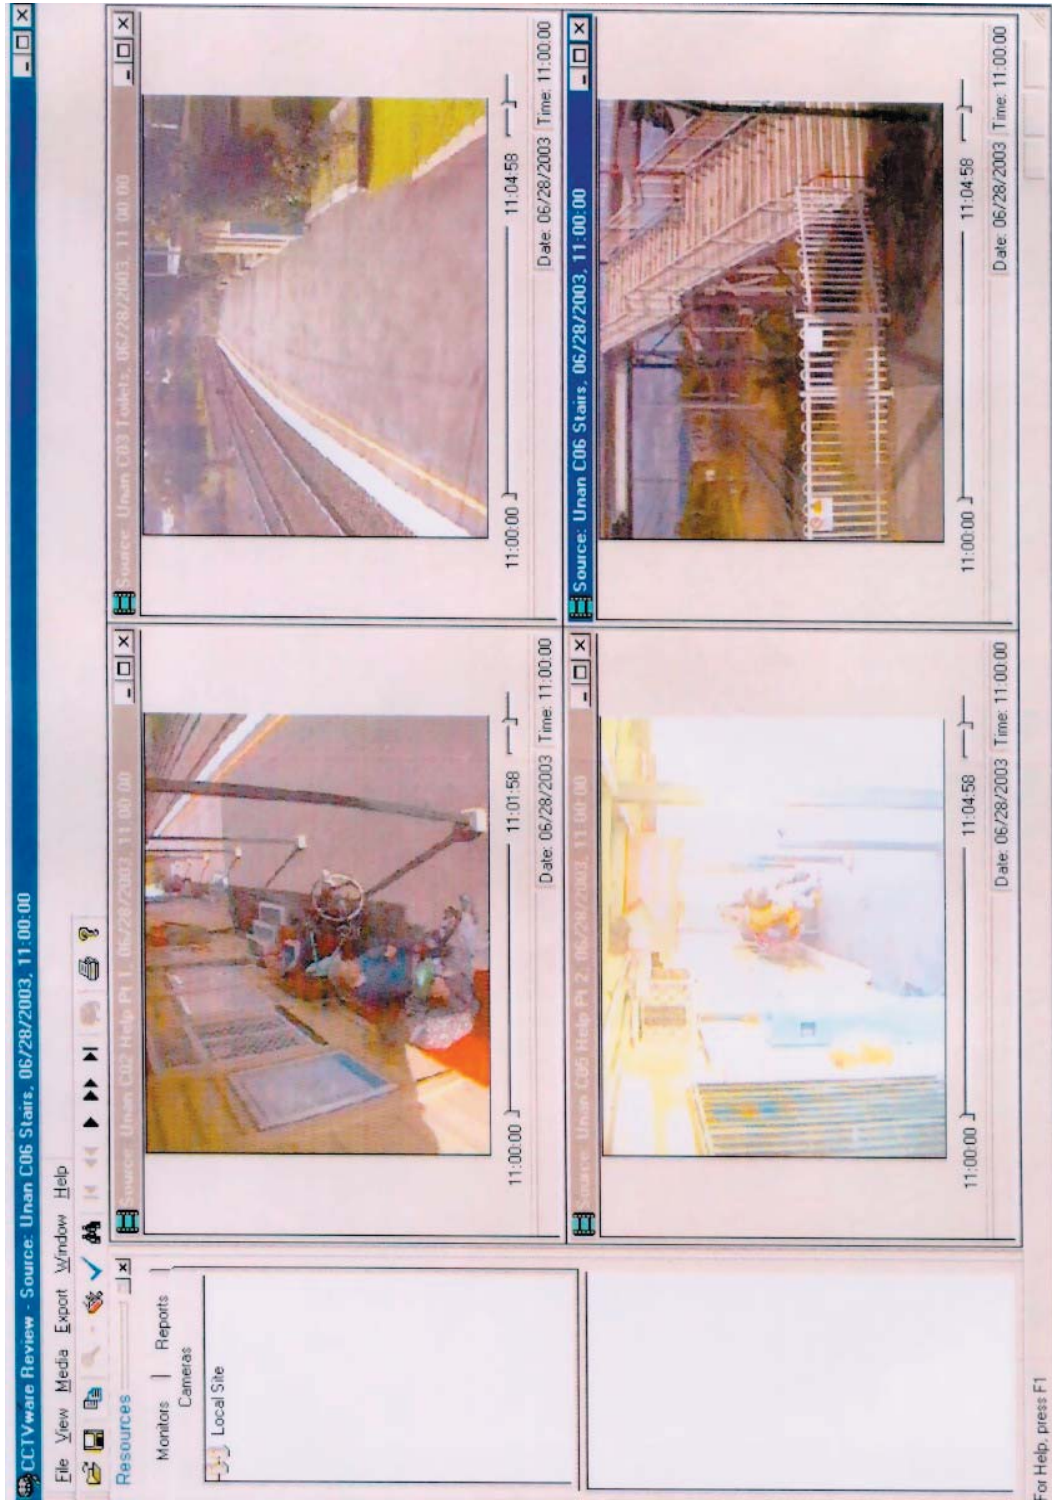
8.4 CCTV Time References

CCTV time references noting at 11.00am that both the City Rail passenger train K431 and B9162 were not visible from the Station CCTV cameras.
