**Office of Transport Safety Investigations**

**RAIL SAFETY INVESTIGATION REPORT  
SELF-HARM FATALITY ON THE EASTERN  
SUBURBS RAILWAY  
TOWN HALL – CENTRAL TUNNEL SECTION**

**30 AUGUST 2006**

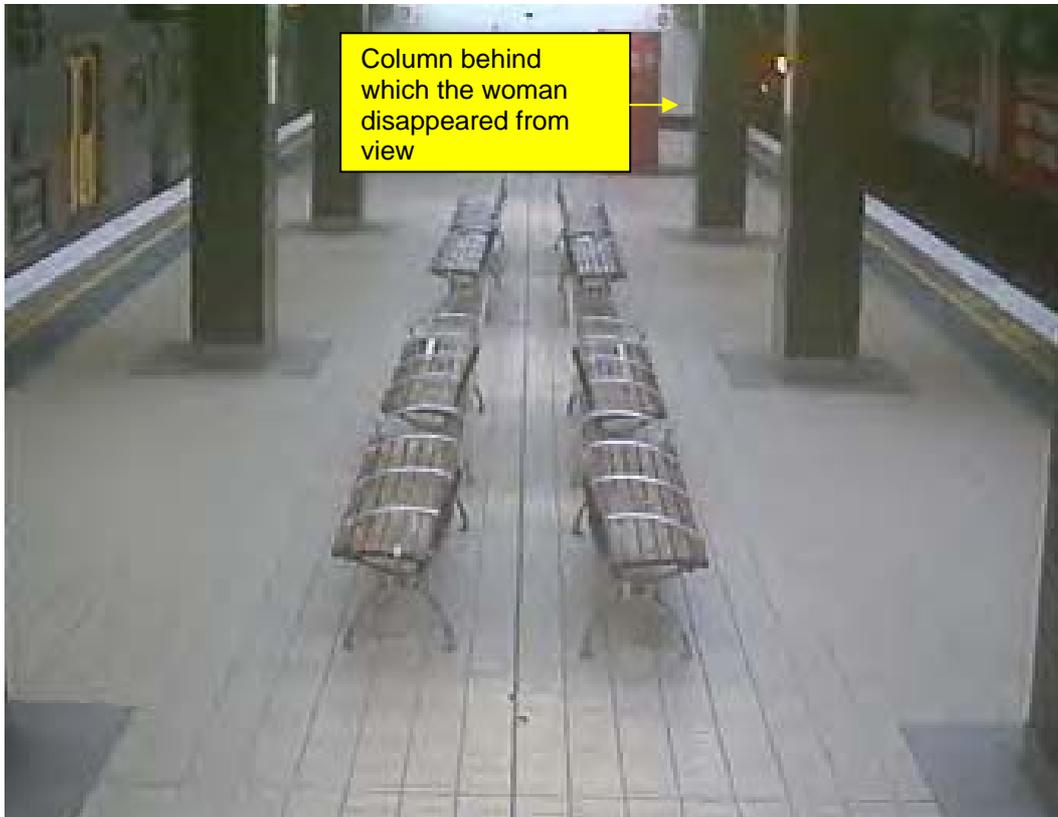
- 1.5 CCTV footage shows the woman on Platform 25 of Central Station between 2:41pm and 3:10pm but then disappearing as she steps behind a column at the Northern end of the platform (*see Photo 1*). She was not seen to re-

**Photo 1: CCTV frame showing Platform 25. Note the extent to which vision of the tunnel portals is obscured by the columns**

It is recommended that RailCorp ensures that the entrances to all tunnels on the metropolitan railway that can be accessed via a passenger platform are effectively covered by CCTV.

- i. the camera best placed to provide coverage of the tunnel's portals has its field of vision obscured by a row of columns (see *Photo 1*);
- ii. although RailCorp's CCTV cameras are 'networked' and monitored centrally, each camera is not monitored continuously and there is no mechanism which alerts platform or control staff to an attempted or actual unauthorised entry into the underground tunnel system from Platform 25, and
- iii. there is no mechanism prior to or within the underground tunnel system to detect and differentiate between train and non-train movement and to alert platform or control staff.

- ii. The CCTV network is limited as a defence against unauthorised entry into the tunnel system from Platform 25 for the following reasons:
  - (1) the camera best placed to capture movement into the tunnel had its field of vision obscured by a platform structure;

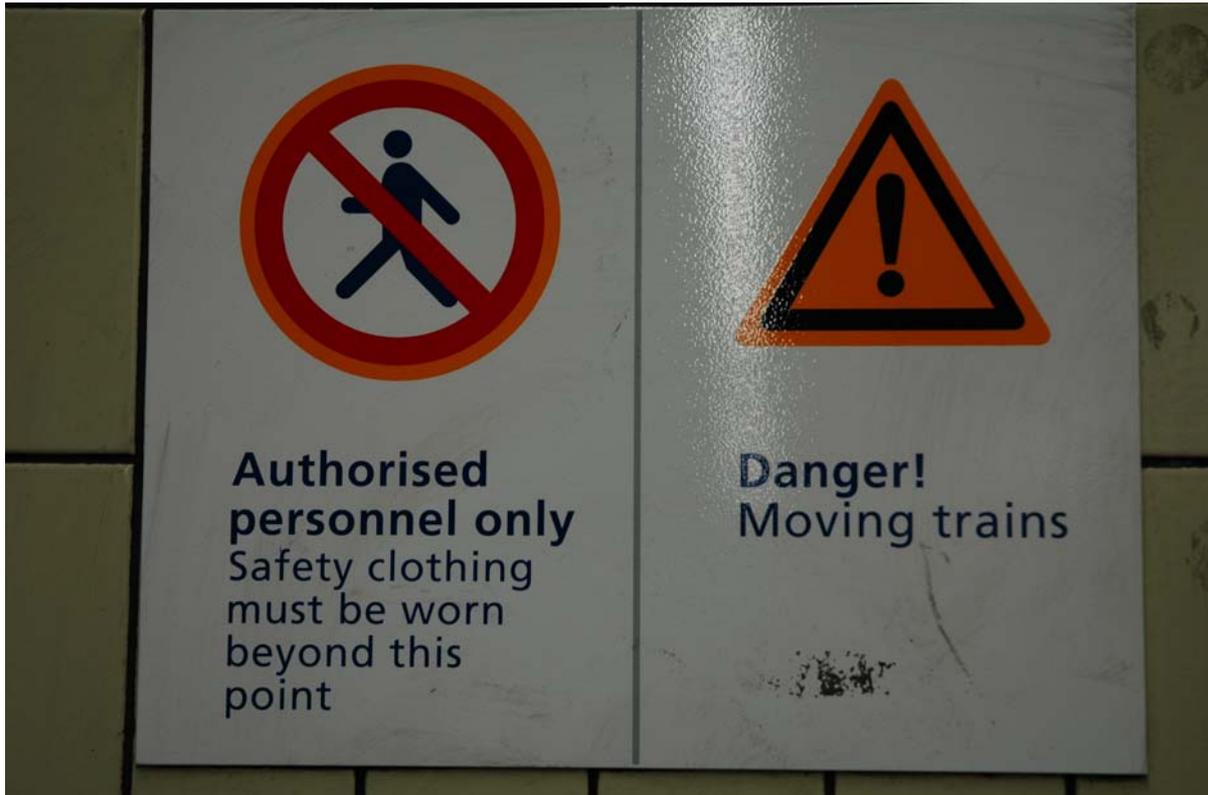
Photo 2: Warning signs at Platform 25, Central Station

1.17 The access restrictions and dangers associated with entry into the ESR tunnel system are described on clearly visible Warning Signs at Central Station's Platform 25 (see *Photo 2*). CCTV cameras are positioned along the platform but constitute only a limited defence against unauthorised entry into the tunnel system from Platform 25 because:

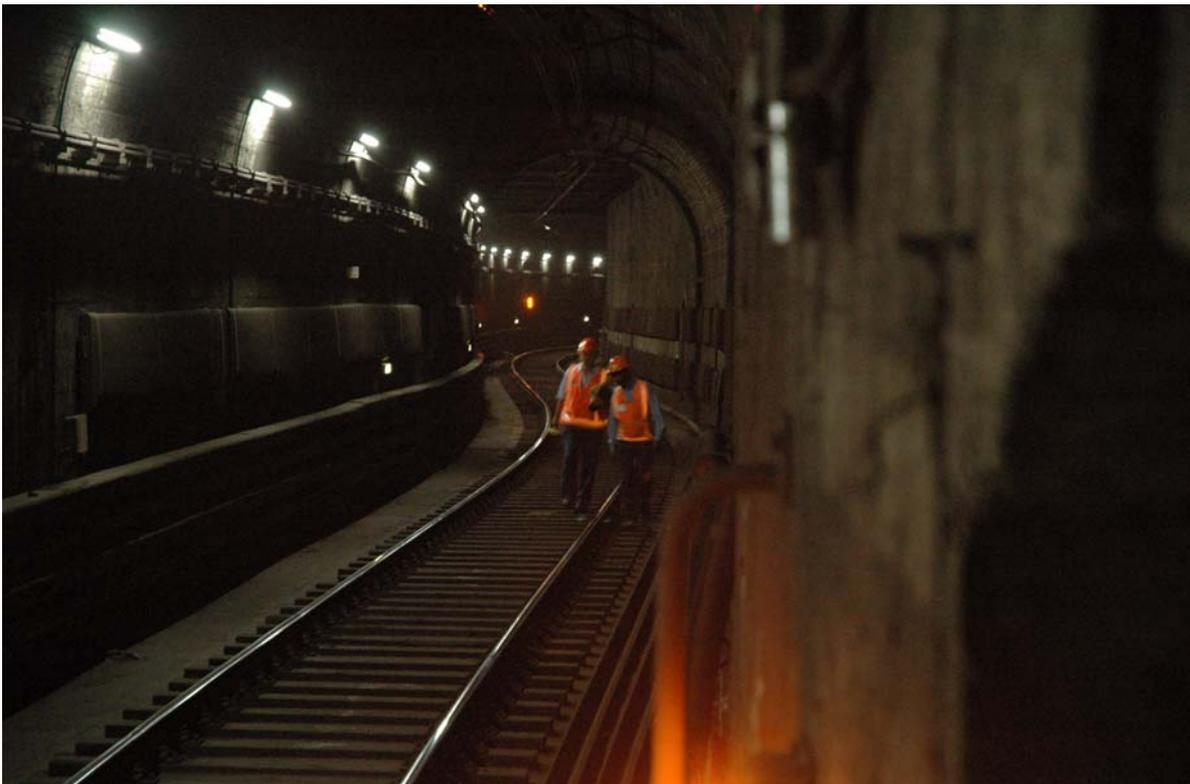
**Photo 3: Typical lighting and walking conditions inside the ESR tunnel system**
