## **BUS SAFETY INVESTIGATION REPORT**

### **BUS AND PEDESTRIAN FATAL ACCIDENT**

**BRUNKER ROAD, ADAMSTOWN, NSW**

**5 NOVEMBER 2019**

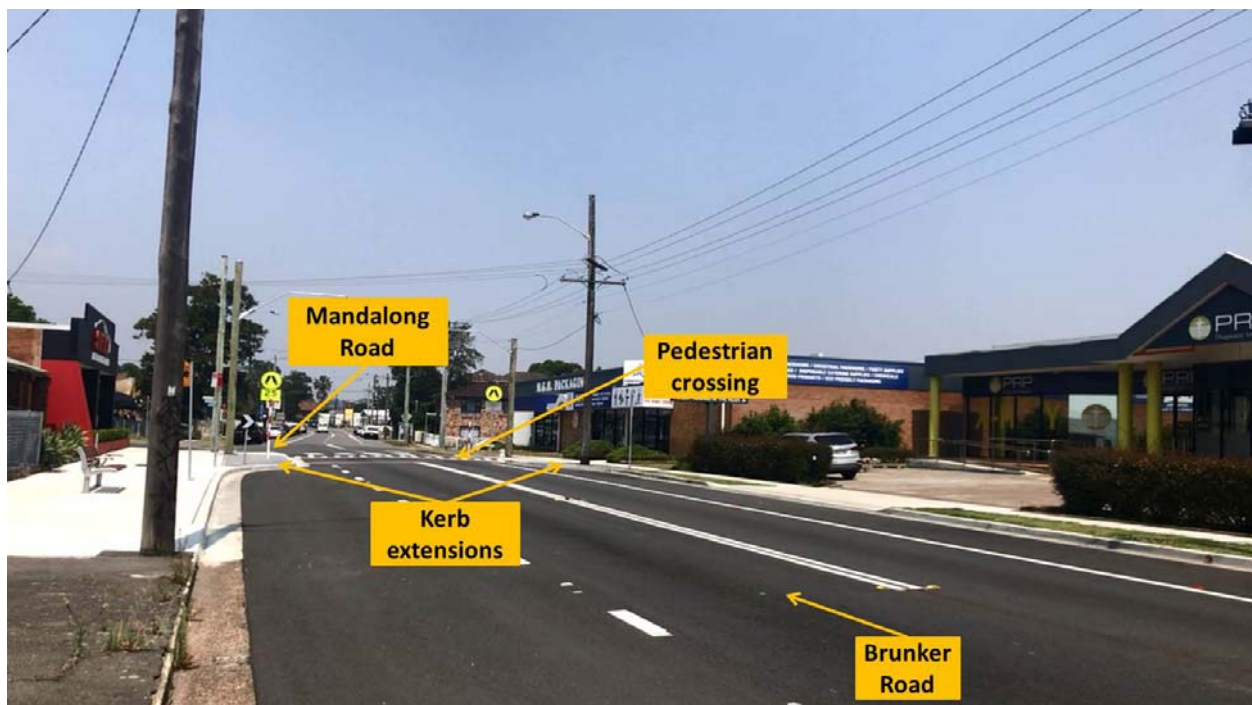
Figure 1: Pedestrian Crossing on Brunker Road

- 1.2 The accident occurred on the pedestrian crossing on Brunker Road near Mandalong Road, Adamstown (Figure 1). Brunker Road is a two-way road with designated parking lanes either side of the main carriageway. Adamstown is approximately five kilometres (km) west of the Newcastle CBD.

- 1.3 The pedestrian crossing was upgraded in February 2019 to include kerb extensions to increase driver awareness of its location.
- 1.4 Prior to this accident, there had not been any other recorded accidents at the pedestrian crossing in the previous 10 years.<sup>2</sup>
- 1.5 The roadway and pedestrian crossing were designed and built to meet Austroads and Newcastle City Council Road Geometry Standards<sup>3</sup>. The speed limit posted for the area was 40 km/h.
- 1.6 The bus's direction of travel at this part of Brunker Road was northeast to southwest.

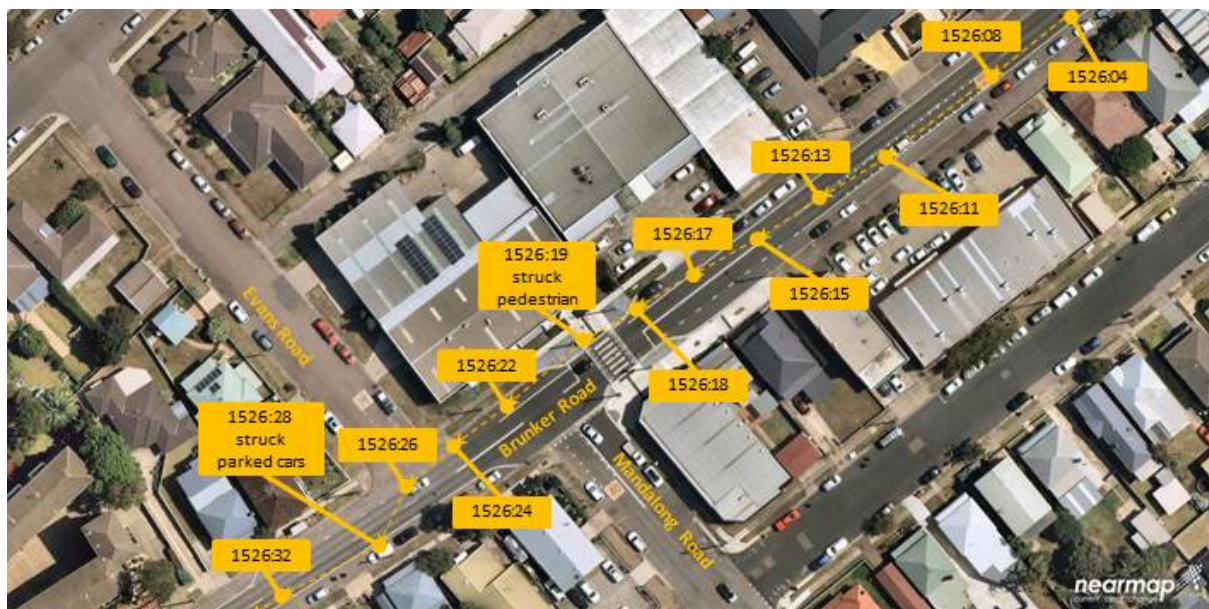
**Figure 3: Path of the Bus**

- 1.25 At 1526:04, the bus slowed to 19 km/h and the bus driver looked to his left before turning back to centre and resuming his driving position (Figure 3).

- 1.26 At 1526:11, the bus veered to the right from the southbound lane towards the northbound lane. The bus driver remained motionless, making no response to correct the change in direction of travel.

- 1.27 At 1526:13, the bus moved across and over the centre broken white lines and into the northbound lane. The bus driver remained motionless and unresponsive to the change in direction of the bus.

- 1.28 At 1526:15, the bus was travelling across the northbound lane.
- 1.29 At 1526:17, the bus had moved further across the northbound lane and approached the kerb extensions of the pedestrian crossing. The bus driver remained motionless, although his body shifted slightly forward off the seat. The bus driver's right hand then slipped from the steering wheel.

- 1.30 At 1526:18, the bus reached the pedestrian crossing near Mandalong Road. The bus had moved across the northbound lane. A person was standing on the kerb next to the pedestrian crossing sign and looking to the south for oncoming traffic (away from the approaching bus).

- 1.31 At 1526:19, the bus travelled up onto the kerb and struck and fatally injured the person.
- 1.32 The bus then struck the pedestrian crossing sign and dismounted the kerb and continued along the parking lane of the northbound carriageway. CCTV showed the bus driver was still slightly forward in his seat with his right hand off the steering wheel grasping in the air momentarily before locating the steering wheel.
