Office of Transport Safety Investigations

BUS SAFETY INVESTIGATION REPORT

UNINTENTIONAL OPENING OF BUS REAR DOORS

3 APRIL 2014

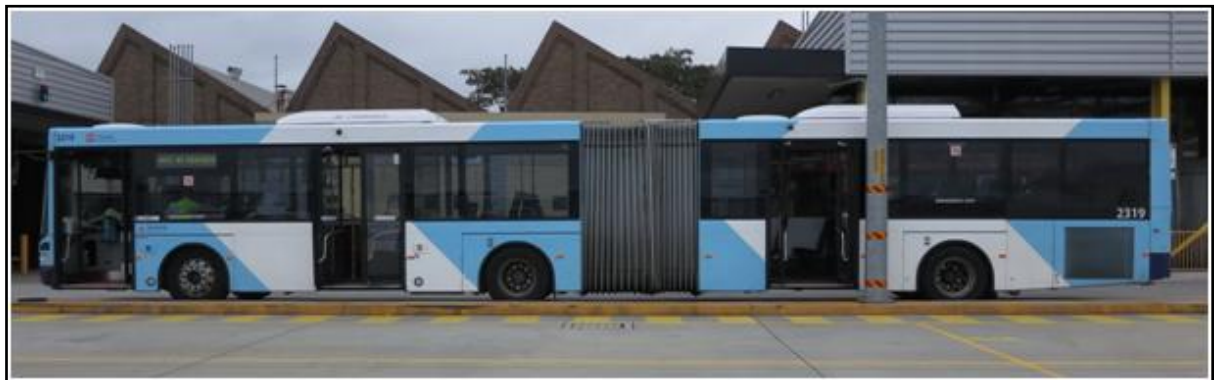
Photograph 1: Side of 2319 ST

- 1.4 The bus was an articulated Volvo B12BLEA model. It had three door openings; all on the near side of the bus (see *Photograph 1*).²

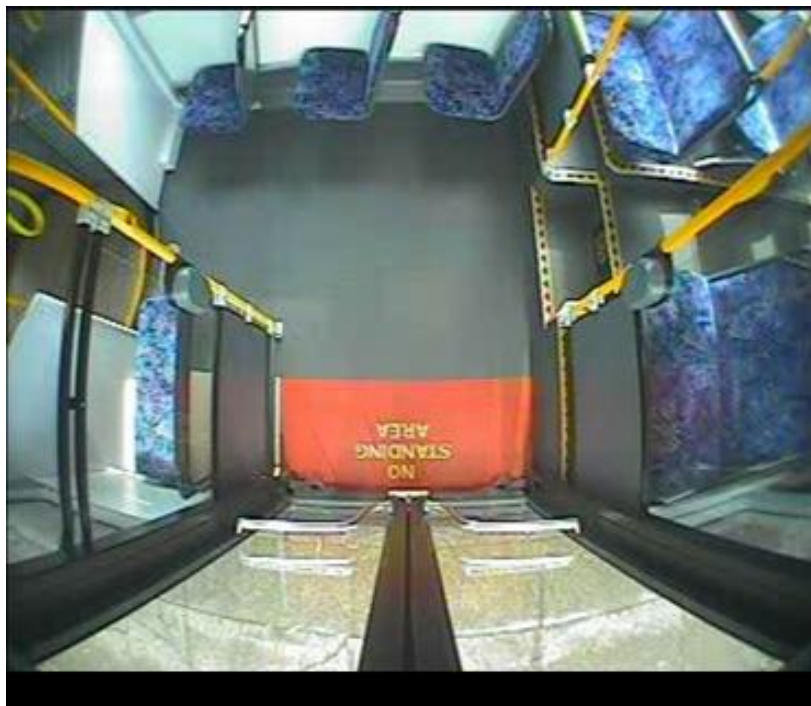
Photograph 3: Vestibule area next to rear doors (empty)

- 1.12 In the vestibule area next to the rear doors there were 12 students. Eight students were standing in this area and two were standing fully on the marked 'No Standing Area' (see *Photographs 3 and 4*). Four students were sharing the three single seats adjacent to the vestibule on the off side of the bus.

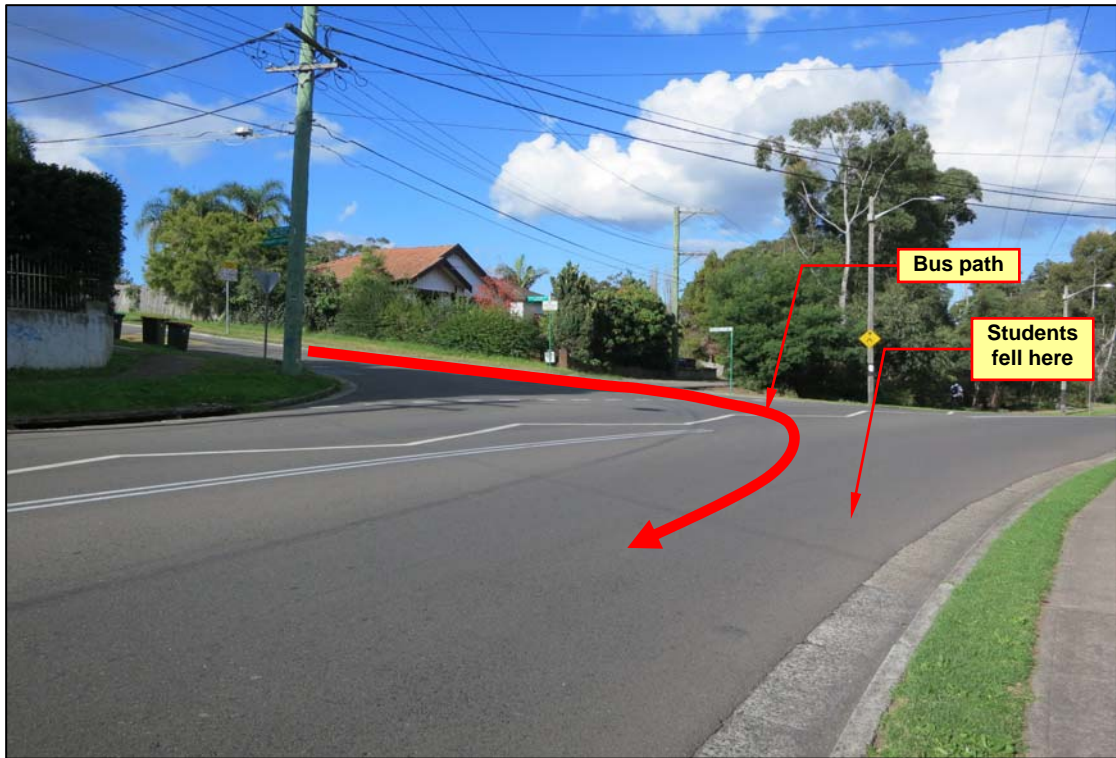
Photograph 5: Malvina St and Buffalo Rd intersection

- 1.14 The bus travelled approximately 200 m southbound along Malvina St, reaching a top speed of 29 km/h. It reached the T- intersection at Buffalo Rd at 1509:39. The bus driver waited for traffic to clear before making the turn. Another STA bus on Buffalo Rd, on the left of 2319 ST, paused to allow this bus to enter Buffalo Rd. At 1509:47 the bus started the right hand turn into Buffalo Rd (see *Photograph 5*).

- 1.15 There is a steep decline for the last 40 m of Malvina St approaching Buffalo Rd. Also, Buffalo Rd has a camber which accentuated the lean of the bus to the left as it made the right hand turn from Malvina St into Buffalo Rd. This incline and camber may have caused instability for the standing students.

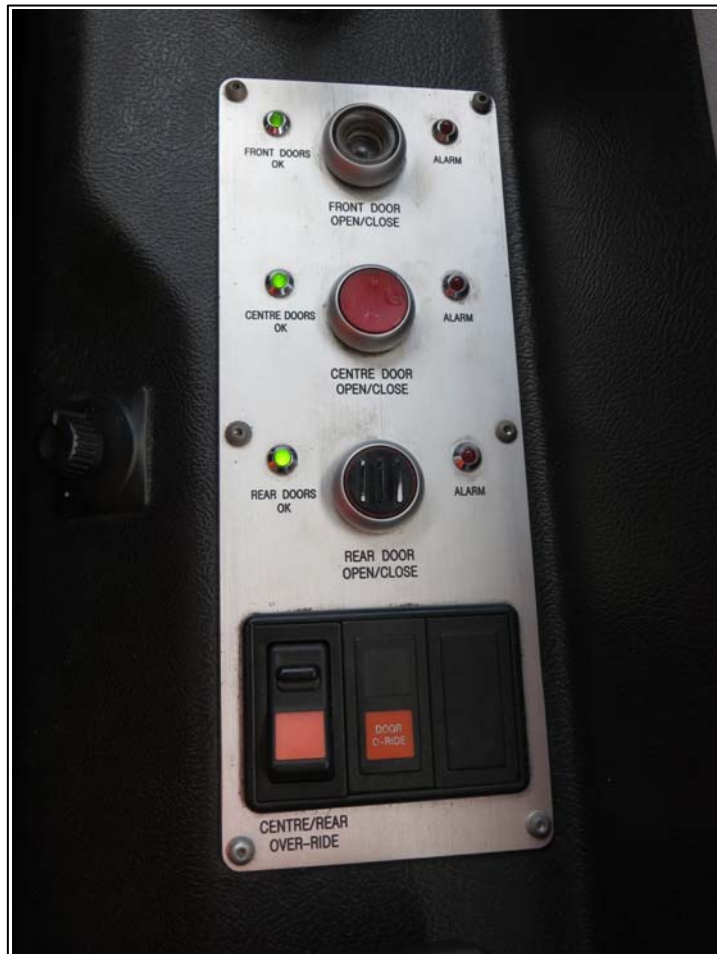
Photograph 13: Bus door controls

2.10 Passenger buses have several safety mechanisms in place to prevent doors opening during travel and also to prevent the doors closing as passengers get on and off. The opening of the doors is controlled by the driver from a dashboard control at the front of the bus. On this dashboard is a warning light which is accompanied by an audible alarm (see *Photograph 13*). This was fully functioning on 2319 ST.

2.11 At no stage did the alarm indicate that the rear doors had opened. This is because the alarm only activates under two conditions. Firstly, if the door sensor detects pressure on the edge of the door panel, such as an arm caught between the doors as they close. Secondly, if the doors do not close or are opened when the vehicle's road speed is under 5 km/h. Under both of these conditions the brakes of the bus will be applied and the throttle will shut

down. Both of these conditions were not met as the bus was travelling over 5 km/h and the pressure sensor on the edge was not involved.

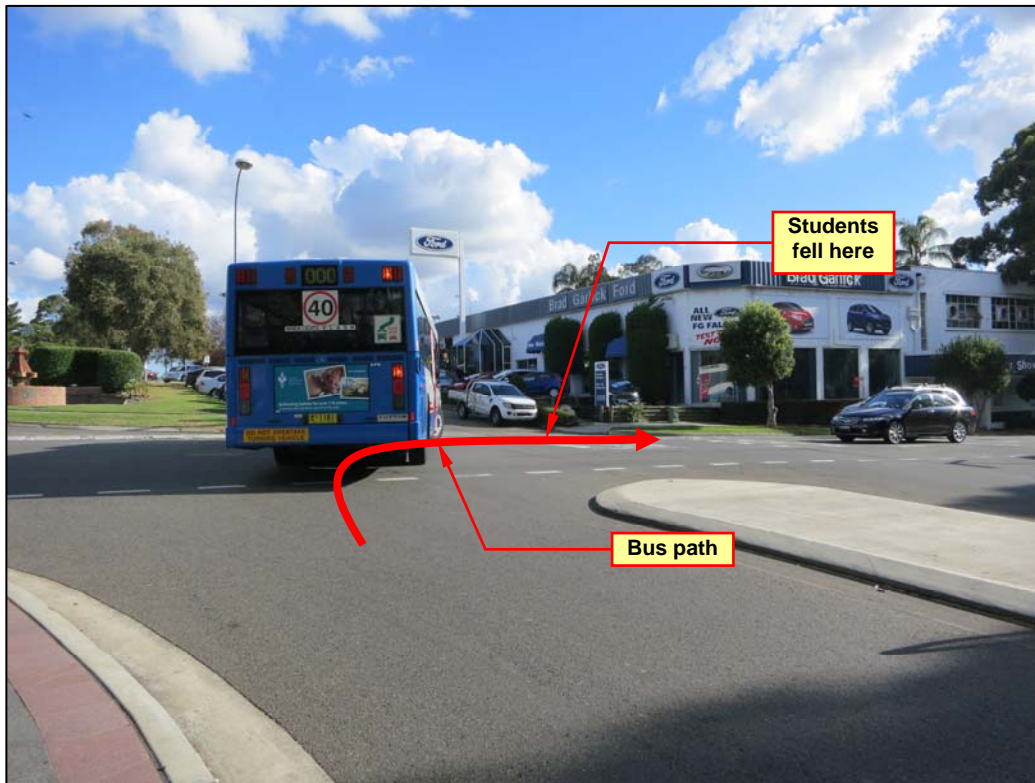
Photograph 14: Intersection of Princes St and Blaxland Rd

- 2.17 A similar incident occurred at 1510 on 14 June 2012 at the corner of Princes St and Blaxland Rd about 1.2 km from Ryde Secondary College (see *Photograph 14*).

(A turning bus at approximate location of incident, not the bus involved in the incident.)

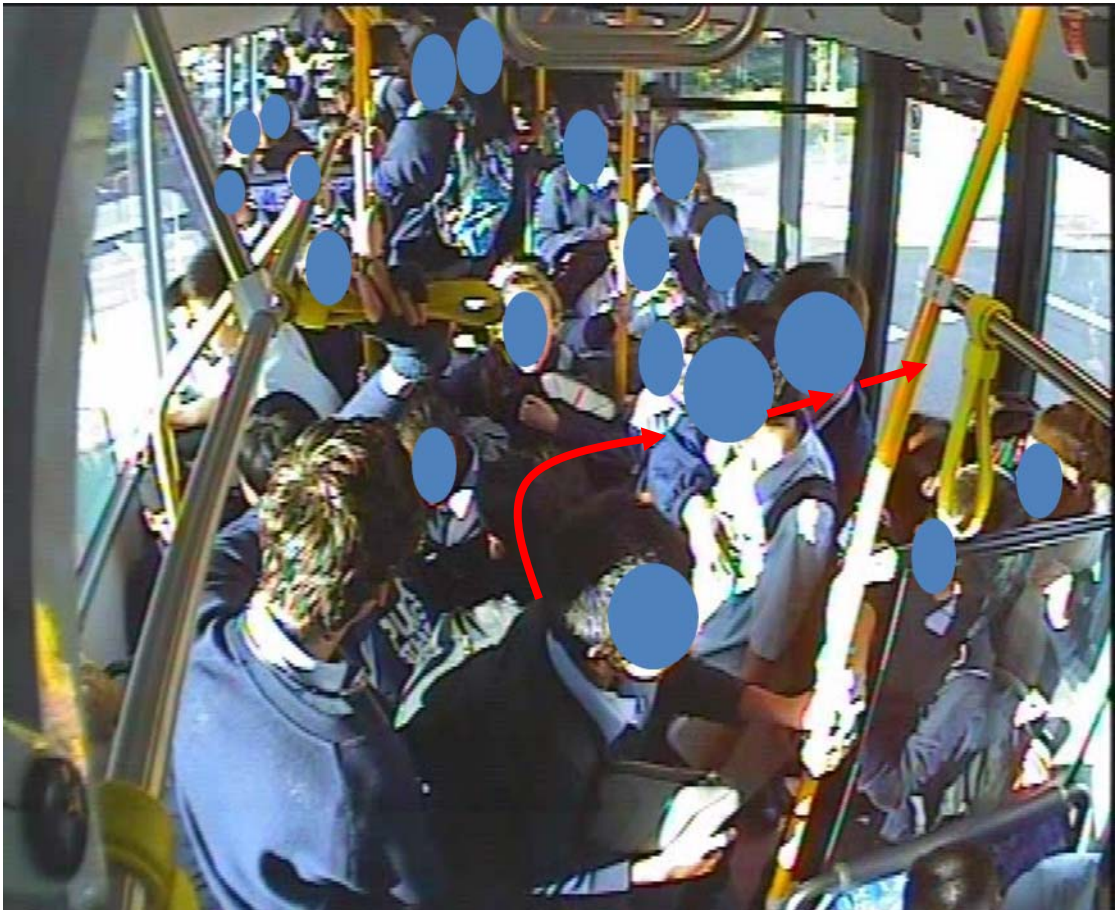
Photograph 15: Students in rear door vestibule just prior to incident

- 2.18 On this occasion five students fell from the rear doors of the bus. The bus involved, 2318ST, entered service with STA on 29 June 2011. It was the same model bus as the one from which the two students fell on 3 April 2014.
- 2.19 The bus departed Ryde Secondary College at 1507 with approximately 85 students. Three students were standing in the 'No Standing Area' at the front of the bus near the driver. The rear vestibule area was crowded, with approximately 12 students in this area. Three students were seated and three other students were standing in the red-coloured 'No Standing Area' (see *Photograph 15*).

- 2.20 As the bus travelled along Princes St, towards the corner with Blaxland Rd, the movement of the bus caused some students to bump into each other in the crowded rear vestibule. Then, at 1510, as the bus started its right hand turn into Blaxland Rd there was a disturbance in the vestibule area. Three schoolboys were behaving in an unruly manner which caused them to lose their balance. Together the three schoolboys fell backwards towards the rear doors. This action forced two other schoolgirls against the doors.
