Office of Transport Safety Investigations

TECHNICAL INSPECTION FINDINGS

HUNTER VALLEY BUS 4358MO FIRE

WANGI WANGI 19 MAY 2014

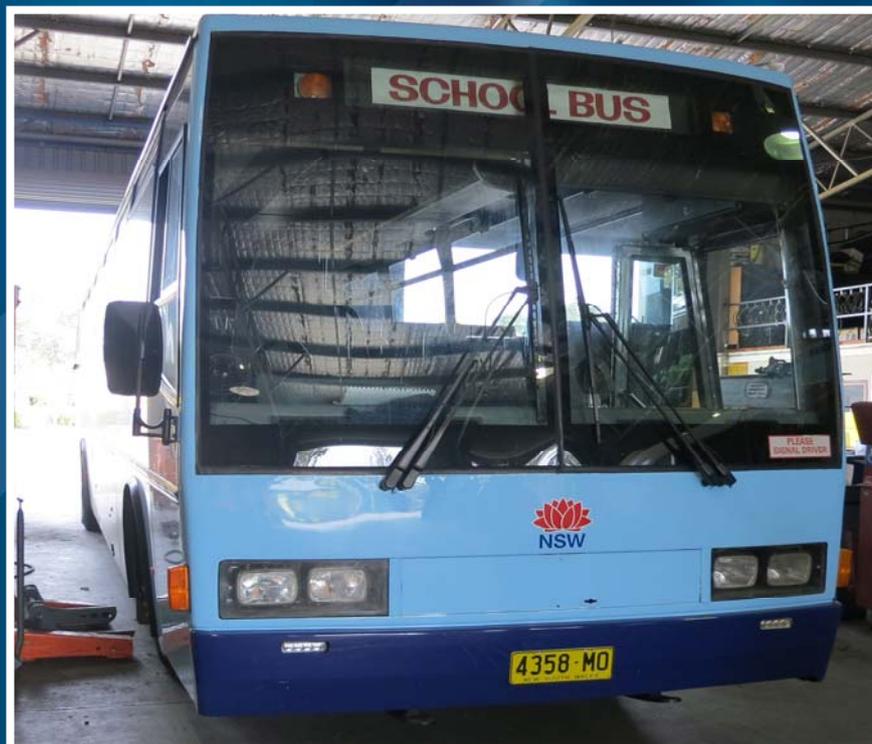
The driver was alerted to the fire by the driver of a following bus who observed flames and smoke emanating from the rear of bus. The driver immediately stopped the bus, shut off the engine and the electrical system, evacuated the twelve school children and discharged a portable fire extinguisher (dry powder) to extinguish the fire. The driver's prompt action prevented his passengers from being injured and prevented damage to the engine and ancillary items. (See photo 1)
