Office of Transport Safety Investigations

BUS SAFETY INVESTIGATION REPORT

UNINTENTIONAL OPENING OF BUS REAR DOOR

19 MAY 2016

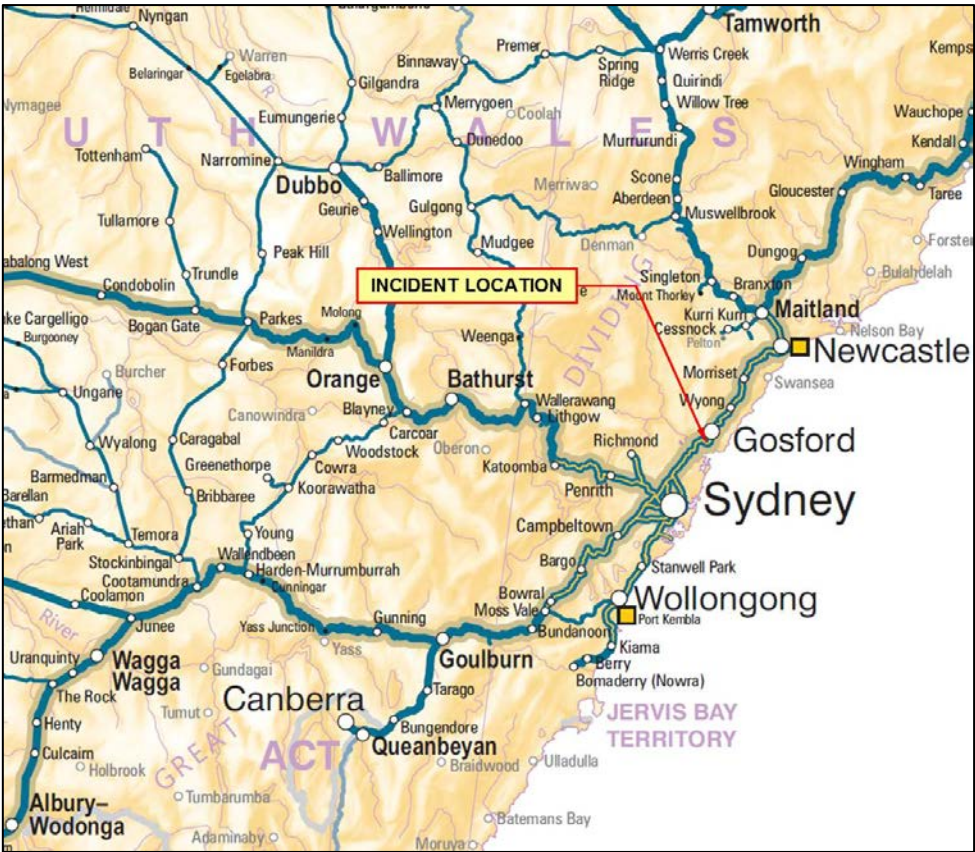
Figure 1: Incident location - Point Clare

- 1.2 The incident occurred on Wendy Drive, Point Clare on the Central Coast in NSW (see *Figure 1*). The suburb of Point Clare is 49 km north of Sydney's central business district.
- 1.3 Wendy Drive is a residential suburban street with a speed limit of 50 km/h. The location where the student fell out is a gradual right-hand curve in the direction of travel for the bus, outside the entrance to the ambulance station where a driveway enters the road. The road surface is bitumen with numerous filled potholes. In addition, there are areas of the road that have deteriorated to loose gravel creating a rough road surface. The road has a slight slope down towards the ambulance station driveway (see *Figure 2*).

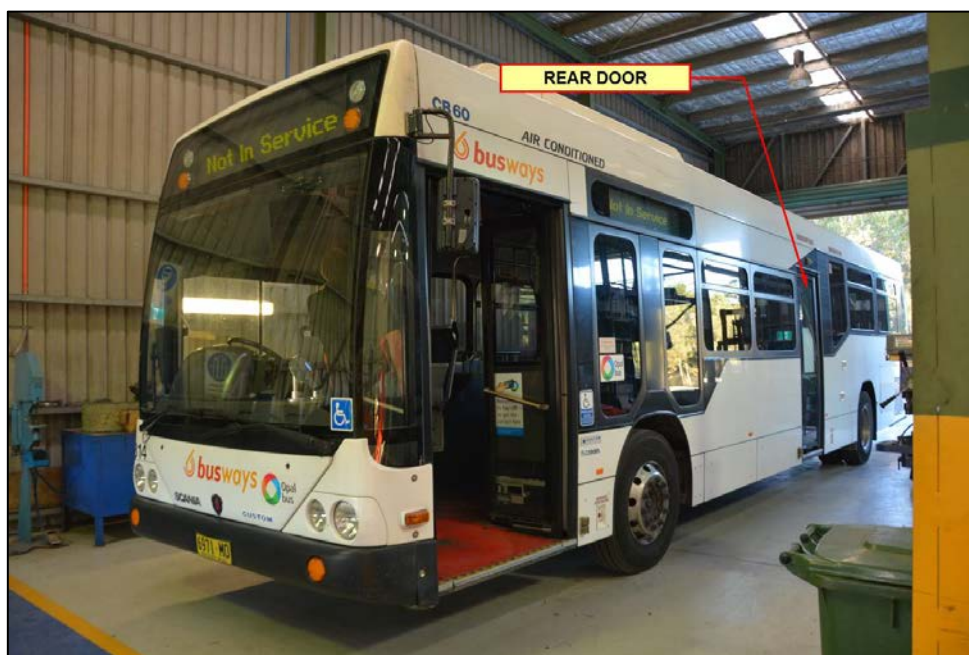
Figure 3: Busways bus 6971 MO

- 1.5 The bus, a 2007 Scania K230UB model, was a two door city bus, registration 6971MO. It was fitted with a Custom Coaches CB 60 body. The bus was operated by Busways out of their Kincumber Depot. The odometer reading at the time of the incident was 535,177 km. The two door openings were on the near side² of the bus (see *Figure 3*). The front door consisted of two door leafs, and the rear door had a single door leaf. It was the rear door that opened during the incident. The door aperture measured approximately 815 mm wide by 2050 mm high.

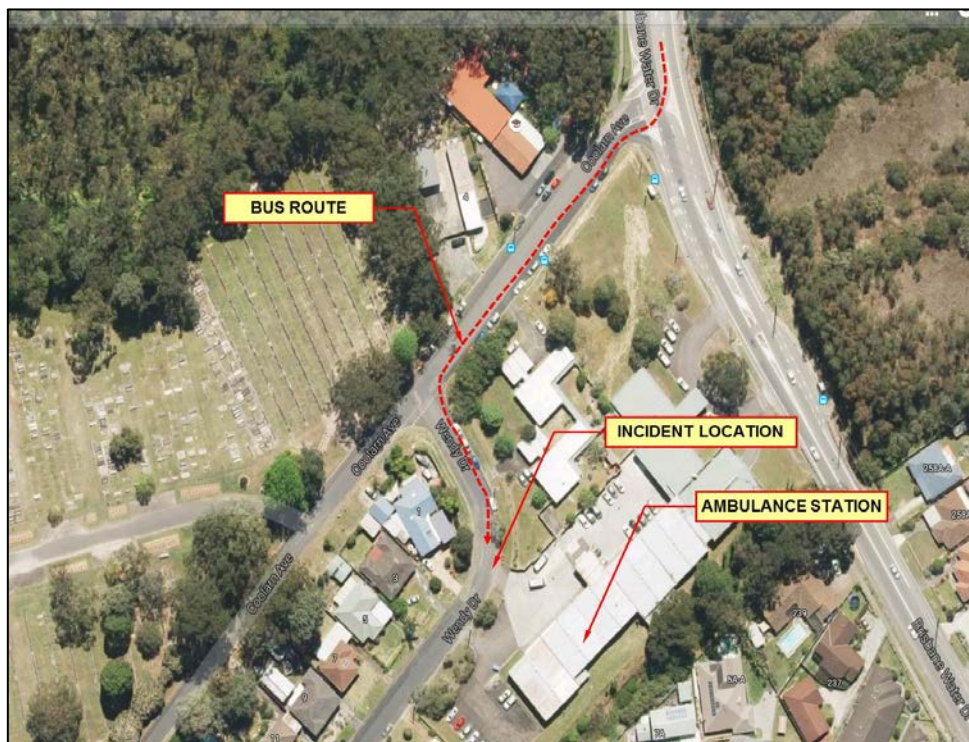
Figure 5: Bus route leading up to incident

- 1.11 The bus turned the corner into Wendy Drive and made a gradual right-hand turn past the rear of the ambulance station when the student fell out (see *Figure 5*). The road camber and the uneven surface of the road likely created instability for the leaning student and introduced additional forces against the rear door.

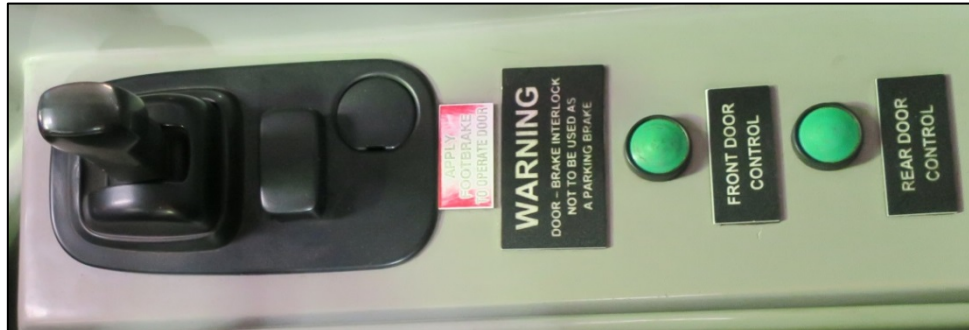
Figure 10: Door controls

- 2.11 Passenger buses have several safety mechanisms in place to prevent doors opening during travel and also to prevent the doors closing as passengers get on and off. The opening of the doors is controlled by the driver from a control panel adjacent to the driver's seat. (see *Figure 10*). These controls were fully functional when tested following the incident.

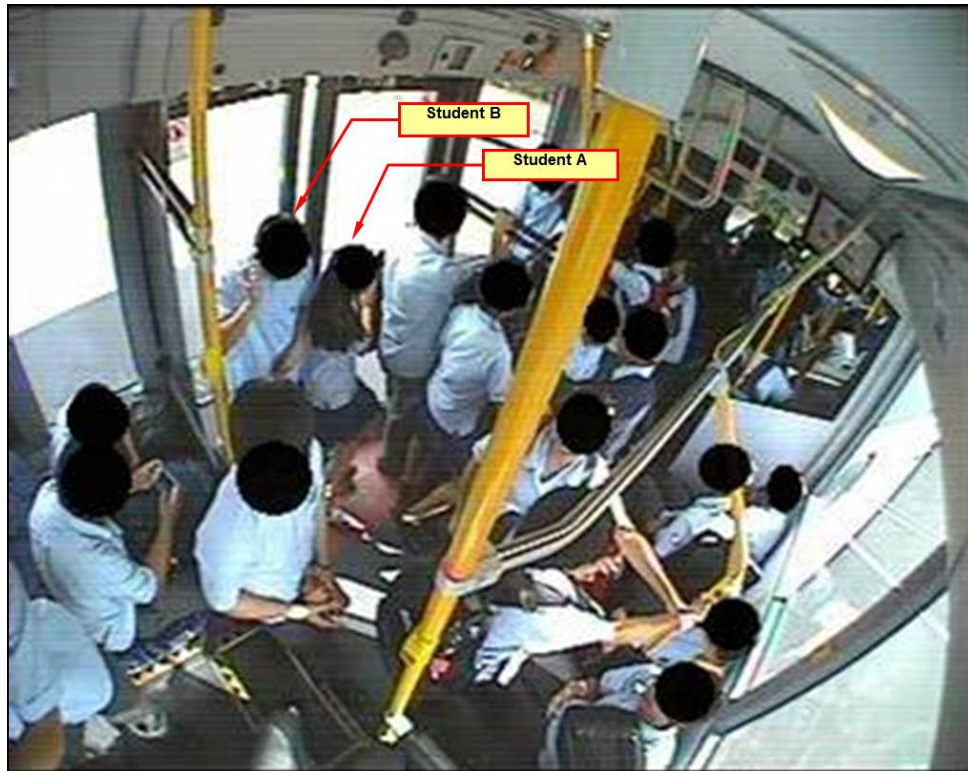
Figure 14: Student A stumbles against student B (2014)

- 2.29 A second incident occurred on 3 April 2014, when, two students standing in the rear vestibule area fell against the rear doors of the bus. As the bus was making the turn, a student, standing in the vestibule area, stumbled and fell against a another student (see *Figure 14*). The student was standing unsupported facing away from the doors and talking on a mobile phone. The force of the students falling against the doors again caused the upper door bracket to separate from the pivot pin of the door. The students fell onto the road sustaining minor injuries (see *Figure 15*).
