BUS SAFETY INVESTIGATION REPORT

BUS FIRE

SYDNEY HARBOUR BRIDGE

15 SEPTEMBER 2016

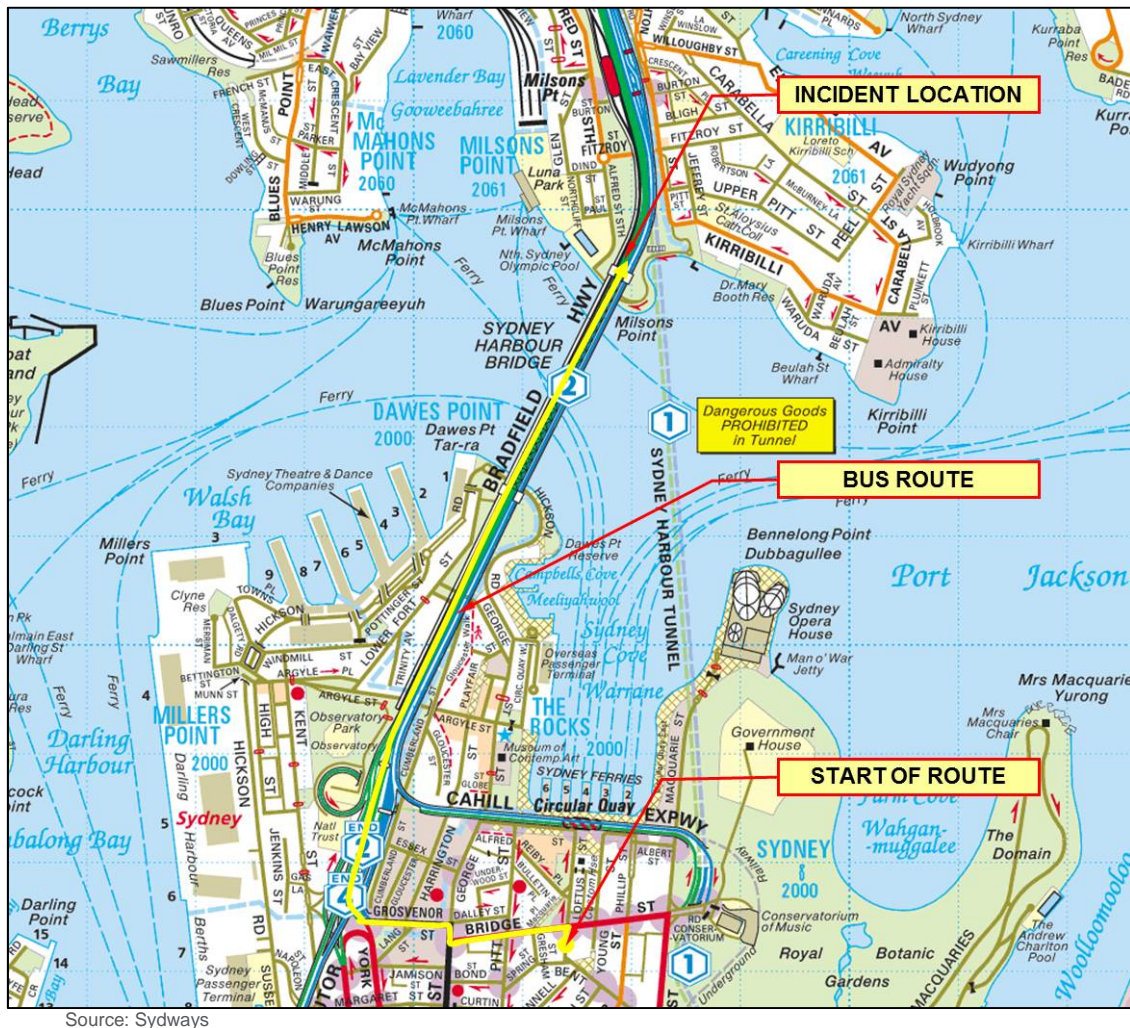
Figure 1: Map of incident location and route of bus

- 1.10 At 1718 the bus departed Bridge Street, five minutes behind schedule. The route took the bus west up Bridge Street, onto Grosvenor Street, across York Street onto the Bradfield Highway and the Sydney Harbour Bridge deck (see *Figure 1*). At 1720:49 the bus passed underneath the toll gantry at the southern entrance to the bridge. The driver said there was no performance issue with the bus. CCTV footage from a bus travelling behind MO3726 showed no external sign of smoke or fire. The traffic at the time was flowing

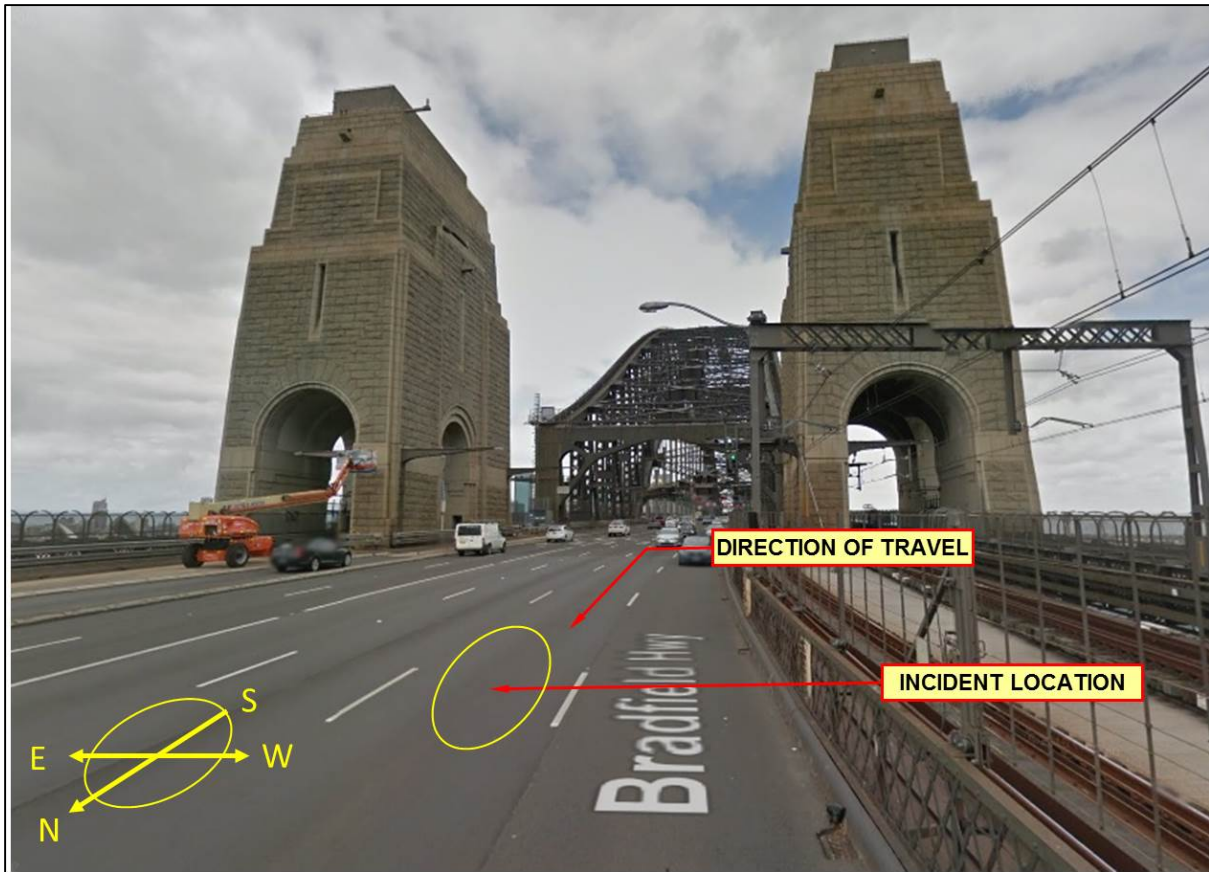
Figure 5: Bradfield Hwy and incident location, looking south

- 1.25 The incident occurred in lane 2 of the Bradfield Highway on the Sydney Harbour Bridge at Milsons Point (see *Figure 5*). The bridge deck carries, at this point, from west to east, a bicycle lane, twin rail lines, the six-lane Bradfield Highway, a bus lane, the one-lane Cahill Expressway and a pedestrian footpath.
- 1.26 The driver stopped the bus about 70 m past the north-western pylon in lane 2.

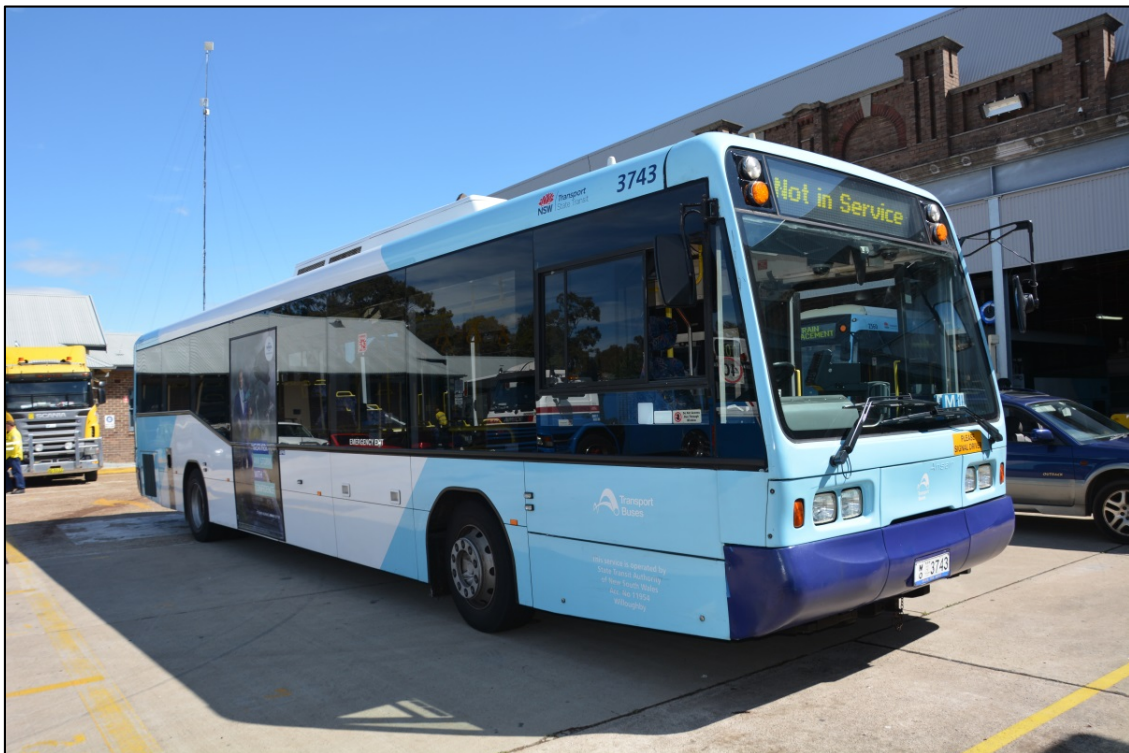
Figure 6: Similar model Scania bus

- 1.30 The bus was a two door city bus, registration MO3726, a 1996 Scania L113CRL diesel powered model (see *Figure 6*). It was fitted with an Ansair Orana body. The bus was operated by the STA out of the Willoughby Depot. There were 155 other buses of the same model in the STA fleet.
