BUS SAFETY INVESTIGATION REPORT

**CHARTER BUS FIRE
HOMEBUSH, NSW
8 FEBRUARY 2017**

Investigation Reference 04765

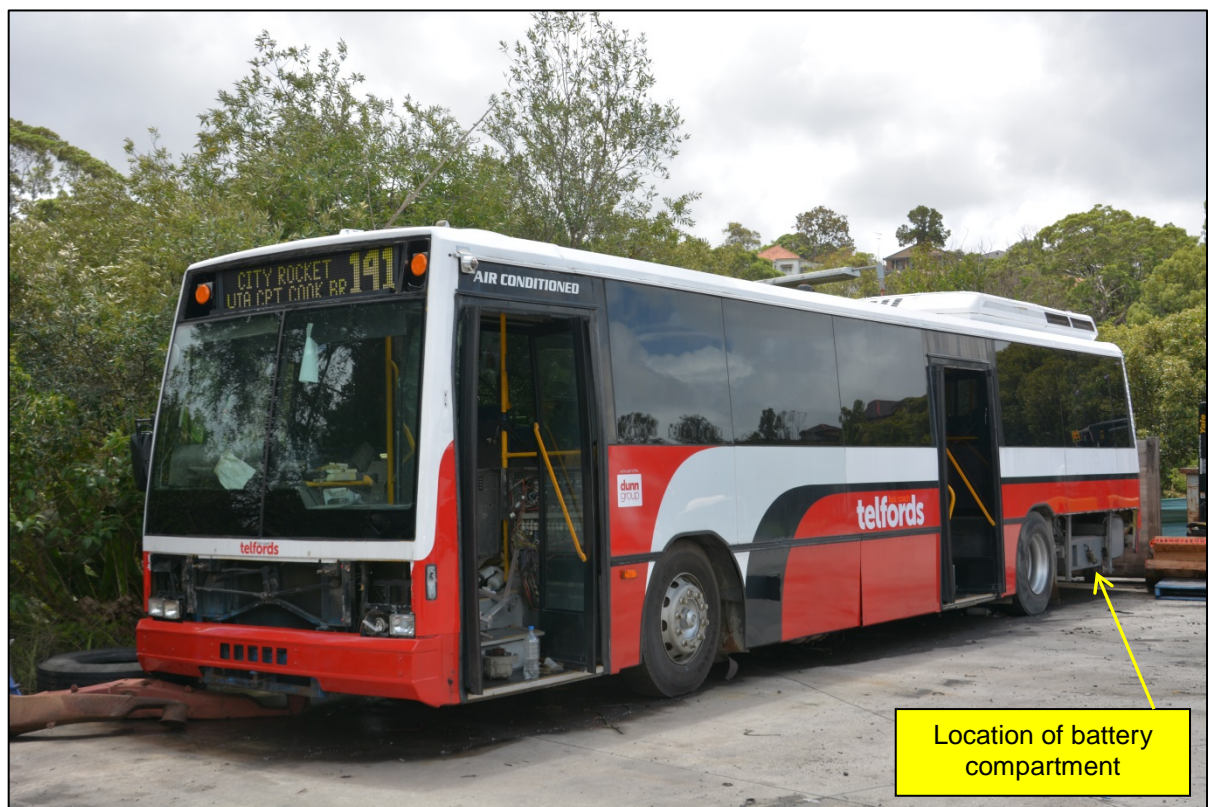
Figure 2: Identical model bus to TV8308 with a different livery

- 2.19 The batteries are located under the floor at the NSR of the bus behind the rear axle (*see Figure 2*). A "swing out" tray provides accessibility during maintenance.
- 2.20 The batteries are secured to the tray by two right-angled metal retainers. The metal retainers run across the upper corners of each end of the two 12V DC batteries and are secured to the battery tray assembly.
- 2.21 Inspection of a similar model bus indicated that a gap of approximately 15mm between the rearward retainer and the battery that could allow the terminal end of the battery to move under the retainer allowing the positive terminals to contact the metal retainer causing an electrical short circuit³ of the battery (*see Figure 6 and 4*).
