Office of Transport Safety Investigations

BUS SAFETY INVESTIGATION REPORT

SCHOOL BUS FIRE

6 MARCH 2017

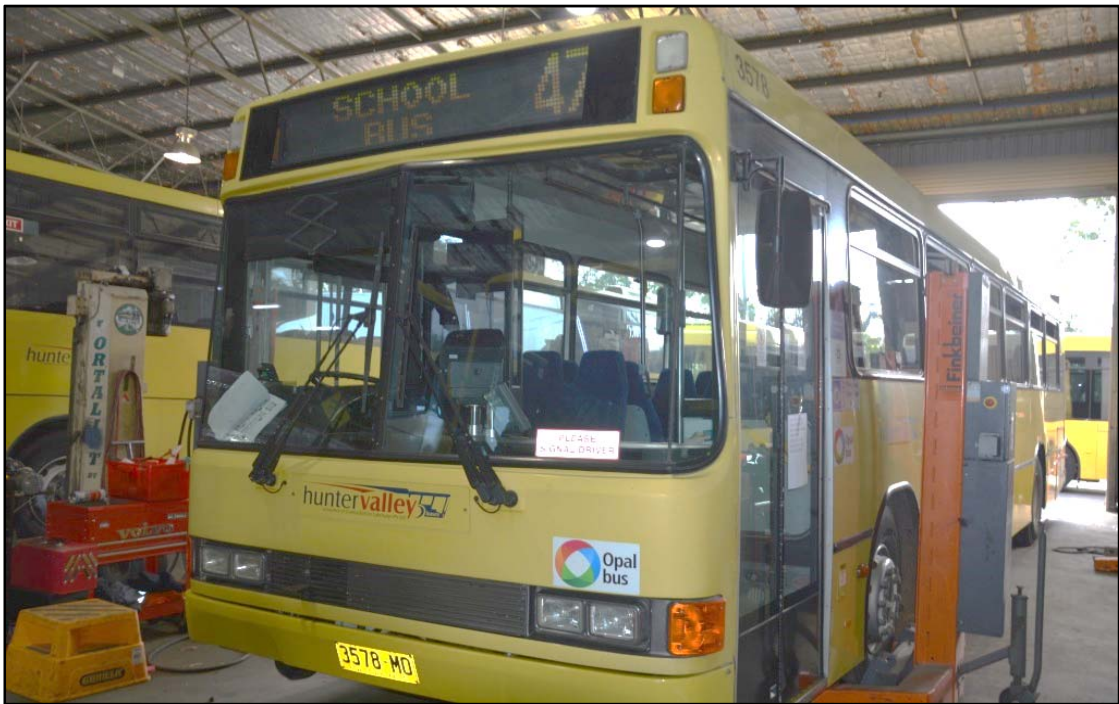
Figure 4: Bus involved in incident

1.13 The bus was a 1997 Mercedes O400 model diesel powered model, registration 3578MO (see *Figure 4*). At the time of the incident the odometer reading was 1,117,892 km. The bus was operated by the Hunter Valley Buses out of the Thornton Depot. There were 15 other buses of this model in the Hunter Valley Buses' fleet.
