**Office of Transport Safety Investigations**

## **BUS SAFETY INVESTIGATION REPORT**

**COACH FIRE**

**26 SEPTEMBER 2011**

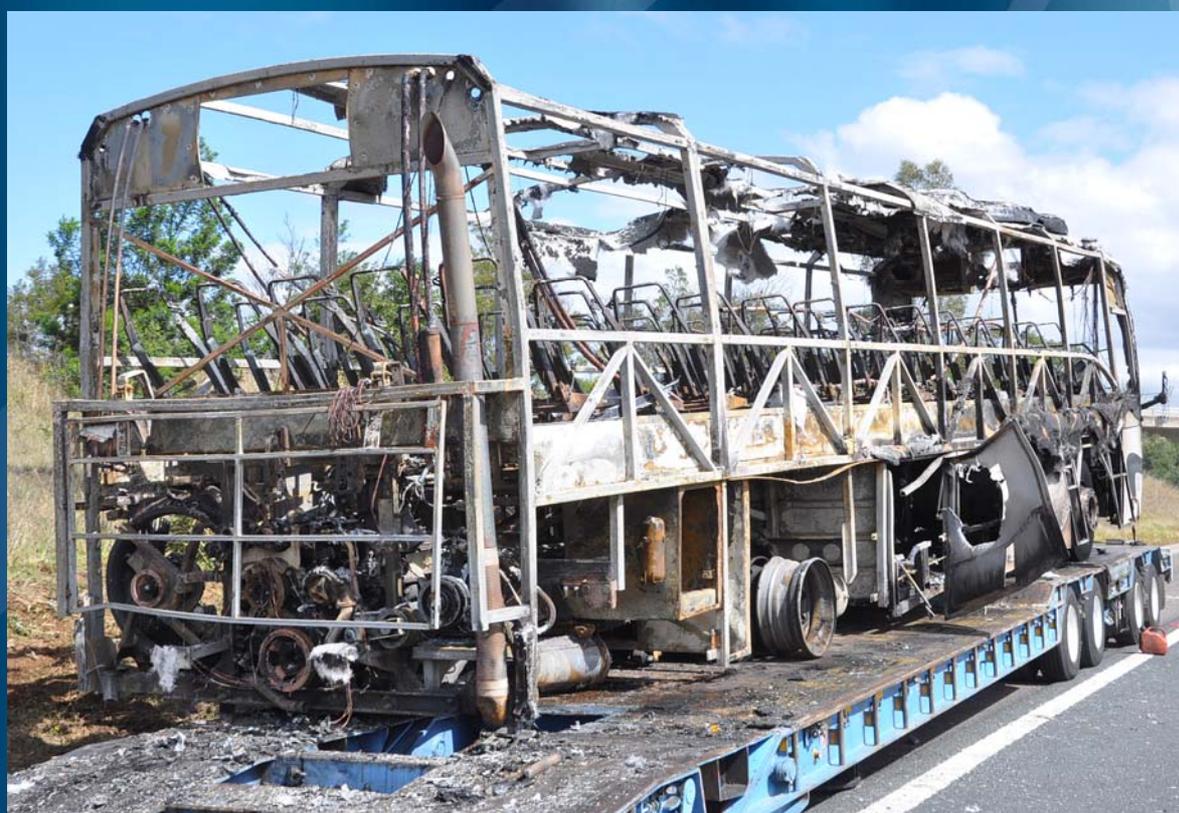
**Photograph 1: Wreckage of the Coach**

1.1 At approximately 9.11am on Monday 26 September 2011,<sup>1</sup> a coach owned and operated by CYC Tours Pty Ltd (CYC) caught fire while travelling from Sydney to Canberra. On observing smoke coming from the rear of the coach, the driver immediately pulled over and stopped in the emergency lane. While the driver evacuated the passengers, the tour guide inspected the engine bay and found the entire top of the engine was engulfed in flames. The coach crew, assisted by a passing truck driver and a Police officer using their own portable fire extinguishers, then attempted to extinguish the fire. However, they were unsuccessful and the coach was completely destroyed by the fire (see *Photograph 1*).
