BUS SAFETY INVESTIGATION REPORT

SYSTEMIC INVESTIGATION INTO AN ALLEGED 'BLIND SPOT' ON MARK II AND MARK III MERCEDES-BADGED BUSES OPERATED BY THE STATE TRANSIT AUTHORITY.

OTSI File Ref: 03004

OTSI File Ref: 03004	Office of Transport Safety Investigations
	Level 21, 201 Elizabeth Street
27 September 2005	Sydney NSW 2000

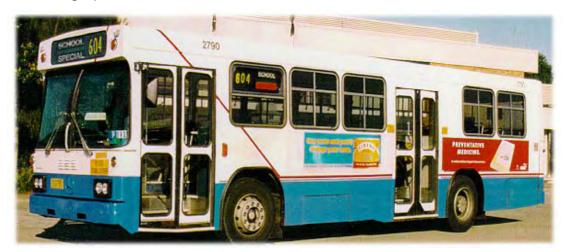
Photograph 3 - Mk IV "Mercedes"

4.4 More contemporary bus designs have narrower 'A' pillars, or an 'A' pillar incorporated into a triangular peep-window, thereby providing bus drivers with an improved field of vision. These design features are apparent in Photographs 3 and 4 of STA's Mercedes Mk IV and Scania variants below.
