## BUS SAFETY INVESTIGATION REPORT

# COLLISION BETWEEN TWO STA BUSES IN THE EASTERN DISTRIBUTOR TUNNEL, SYDNEY 25 FEBRUARY 2005

**OTSI File Ref: 03531**

**28 October 2005**

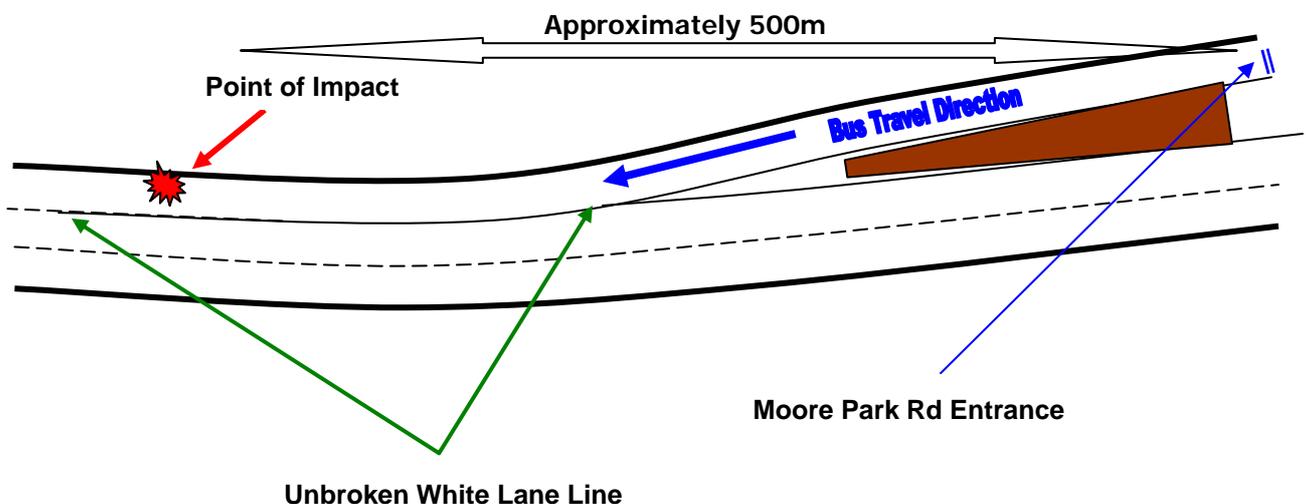
Figure 1 Sketch of Tunnel Carriageway

- 2.4 The Eastern Distributor Tunnel, operated by Leighton Contractors Pty Ltd, is a 1.7km long double deck tunnel, with the Northbound carriageway running directly above the Southbound carriageway. The collision occurred in the lane adjacent to the Eastern wall of the Northbound tunnel, approximately 500m in from the Moore Park Road entrance to the tunnel, as depicted in Figure 1 (not to scale).

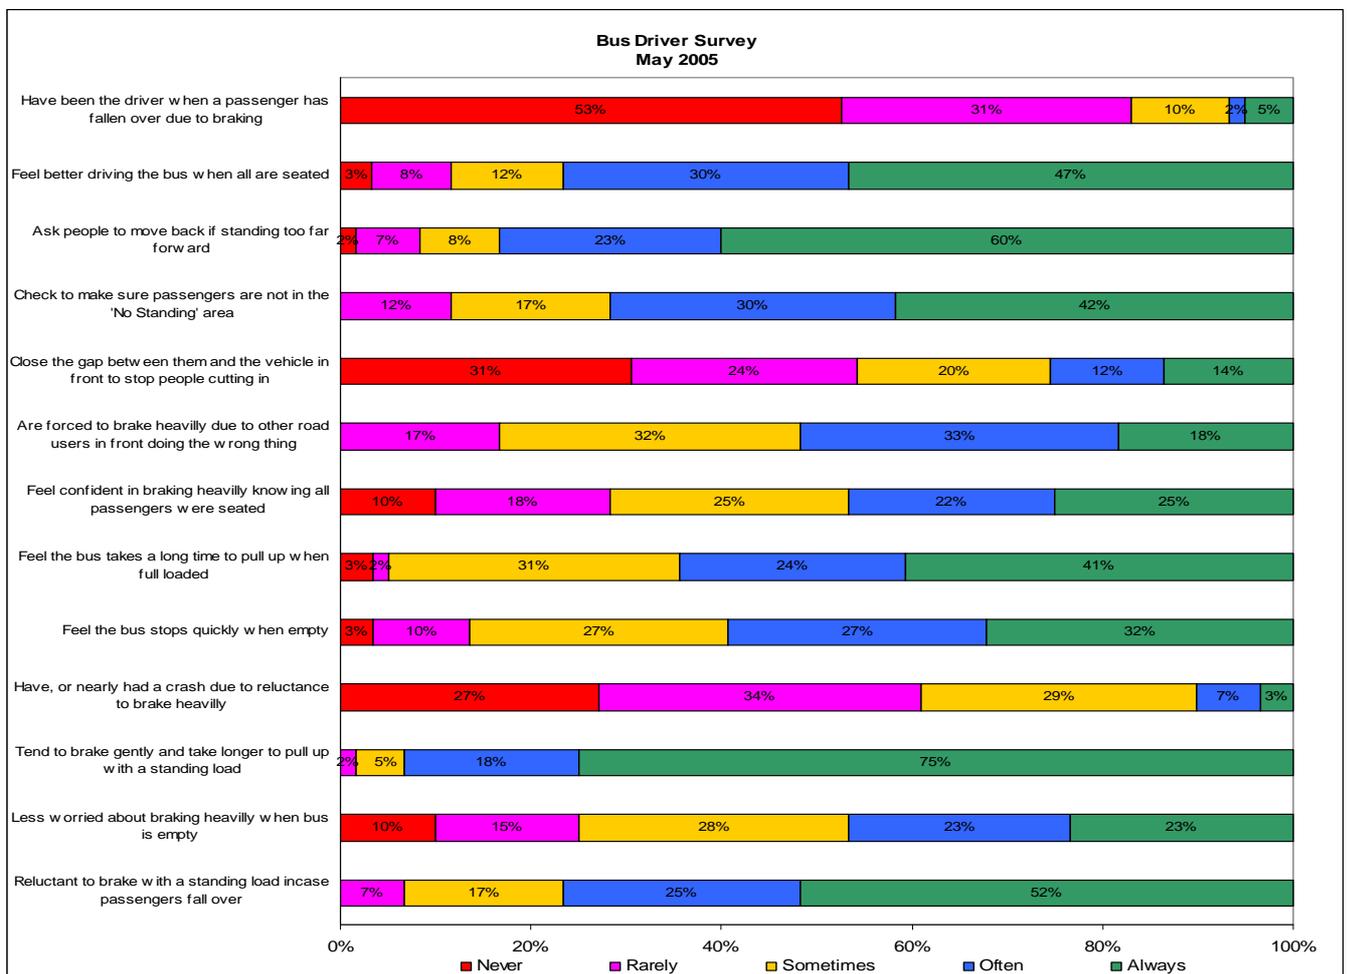
Figure 5 Bus Driving Survey

- 3.17.1 75% indicated **Always** taking longer to stop with a standing load of passengers .
- 3.17.2 52% indicated **Always** being reluctant to brake heavily when carrying standing passengers.
- 3.17.3 47% indicated **Always** feeling better when driving a bus in which all passengers were seated.
- 3.17.4 30% indicated **Often** feeling better when driving a bus in which all passengers were seated.

3.18 These results indicate that as well as being presented with the very real challenge of maintaining separation in areas like the tunnel, bus drivers may be reluctant to brake heavily at the earliest opportunity when confronted with a problem ahead. The obvious implication is that such reluctance results in even less stopping distance.

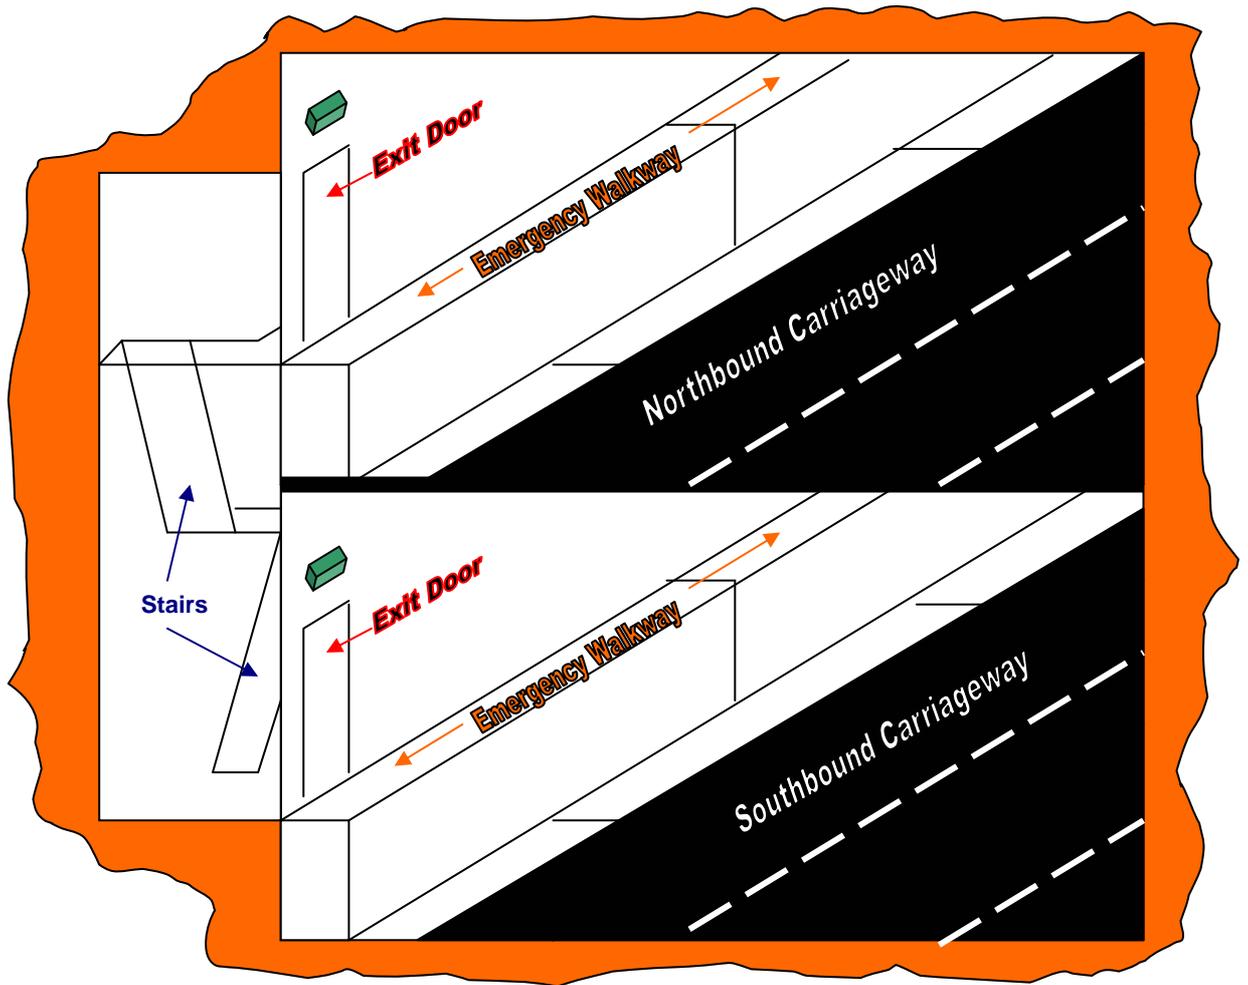
Figure 6 Eastern Distributor Tunnel Configuration and Emergency Exits

- 3.22 The drivers of the second and third buses had the presence of mind to contain their passengers in their buses and fortunately there was no pressing urgency to evacuate. While there are emergency exit doors situated at approximately 120m intervals along the Eastern side of the tunnel carriageway, and the nearest exit was in very close proximity to the buses, the passengers would have had to have exited from the left hand side of the buses to get to the emergency tunnel exits located on the right hand side of the tunnel. This could have exposed them to oncoming traffic in the middle lane. The configuration of the ED Tunnel, and its emergency exits, is shown at Figure 6.
