**Office of Transport Safety Investigations**

## **BUS SAFETY INVESTIGATION REPORT**

**STA BUS COLLISION  
SPIT ROAD MOSMAN**

**14 NOVEMBER 2005**

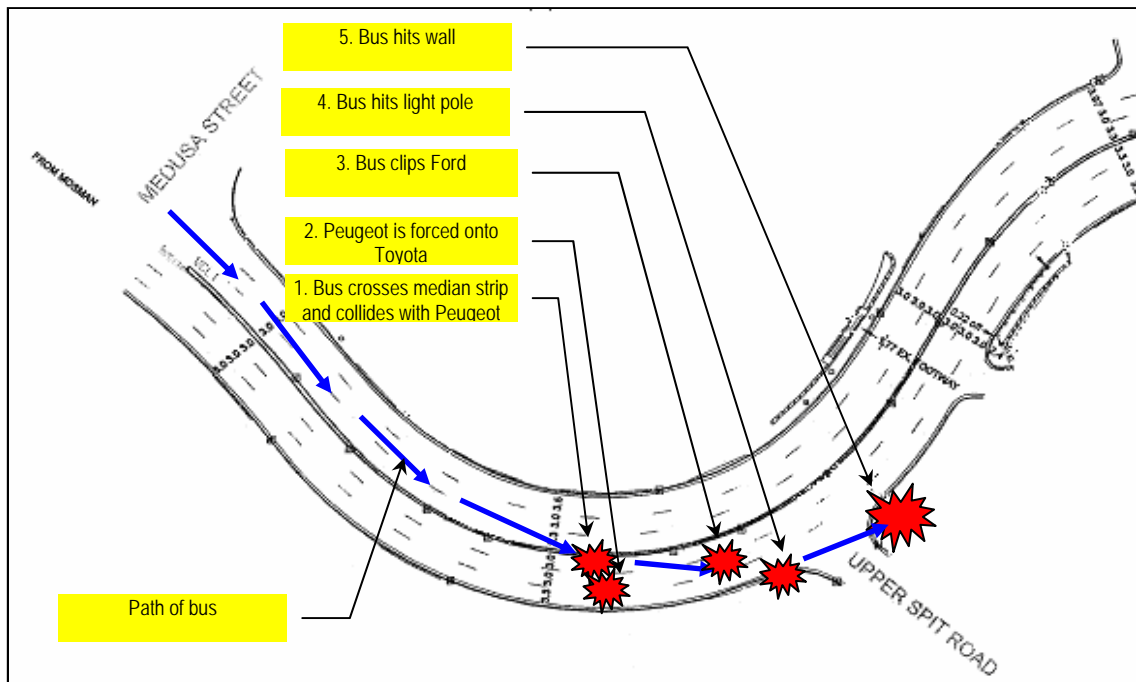
**Figure 2: Accident sequence along Spit Road**

- 2.7 Having crossed the median strip, the bus was immediately confronted with traffic travelling South, or "up" Spit Road. The bus struck a Peugeot 307 sedan travelling in the lane nearest the median strip and pushed the Peugeot diagonally across the road causing it to strike the side of a Toyota Hi-Lux. The bus then struck a Ford Falcon station wagon causing it to spin 180° into the path of a Hino tip-truck with trailer. The Ford became trapped under the front passenger side of the Hino. The bus, however, continued downhill on Spit Road before mounting the footpath and striking a steel light-pole. The light pole, designed to separate upon impact, was carried with the bus as it crossed Upper Spit Road and then projected onto an unoccupied white BMW car parked in Upper Spit Road. The bus was finally halted when it impacted with the

masonry base of a steel fence. This fence was the front boundary of a three-level apartment building, known as Muston Court, on the Northern corner of Upper Spit Road and Spit Road, Mosman. The strength and mass of the fence's masonry base and the density of the surrounding subsurface rock was sufficient to withstand the impact and the damage to the fence was relatively minor. The sequence of the collisions is indicated in *Figure 2*.

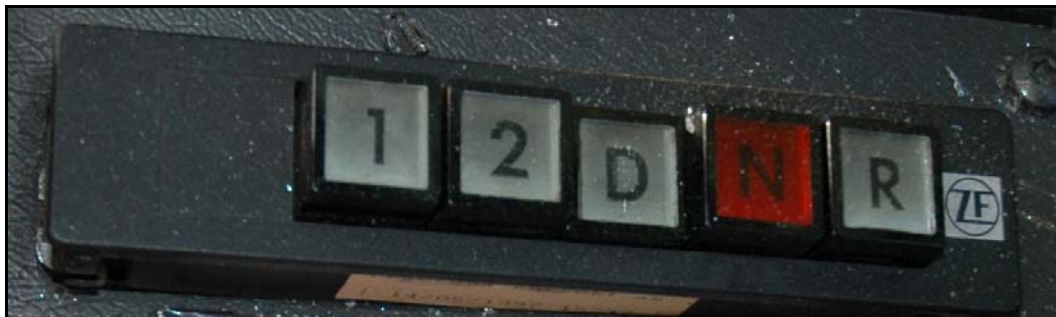
**Photo 7: Gear selection buttons in the bus**

- 2.18 The six-cylinder, rear-mounted diesel engine develops a maximum power of 180kW at 2000rpm. The automatic transmission is operated by pressing one of five gear selection push-buttons on the dashboard of the bus. The selection button "D" is pressed for normal operations and this button was found to be depressed/engaged, as shown in *Photograph 7*, when the bus was inspected at the scene of the accident. The "2" button is used for heavy and/or difficult traffic conditions and has a retarding effect. The "1" button is used for moving the bus a short distance. It should be noted that there is no "Park" button which means that the parking brake must be applied when the bus is not being driven.

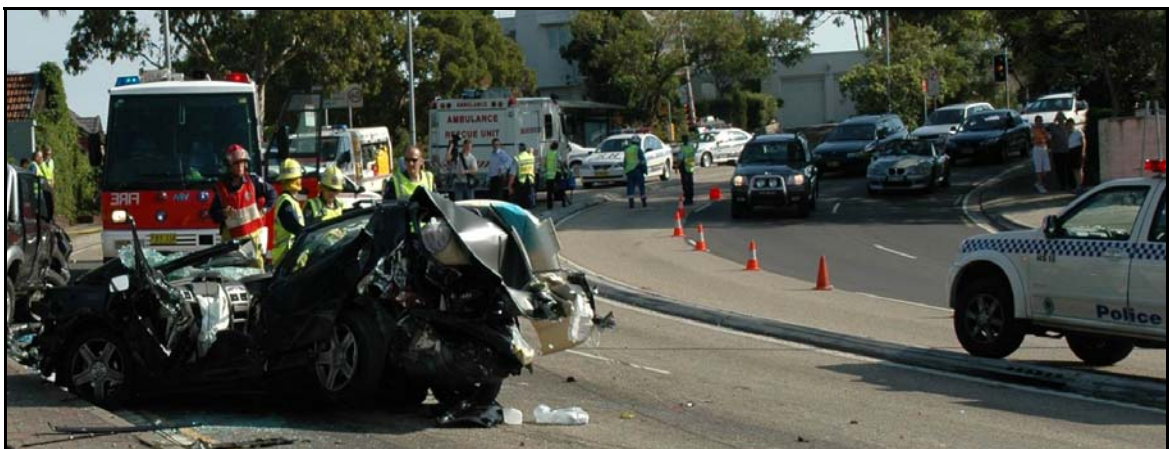
**Photo 11: Emergency Services at the accident scene**

- 3.21 The NSW Police, Fire Brigade and Ambulance services all had representatives on site, as depicted in *Photograph 11*, within 10 minutes of the accidents occurring.
