## Bus Safety Investigation Report

### Woodpark

**Air brake failure on bus resulting in a collision.**

# Road Safety Investigation - Woodpark

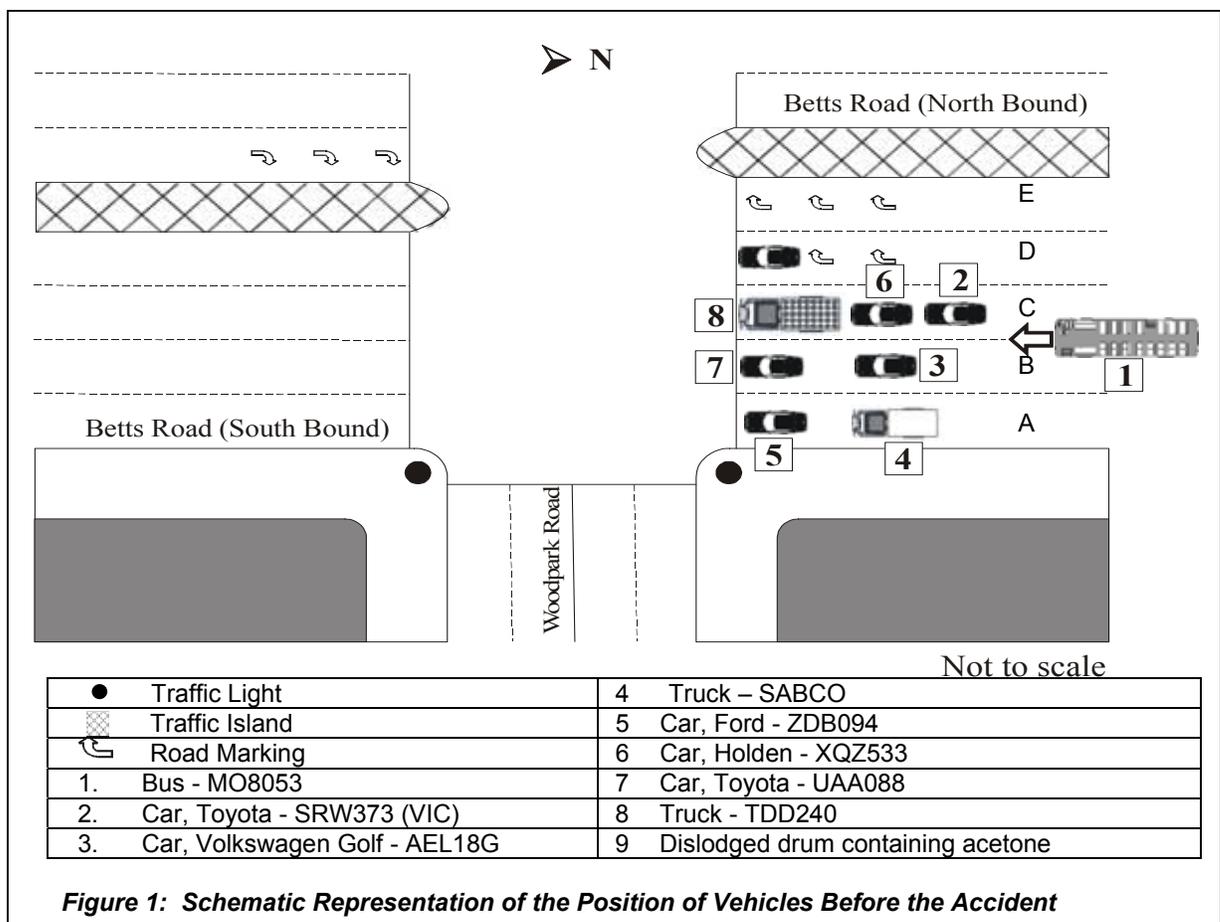
- 3.3 After warning the passengers of the loss of brakes, the driver considered applying the emergency brake but appreciated that he would be unable to both reach the brake handle and concentrate on steering<sup>1</sup>. He therefore elected to steer the bus between stationary vehicles in the lanes indicated as B and C in *Figure 1*. In the process, the bus collided with a vehicle (indicated as 2) at approximately 70 km/h and subsequently with three other vehicles (indicated as 3, 6 and 7) before colliding with the rear of a truck (indicated as 8). The bus and truck came to rest on the island separating north and southbound lanes of Betts Road. (Refer to *Figure 2*).

- 3.4 After the accident, the driver of vehicle 7 repositioned it onto the island behind the truck (8) and bus (1) to minimise the level of obstruction to other vehicles.

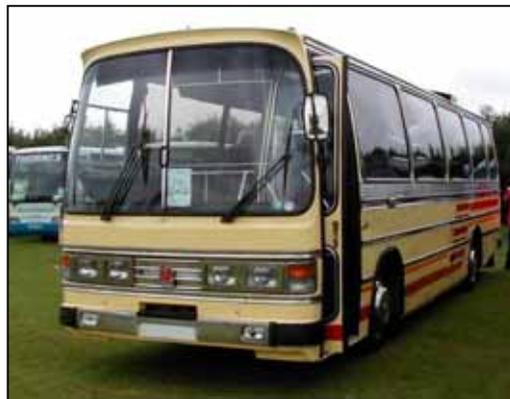
### 3.15 Bus Type

<b>Manufacturer:</b>	Bedford	<b>Tare:</b>	6900 kg
<b>Model:</b>	YLQ	<b>GVM:</b>	10180 kg
<b>Date of manufacture:</b>	January 1980	<b>Type:</b>	Charter
<b>Registration number:</b>	MO8053	<b>Seating capacity:</b>	55
<b>State:</b>	NSW	<b>Passengers:</b>	64
