BUS SAFETY INVESTIGATION REPORT

COACH OVERTURNED

JINDABYNE

11 JUNE 2011

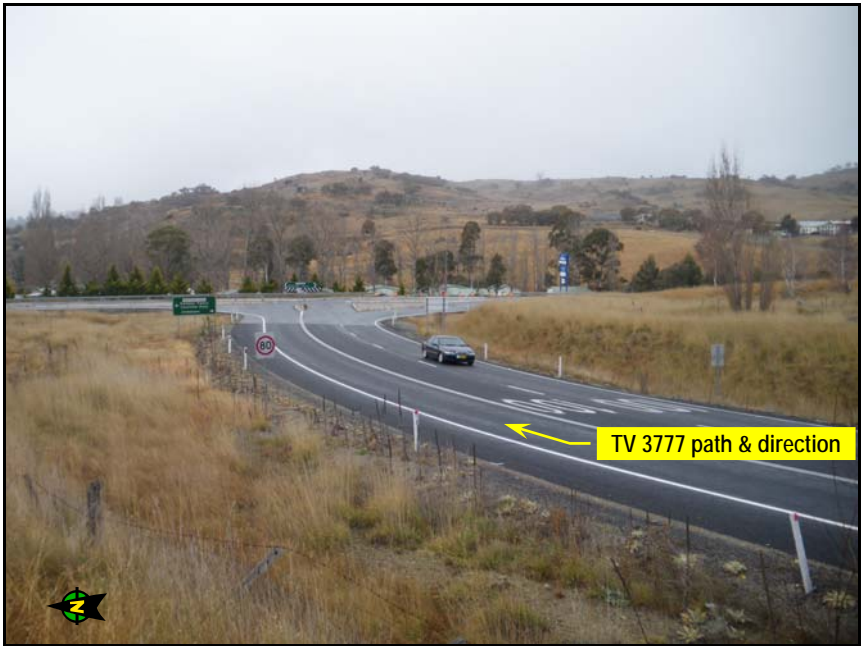
Photograph 1: View of Alpine Way approach to intersection

- 1.3 The accident occurred at the “T” intersection of Alpine Way and Kosciuszko Road approximately 3.5 kilometres West of Jindabyne in the Snowy Mountains Region of NSW. Jindabyne, a small township with a population of 4400, is situated on the edge of Lake Jindabyne approximately 60 kilometres West of Cooma and 460 kilometres from Sydney (see *Figure 1*).
- 1.4 The intersection is the junction of the main roads leading to and from the ski fields at Thredbo and Perisher. It is located at the base of a 1.8 kilometre long descent from Thredbo (see *Photograph 1*) towards the lake and township on a gradient ranging between 5.1% and 10.2%.
- 1.5 A 100km/h speed limit applies on the Alpine Way which reduces to 80km/h 100 metres prior to the intersection. There are no heavy vehicle speed restrictions.

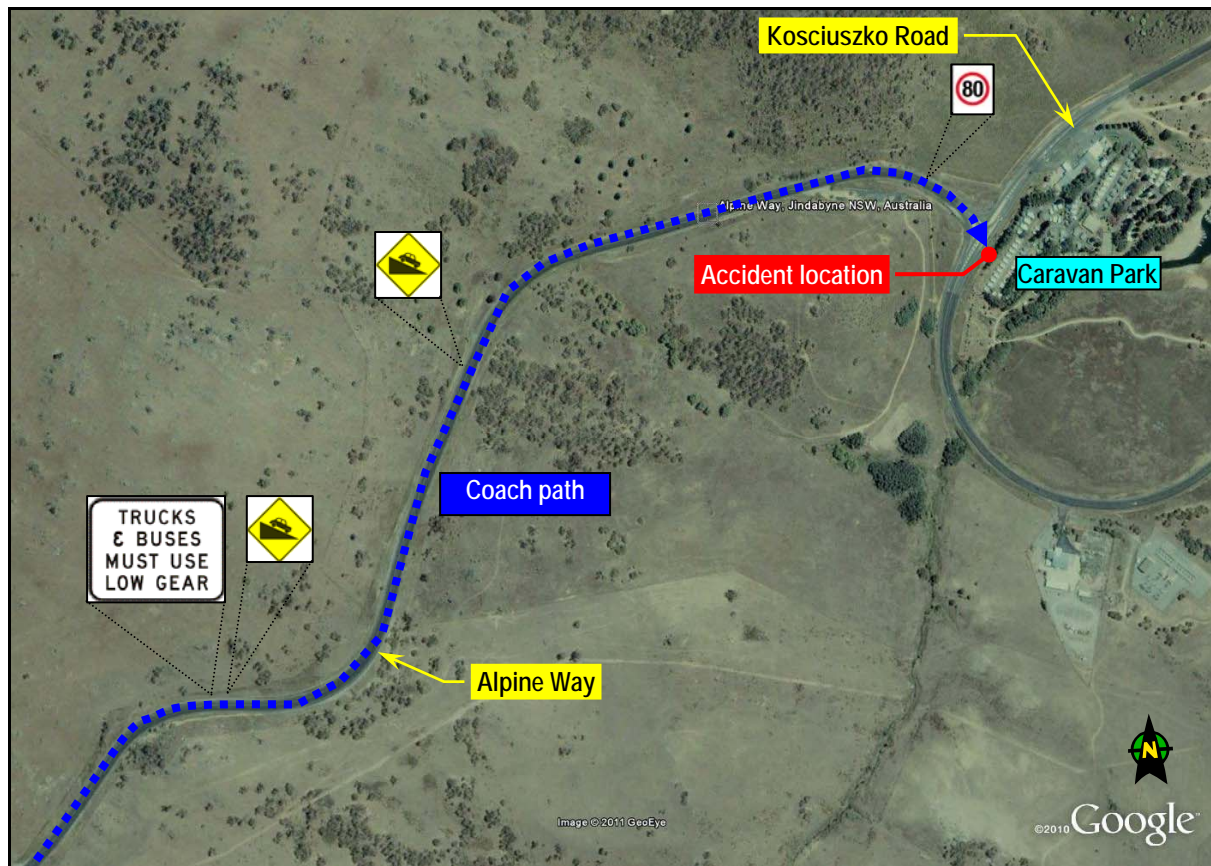
Figure 3: Position of heavy vehicle signage

- 1.26 TV 3777 then passed regulatory heavy vehicle roadside signage indicating *“Trucks & Buses Must Use Low Gear”* and *“Steep Descent”* located approximately 1.6 kilometres from the intersection (see *Figure 3*). Driver 2 recalled that, as he passed the signs, he believed that he was travelling at approximately 40km/h in either 4th or 5th gear. He considered that, in either of these gears, he was in control of TV 3777 and complying with the requirements of the signage. However, the witness recalled that after passing the signs, TV 3777 appeared to increase speed and he did not see its brake lights illuminate. The witness also estimated TV 3777 was travelling at between 60 and 80km/h by this time.

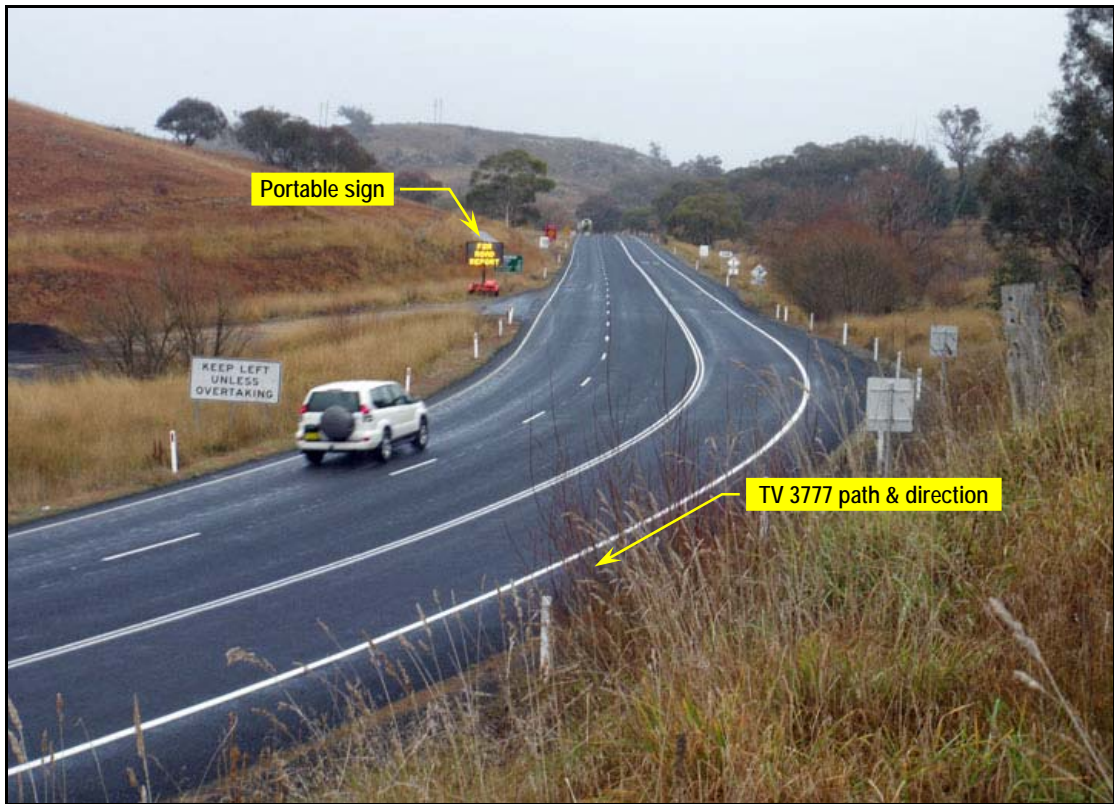
Photograph 2: Position of portable electric sign

- 1.30 Despite the alarm and likely depletion of air, Driver 2 continued “*pumping*” the brake pedal without slowing, and alerted the Director to the situation. Driver 1, who was sitting beside the Director, recalled that the first alert from Driver 2 came shortly after TV 3777 passed a portable electric roadside sign. The

position of this sign was later identified to be approximately 200 metres prior to the intersection (see *Photograph 2*).

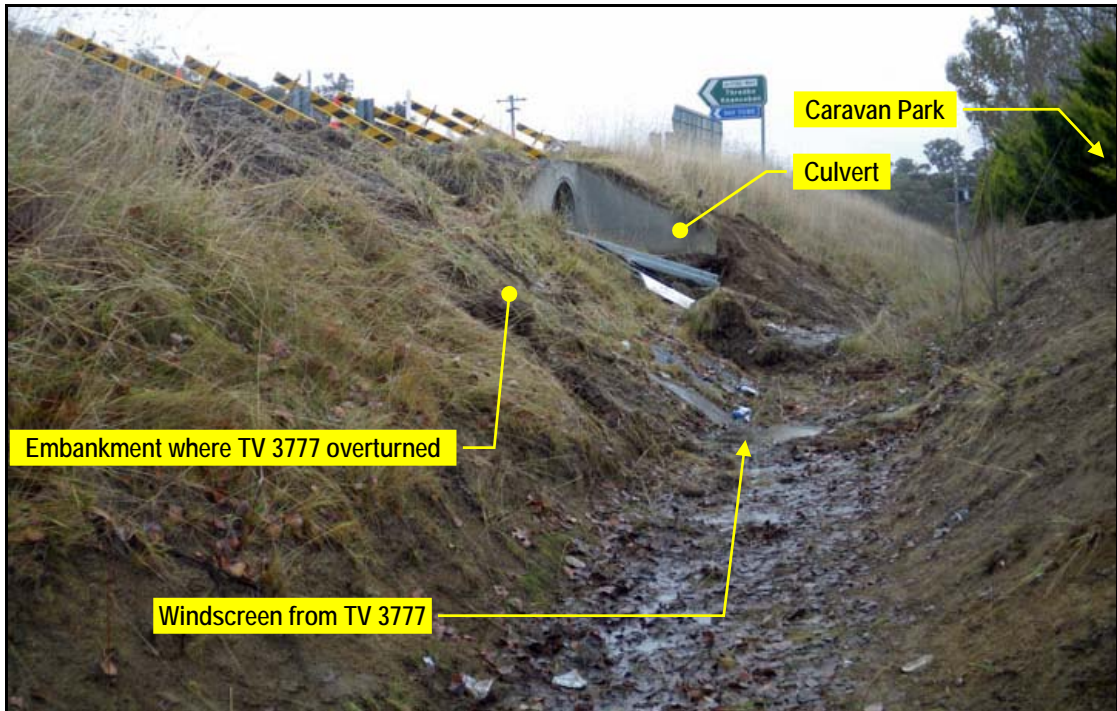
Photograph 5: Drainage ditch where TV 3777 overturned and came to rest

- 1.37 TV 3777 then demolished the guard rail and veered part-way down the embankment of a four metre deep drainage ditch separating Kosciuszko Road from a caravan and cabin park. Here, still upright, it crossed the top of a concrete culvert which emptied into the drainage ditch (see *Photograph 5*).
- 1.38 Now at a virtual standstill, the combination of a high centre of gravity and a steep embankment then caused TV 3777 to roll and land on its roof in the ditch (see *Photograph 6*).

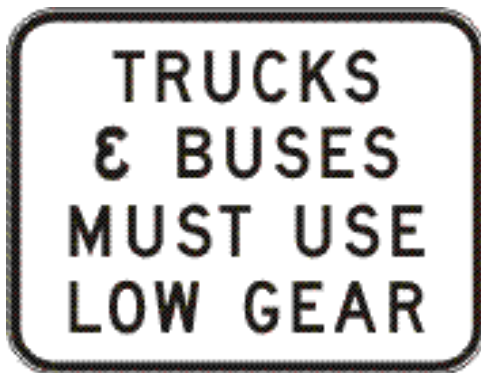
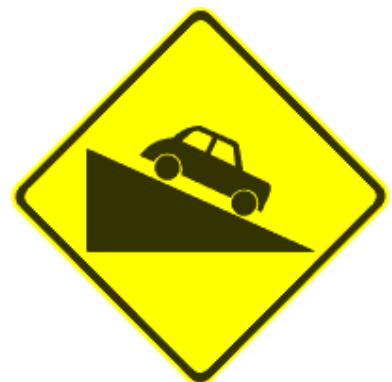
Figure 4: Traffic signage types

2.19 On his approach to the intersection, Driver 2 passed a *TRUCKS & BUSES MUST USE LOW GEAR* (R6-22) sign and two *STEEP DESCENT* (W5-12) symbolic signs (see *Figures 3 and 4*). The R6-22 sign and one W5-12 sign were positioned approximately 1600 metres prior to the intersection. The other W5-12 sign was positioned 1000 metres from the intersection.

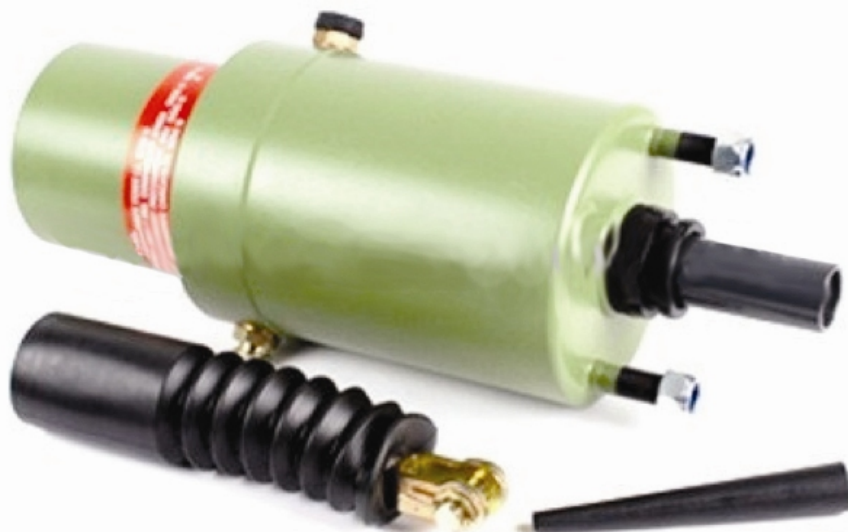
Photograph 7: Brake chamber type fitted to TV 3777

2.28 The brake chambers on TV 3777 were dual action, European type, combination service brake/spring parking brake units (see *Photograph 7*). Air pressure is required to release the spring parking brakes. They are not fitted with any manual release mechanism, as found on other types, should the vehicle be unable to build up or hold sufficient pressure in its air system.

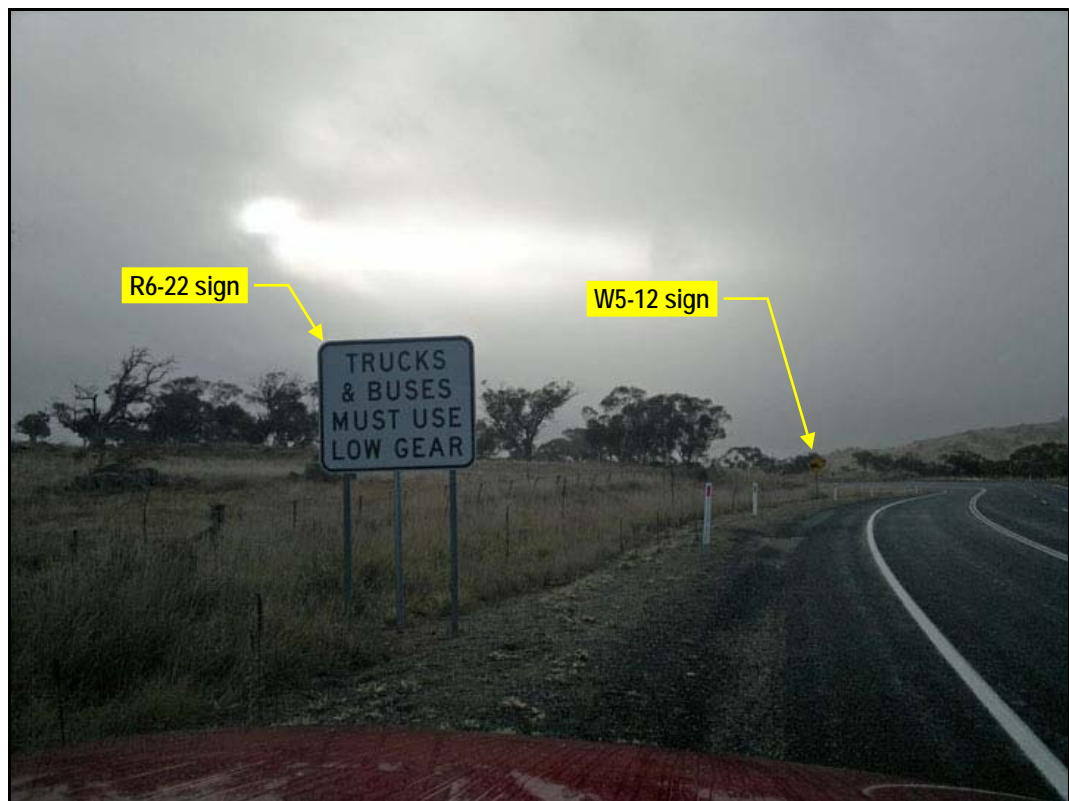
Photograph 12: Heavy vehicle signage at top of grade

- there were no safety ramps or vehicle arrest pits on the descent;
- there were no tyre scuff marks found on the roadway surface between the top of the grade and those commencing at the intersection median strip to indicate that the wheels on TV 3777 had slid or locked up at any stage prior;
- there were no damaged white posts or tyre scuff marks on the gravel road shoulders that would indicate TV 3777 had swung wide at speed off the roadway at any stage during the descent;
- there was no cracking or visible defects on the road surface;
- all road signage, including the heavy vehicle specific signage, was in a clean, clear and legible state. There were no issues with visibility or vegetation obscuring the signage (see *Photograph 12*);
