# **BUS SAFETY INVESTIGATION REPORT**

## **PEDESTRIAN FATALITY, BUGATTI DRIVE, INGLEBURN**

**5 AUGUST 2009**

**Investigation Reference 04450**

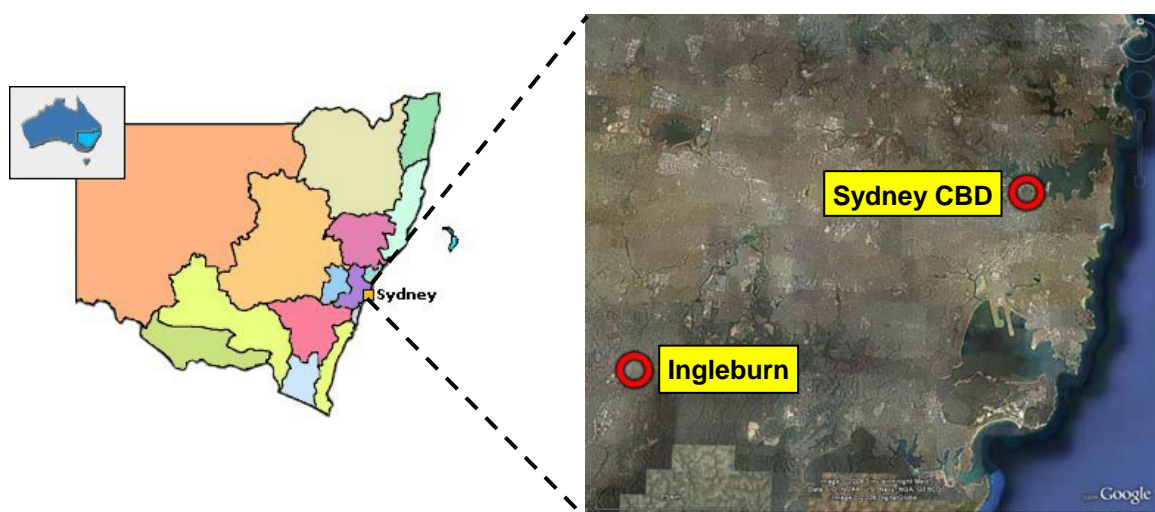
Figure 1: Accident location

- 1.8 The incident occurred on Bugatti Drive, Ingleburn, adjacent to the intersection with Cadillac Place where the victim's family resides. Ingleburn is located in the South Western outskirts of Sydney approximately 35km from the Sydney CBD.

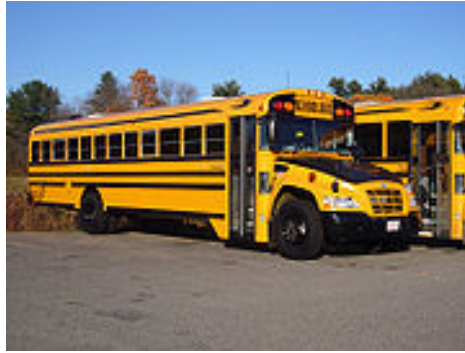
**Photo 8: Typical North American yellow school bus**

- 2.56 When one examines international experience in school bus safety, comparisons are often made to that of the United States of America and Canada. Most American school buses have been painted yellow since 1939. In that year, Dr. Frank W. Cyr, a professor at Teachers College at Columbia University in New York, organised a meeting to establish national school bus construction standards. It established yellow as the colour for body paint, which became known officially as *National School Bus Chrome Yellow* and later came to be more commonly referred to as 'school bus yellow'. This colour was selected because black lettering on that hue was the easiest to see in the semi-darkness of early morning and late afternoon (see *Photos 8 and 9*).

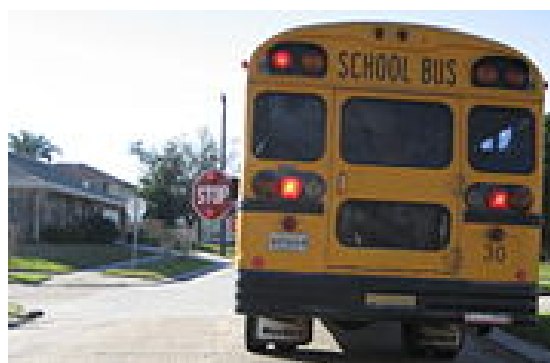
**Photo 10: Yellow school bus with STOP arm deployed and warning lights flashing**

- 2.59 During the early 1950s, States in the USA began to specify a mechanical stop arm which the driver would swing out from the left side of the bus to warn traffic of a stop in progress (see *Photo 10*). The portion of the stop arm protruding in front of traffic was initially a rectangle with "STOP" painted on it.

In later years, electromechanical wig wag flasher controls were replaced by electronic ones, and the warning lights were increased from four (two front and two rear, all red), to eight (two amber to warn of an impending stop, and two red to indicate a stop in progress, front and rear). *Photo 10* also shows that the rear of these buses (and indeed the whole bus) is free of visual clutter, such as advertising.

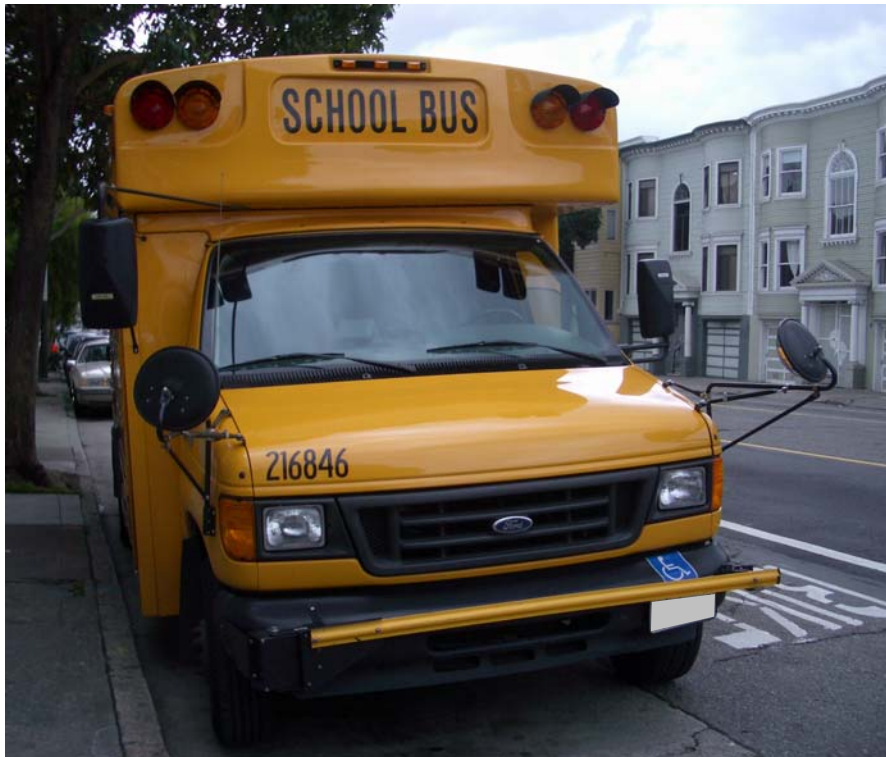
**Photo 11: Yellow school bus with front boom arm fitted, but not deployed**

- 2.60 In the USA, approximately two thirds of students killed outside a school bus are not struck by other vehicles, but by their own bus. To reduce the driver's blind zones, more sophisticated and comprehensive mirror systems have been developed. Additionally, windshields on almost all late model buses have been significantly enlarged to remove obstacles from the driver's lines of sight.
- 2.61 To prevent pedestrians walking so close to the front of the bus that the hood hides them from the driver, most new buses are equipped with crossing (or boom) arms, which swing out from the front bumper while the bus is stopped for loading or unloading (see *Photo 11*). These force passengers to walk some two or more metres forward of the bus before they can begin to cross the road in front of it.

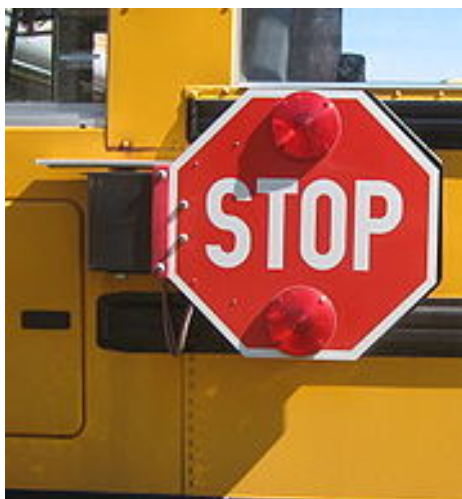
**Photo 12: Close up of a typical STOP arm**

- 2.62 Today, Canada and US Federal Motor Vehicle Safety Standards regulate the specifications of the stop arm as a double-faced regulation octagonal red stop sign at least 45cm across, with white border and uppercase legend. It must be retro reflective and/or equipped with alternately-flashing red lights. Alternately, the "STOP" legend itself may also emit red light (see *Photo 12*).
