BUS SAFETY INVESTIGATION REPORT

BUS ACCIDENTS OCCASIONING DEATH AND SERIOUS INJURY

WEST PENNANT HILLS, RUTHERFORD AND SYDNEY CBD

19 – 27 JUNE 2007

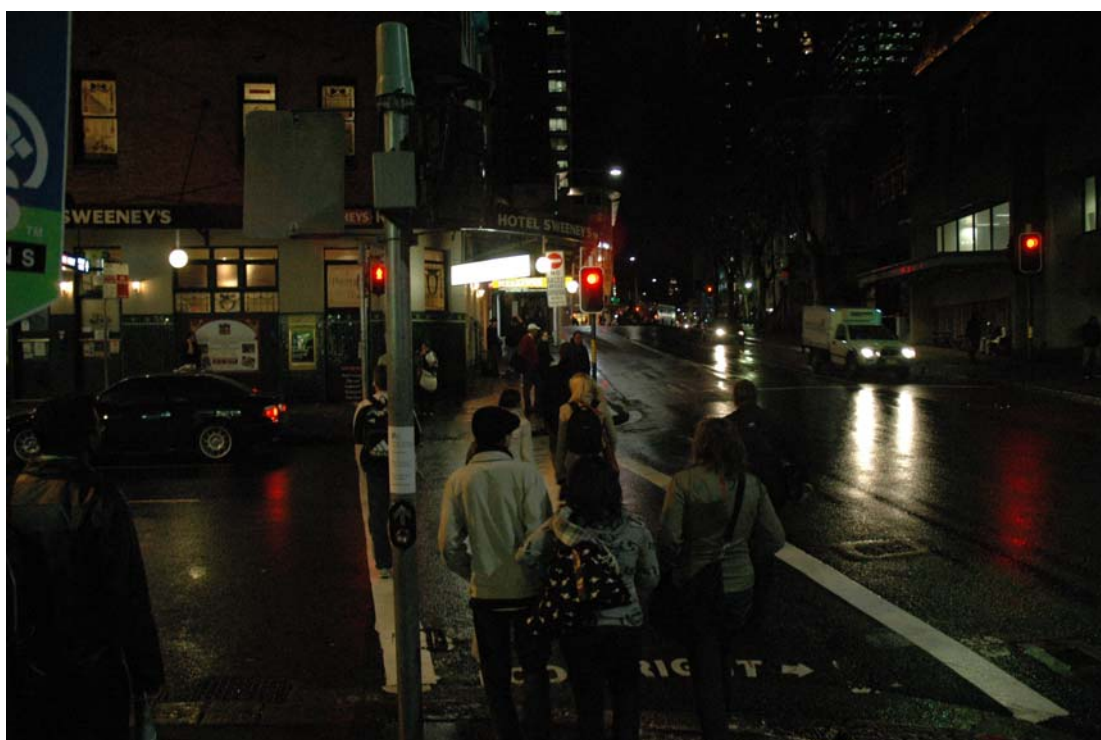
- e. Large numbers of pedestrians cross Clarence Street at its intersection with Druitt Street.
- f. Pedestrians are required to wait up to 90 seconds between crossing opportunities and many of them opt not to do so (refer to *Photo 7*).
- g. Those pedestrians who proceed against the lights impede the progress of vehicles which have the right of way to turn into Clarence Street and contribute to inappropriate driver behaviour which results in vehicle congestion across the pedestrian crossing. Because the pedestrian crossing becomes blocked, pedestrians then attempt to cross at other than the designated crossing place, or proceed at a time when they are not permitted to do so.

Photo 7: Pedestrians crossing against the traffic lights in Clarence Street

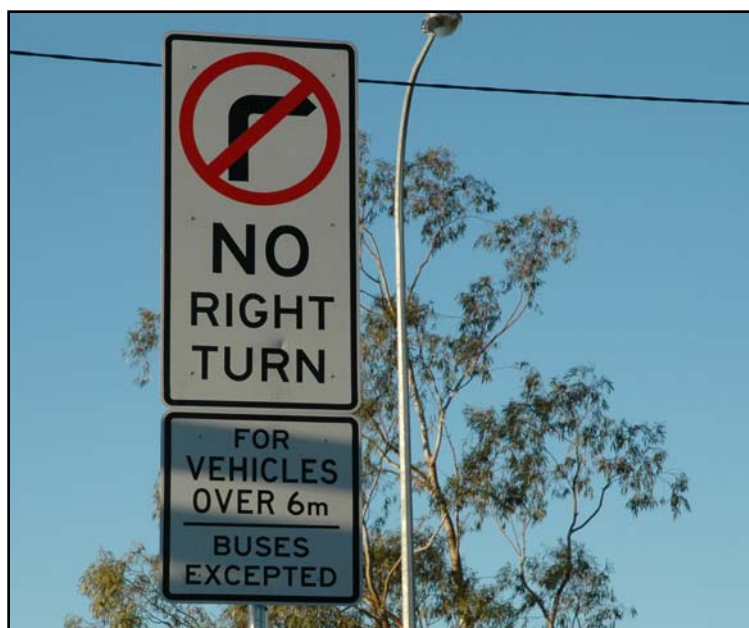
Photo 9: Road sign at intersection of Hillview and Arthur Streets

- 3.6 The general traffic arrangements in the area at which the accident occurred and the relative direction of travel of the bus and the cyclist are depicted in *Diagram 4*. It is important to note that only buses and vehicles over six metres in length are permitted to turn right from Hillview Street into Arthur Street (see *Photo 9*), and that the cyclist commenced to turn into Hillview Street from the wrong side of Arthur Street.

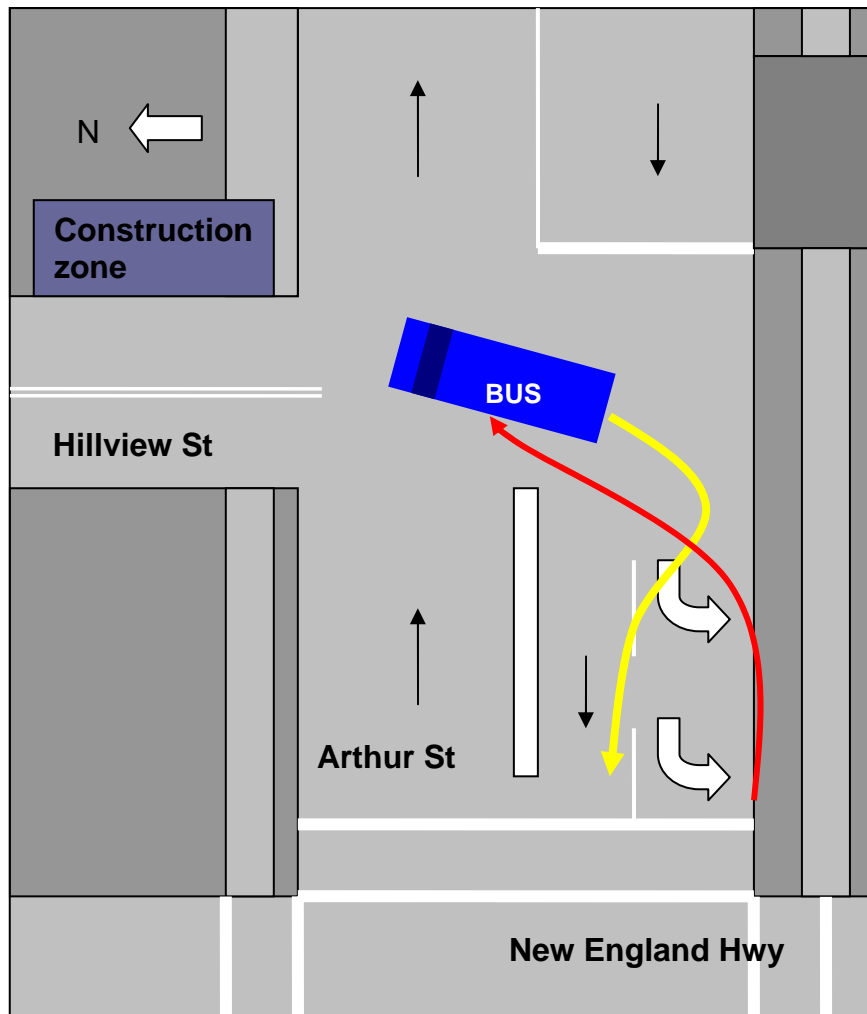
Diagram 4: Bus and Cycle passage at intersection of Hillview and Arthur Streets

(The approximate paths of the bus and cyclist, as reported by witnesses, are indicated by yellow and red arrows respectively)

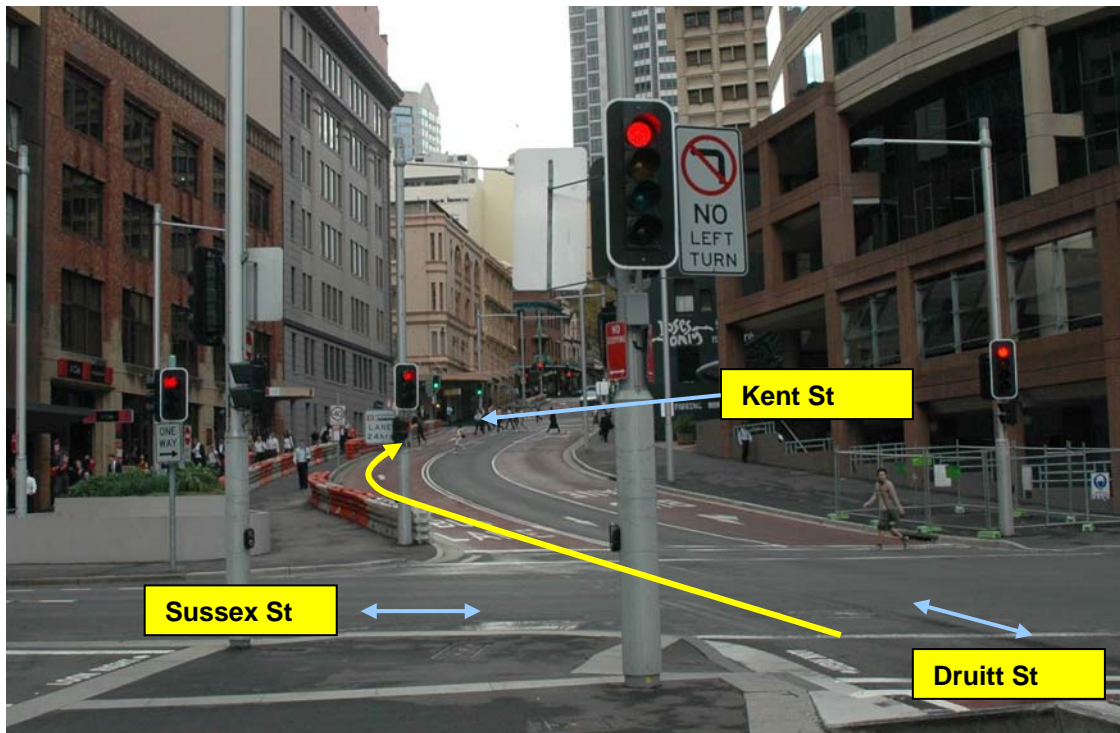
- 4.13 The bus driver described coming off the Western Distributor and proceeding along Druitt Street at approximately 50km/h. This was the maximum speed permitted in Druitt Street and the bus driver's estimate was subsequently confirmed after OTSI's examination of CCTV recordings taken on board the bus and calculation of the time taken to pass specific points that could be identified on the recordings. The driver recalled that she had a green traffic indication as she approached the intersection with Kent Street and that the indication at the next intersection, with Clarence Street, was also green (refer to *Photo 17*).

Photo 17: Druitt Street, looking Eastwards with the approximate path of the bus shown in yellow

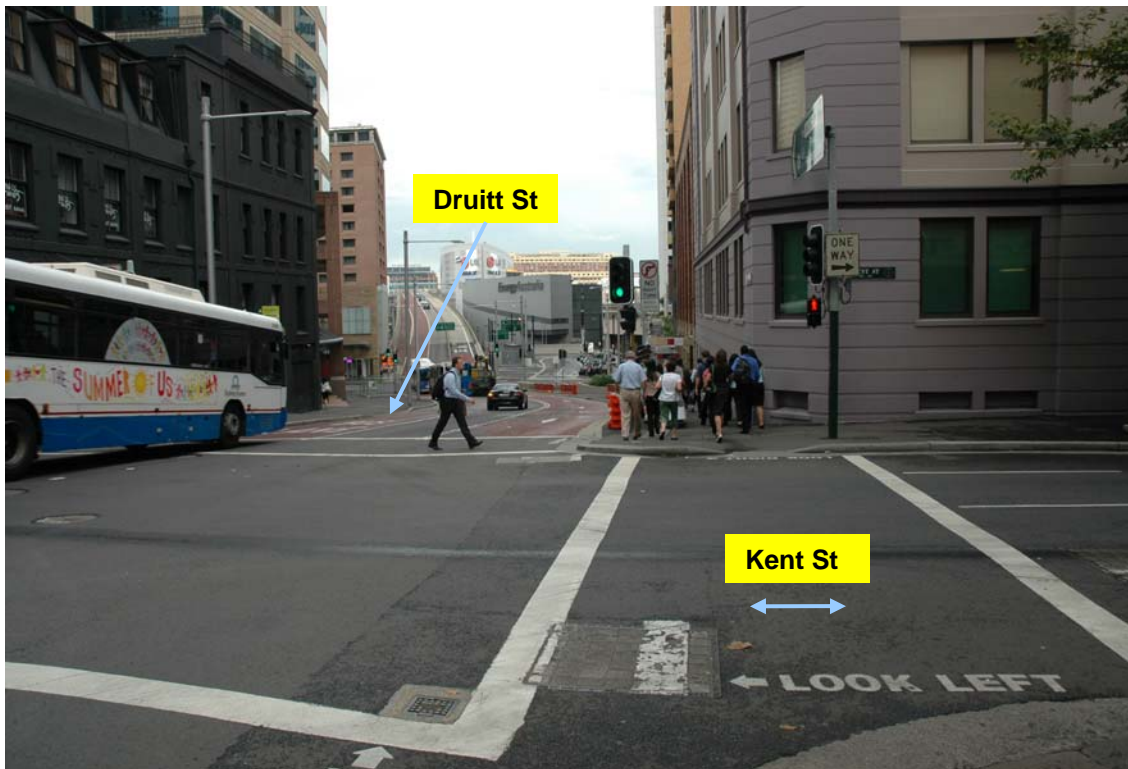
- 4.16 Witnesses described the point at which the pedestrian commenced her crossing as being approximately seven metres West of the designated pedestrian crossing. *Photos 18 and 19* indicate where the pedestrian should have crossed and approximately where she commenced her crossing respectively. *Photo 19* also shows three pedestrians, in the foreground, who are also not making use of the designated pedestrian crossing. The one on the right is attempting to cross from about the same location as the pedestrian who was seriously injured on 27 June 2007.

Photo 18: Intersection of Druitt and Kent Streets, looking Westwards

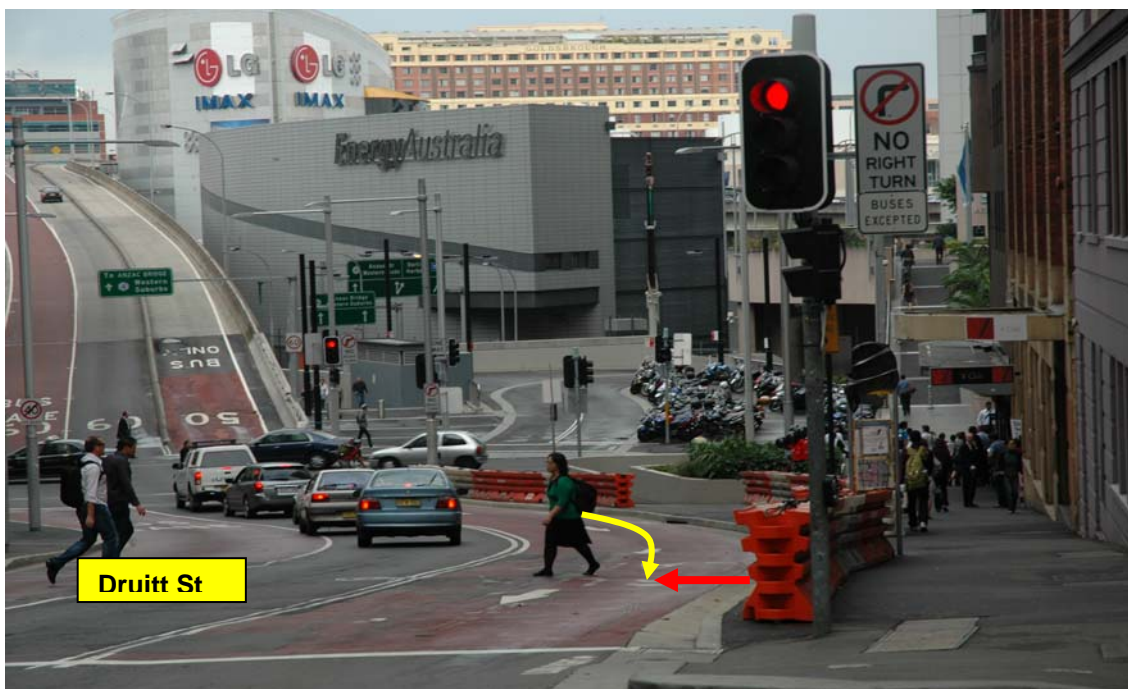
Photo 19: Druitt Street looking Westwards immediately beyond its intersection with Kent Street, with the approximate paths of the pedestrian and the bus shown in red and yellow respectively

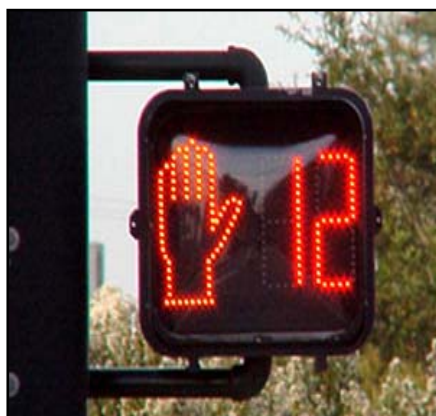
Photo 22 : Countdown pedestrian signal indicating that there is 12 seconds until a solid red 'Don't Walk' signal appears

- 4.23 Sydney Council has also advised OTSI that it is giving consideration to the introduction of countdown pedestrian signals. These signals provide pedestrians with an indication of how much time they have before a solid red 'Don't Walk' signal appears (refer to *Photo 22* below). Such devices are already in use in many cities throughout the world including Boston, London, New York, San Francisco and Tokyo. While the timers provide extra information for pedestrians relating to their crossing time, there is little reliable research as yet to confirm the extent to which they positively influence pedestrian behaviour, although a recent New Zealand study¹¹ indicates that behaviour improved at one of two sites at which such devices were installed in Auckland, but deteriorated at the other. It also suggested that the effectiveness of the devices appeared dependant on choosing suitable locations for their installation. That said, OTSI considers that it would be useful to trial such signals within Sydney's CBD.
