Office of Transport Safety Investigations

TECHNICAL INSPECTION FINDINGS

FIRES INVOLVING LINQ BUSLINES COACH 4244 MO

10 SEPTEMBER 2013 and 10 NOVEMBER 2013

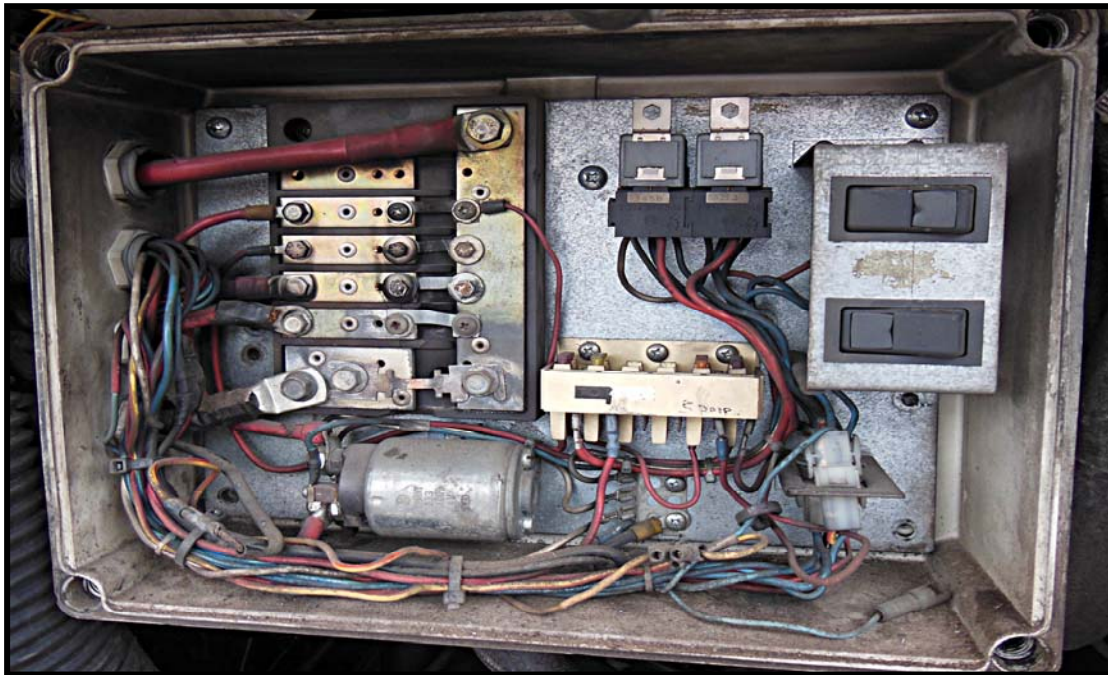
Photograph 5: Undamaged rear control centre housing with Perspex cover removed

Within the engine compartment, the outer plastic covering of the rear electrical centre had completely burnt away destroying the circuit board. All wiring looms from the electrical centre to the alternator, air conditioning, engine sensors and rear lighting were destroyed. The intensity of the fire had caused the metal mounting back plate to come off its metal brackets (see *Photograph 6*).
