BUS SAFETY INVESTIGATION REPORT

FIRE INVOLVING STA BUS MO 1695

MOSMAN

1 APRIL 2015

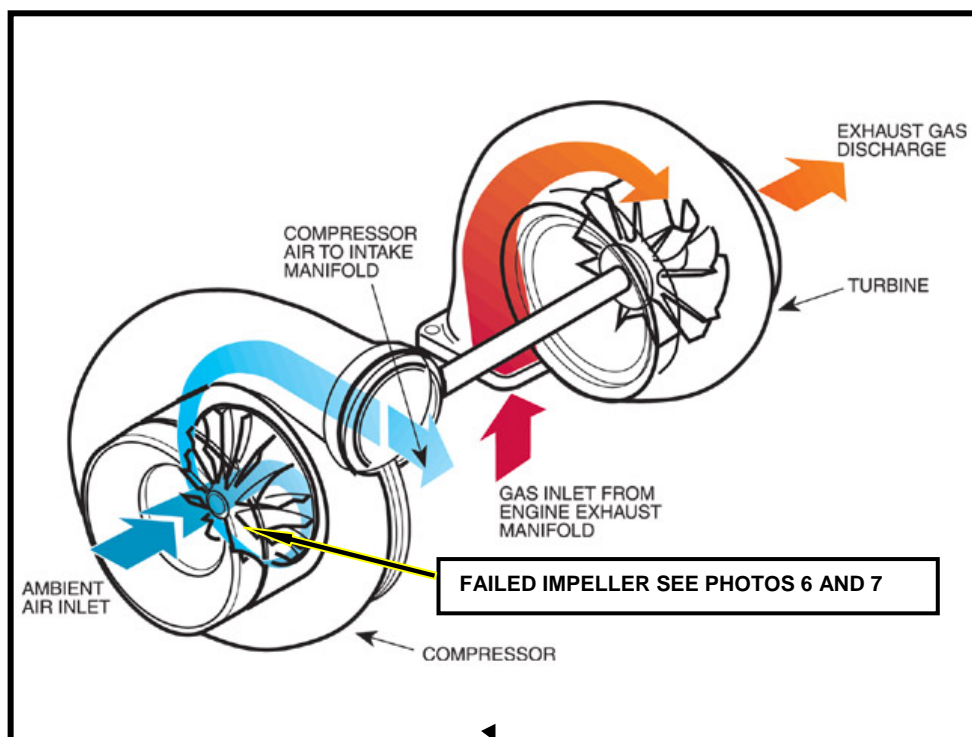
Diagram 1: Exploded view of turbocharger

2.9 The STA commissioned an independent metallurgist to carry out a macro examination of the failed impeller and form a preliminary opinion about the likely/possible cause of failure. The metallurgist's report concluded:

- i. *Out of specification microstructure associated with incorrect heat treatment.*
 - ii. *Out of specification material composition.*
 - iii. *Out of specification hardness.*
3. *Radiography revealed no visible material defects.*
 4. *Because the impeller had failed as a result of the formation of what appear to be two diametrically opposite fatigue cracks, it is more likely than not that the failure was associated with abnormal loads in the bore of the impeller.*

The more likely cause of abnormal loads in the bore of the impeller would be material contamination in the bore of the impeller when it was fitted to the shaft.
