Office of Transport Safety Investigations

BUS SAFETY REPORT

BUS FIRES IN NEW SOUTH WALES IN 2014

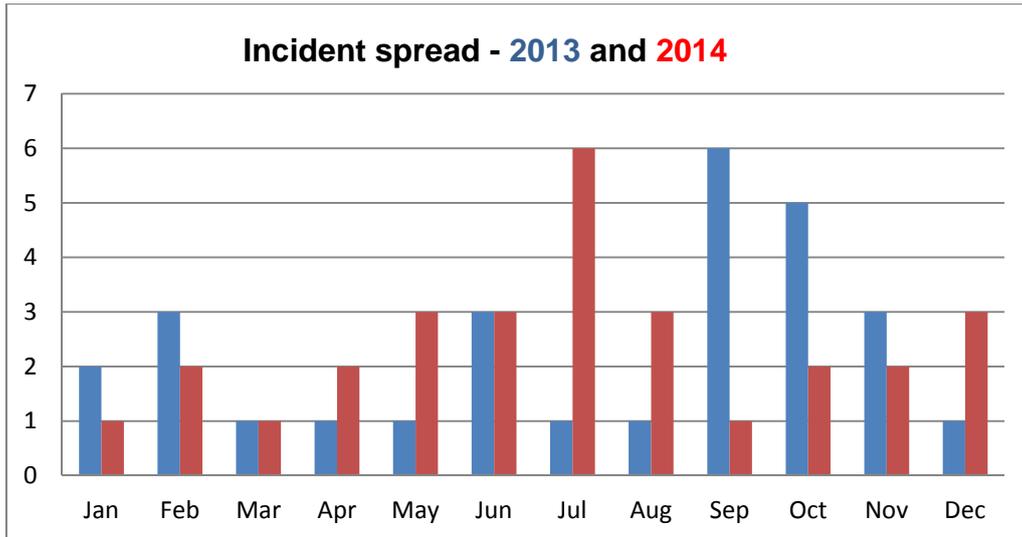
Figure 1

Twenty-nine fires were reported in 2014, and were distributed through the year as shown in *Figure 1*. Brief details of each incident are shown in *Appendix A*.

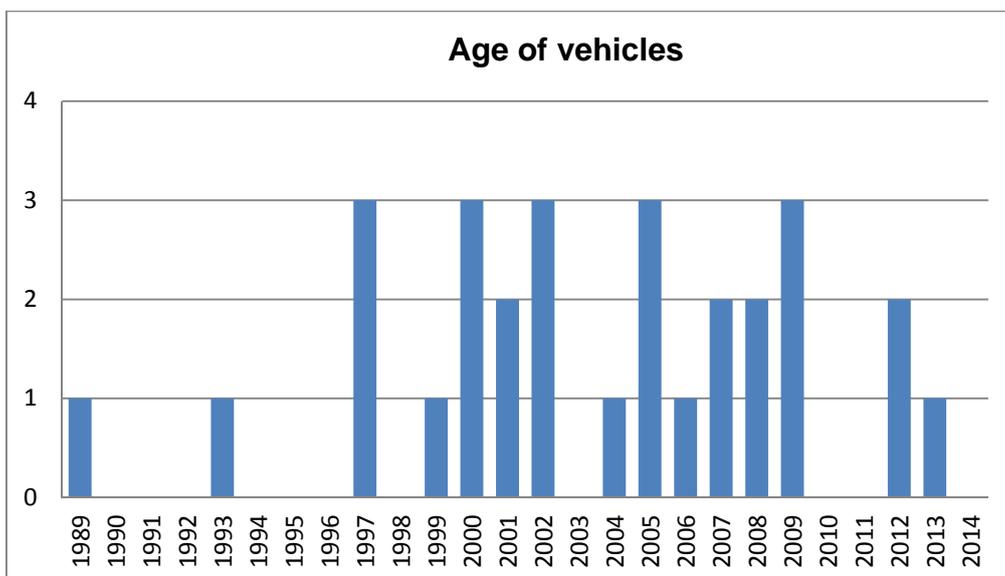
Figure 2

In 2013 eight (28%) coaches were involved in incidents; whereas in 2014 coaches only featured on three (10%) occasions. Apart from a 1989 coach and a 1993 model bus, the ages of the buses involved ranged between one and 17 years (see *Figure 2*). Seven different makes of vehicle were involved. Twenty-four of the buses were diesel-fuelled; the remaining five were CNG-fuelled. The CNG-fuelled buses all experienced fluid leaks which involved coolant or oil coming into contact with hot surfaces.

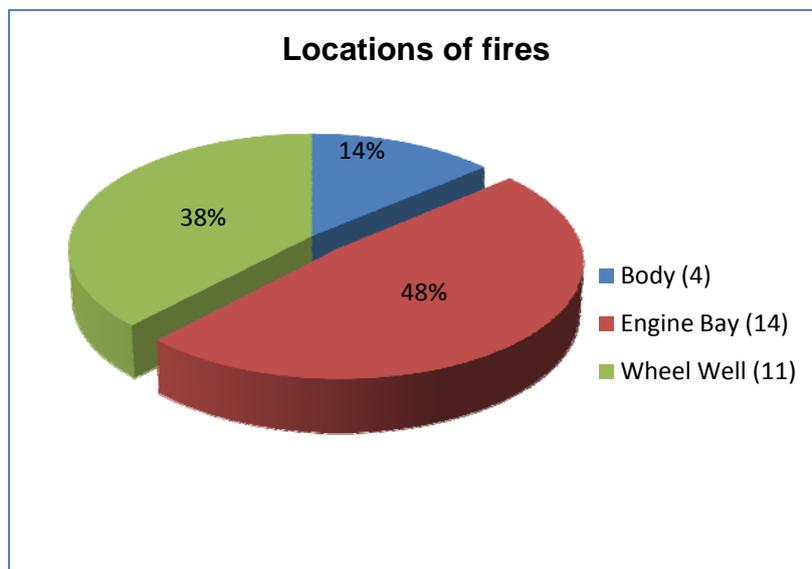
Figure 3

Fourteen fires originated in the engine bay compared with 16 in 2013. Eleven originated in a wheel well. Ten of these were associated with brakes, the other with a tyre. This represents a marked increase on 2013 when six originated in the wheel well area. Four originated in another location within the body of the vehicle compared with five in 2013 (see *Figure 3*).

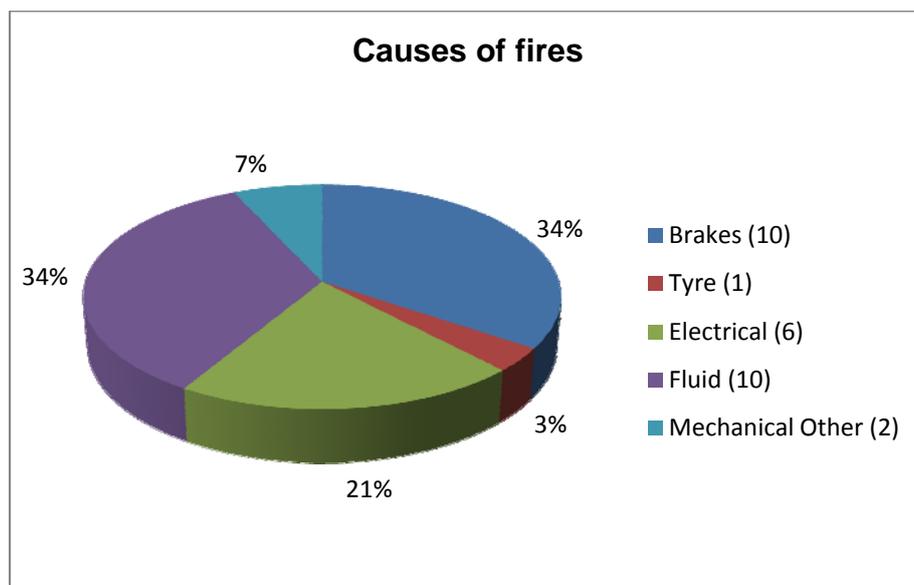
Figure 4

The data for the causes of fires in 2014 are shown in *Figure 4*. The percentages are broadly consistent with previous experience but with small reductions in the number of fires caused by electrical faults and fluid leaks being off-set by the increased number of brake related incidents.

Reports by operators identified brake adjustment (3), sticking brake callipers (3) and driving technique (2) as the main reasons for brake related incidents. The exact mechanism that caused another was not clear. A tenth resulted from an air leak which caused the brakes to apply unintentionally. One report of sticking brake callipers stated there was a known fault, “subject to a manufacturer’s recall”. Of the incidents reported as driver-related, one was due to the manner in which the handbrake was used and the other was attributed to overheating caused by overuse of the brake on an extremely hot day.
