## **TECHNICAL INSPECTION FINDINGS**

**ROLLOVER INVOLVING NOWRA TOURS COACH TV 4604**

**TIMBOON COLAC ROAD, PIRRON YARROCK, VICTORIA**

**15 AUGUST 2010**

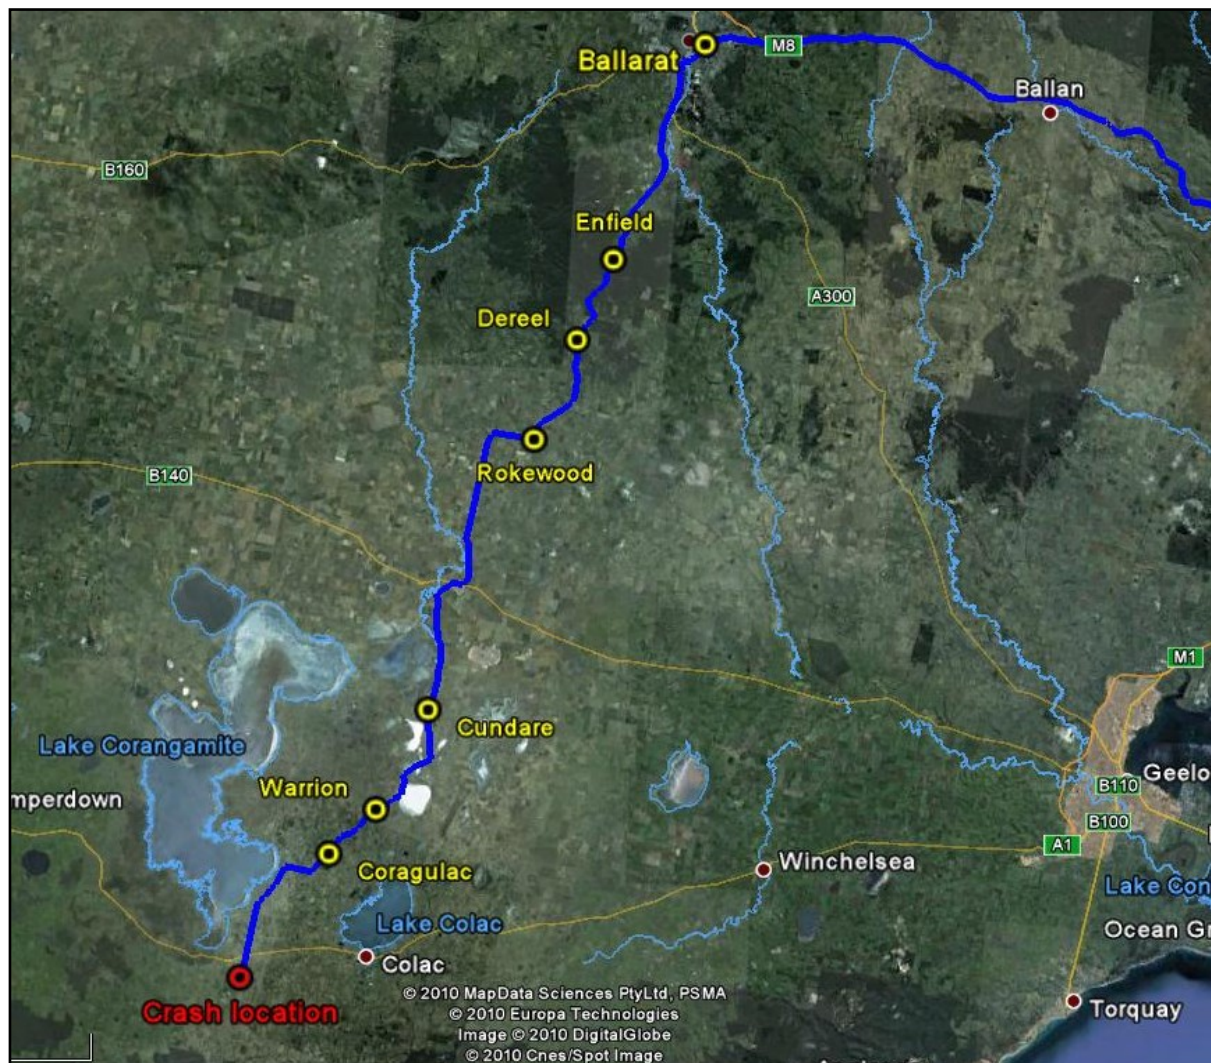
**Figure 3: Tour route and crash location**

The coach had left Melbourne at 7:43am and had arrived at Ballarat at 9:20am. After sightseeing and lunch, the group left Ballarat at 12:51pm and headed South along the Colac – Ballarat Road before deviating to the West to skirt along the Eastern side of Lake Corangamite. At 2:13pm they crossed the Princes Highway from Nalangil Road to Timboon Colac Road and continued South. The route followed by the coach was determined by examination of the C-track GPS records and is shown in *Figure 3*.

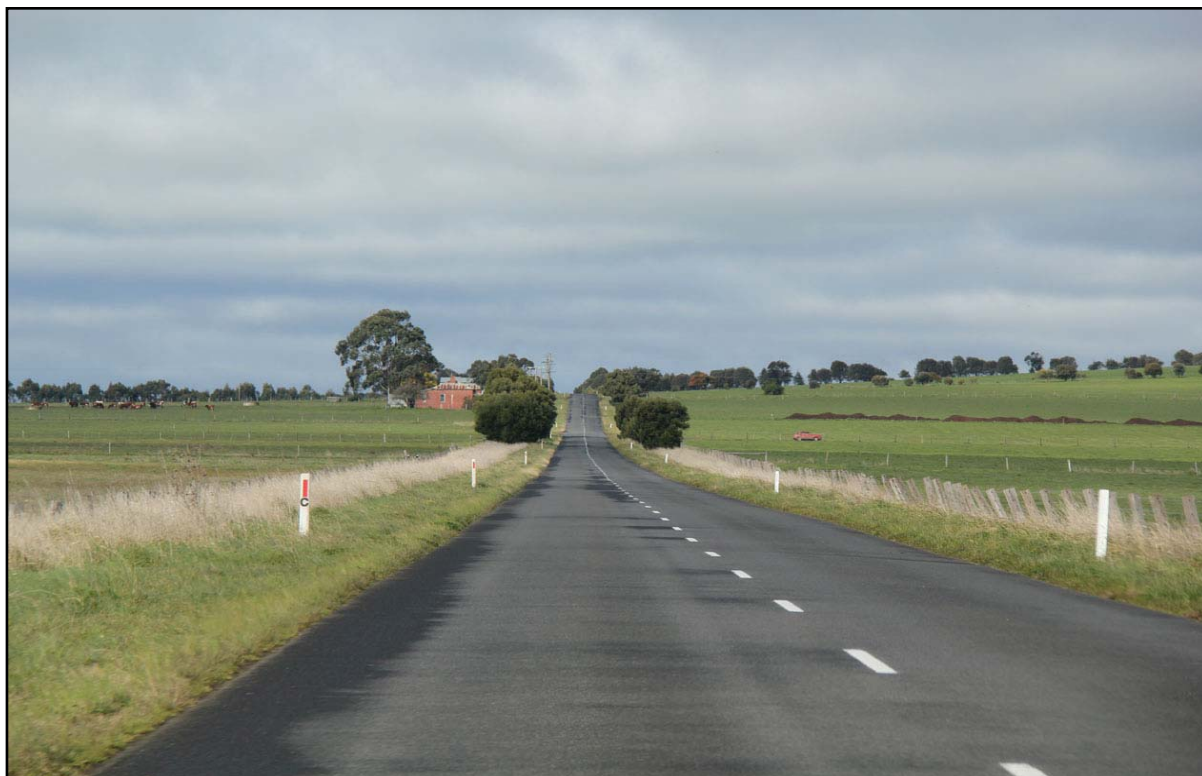
The coach left Ballarat with the group on board at 12:51pm, heading South toward its next destination, the Great Ocean Road and the Twelve Apostles. The trip was through rural Victoria on predominantly two lane country roads in fair condition (*Photograph 9*) but with one section of narrower road with no centreline and with broken edges (*Photograph 10*). The terrain was flat to undulating, generally through open farmland with some areas of natural woodland. There was very little traffic and the speed limit was generally 100km/h except for a number of small towns and localities with limits of 60km/h or 80km/h. The driver kept comfortably within the 100km/h speed limit, generally travelling at speeds between 80km/h and 96km/h. The weather was overcast with occasional rain.

**Photograph 9: Nalangil Road south of Williss Road intersection**

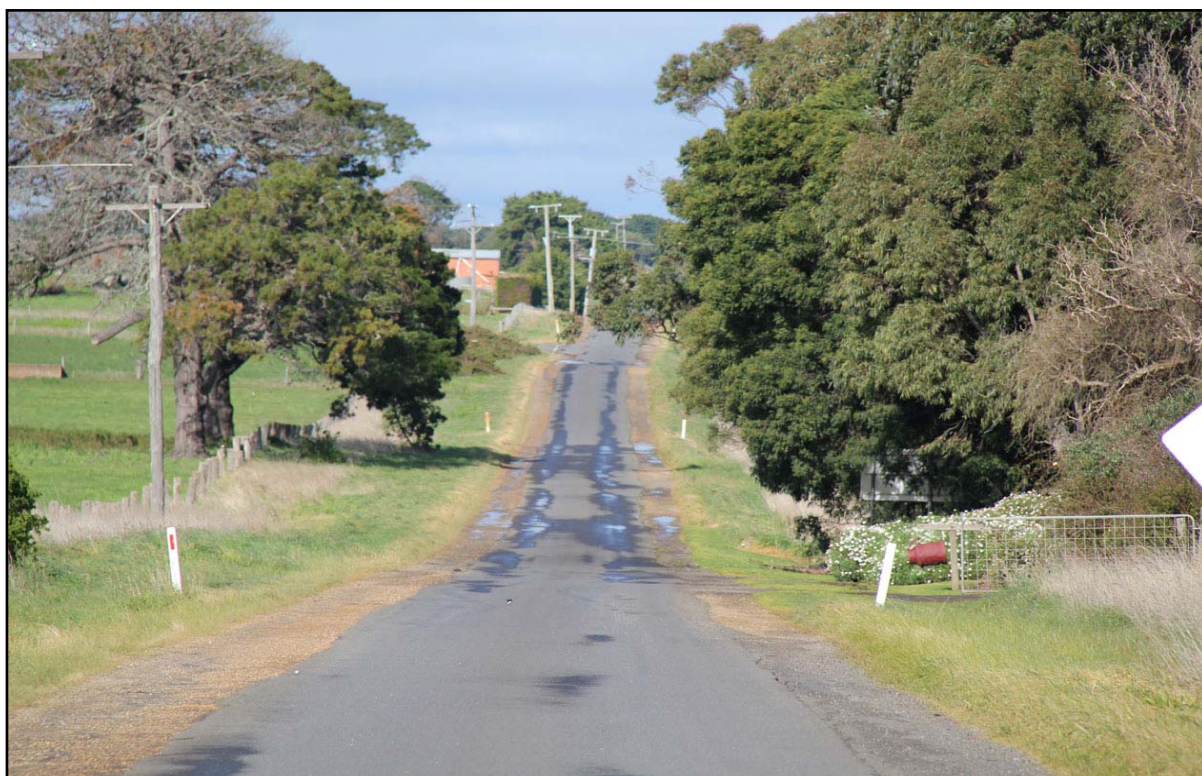
**Photograph 10: Nalangil Road south of Lineens Road intersection**
