FERRY SAFETY INVESTIGATION

COLLISION AND GROUNDING OF THE *LADY NORTHCOTT*

SYDNEY HARBOUR

11 and 13 December 2012

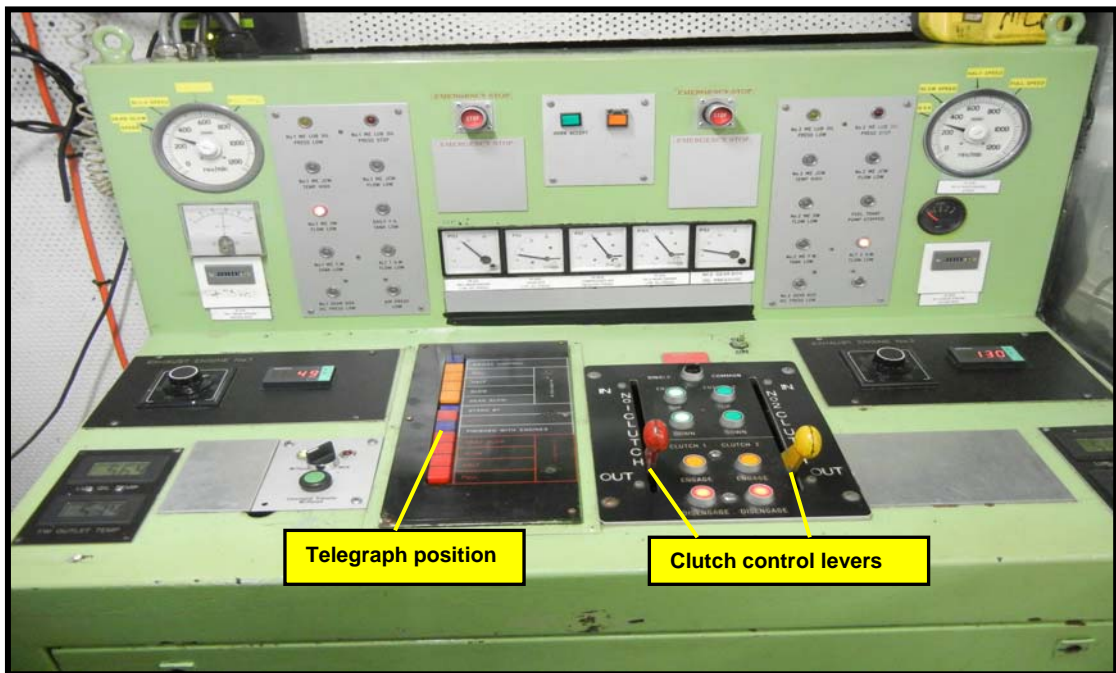
Photograph 6: Lady Northcott's MCR controls

- 2.27 As can be seen from *Photograph 6*, the telegraph control is sturdy, requiring a deliberate manual movement over an appreciable distance to change commands between '*ahead*' and '*astern*'. A series of mistaken control selections (or accidental bumps) is an unlikely coincidence.
