Office of Transport Safety Investigations

FERRY SAFETY INVESTIGATION REPORT

CLOSE QUARTERS

25 JULY 2012

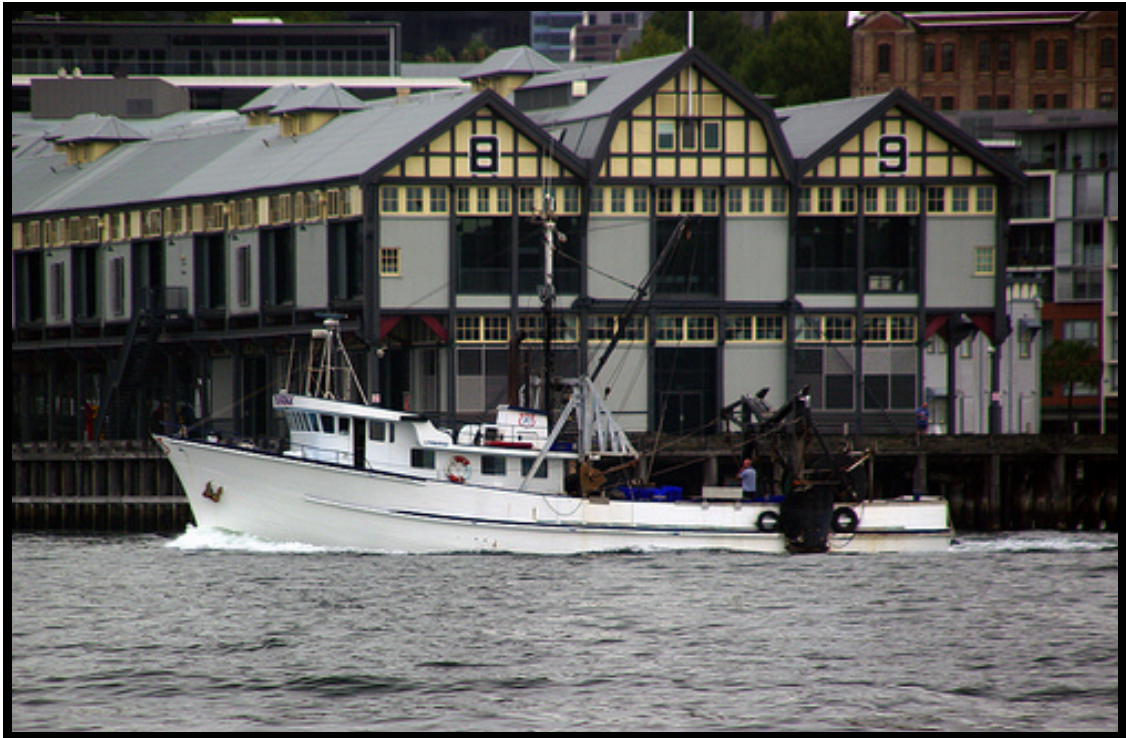
Photograph 1: *Francesca*

- 1.5 *Francesca* was exhibiting the prescribed lights for a power-driven vessel less than 50 metres in length in accordance with COLREGs Rule 23 (a) (i), (iii) and

(iv). Additionally, it was exhibiting bright white floodlights on top of the trawl gantry aft of the wheelhouse. The crew was using a compressed air operated horn at arbitrary intervals in lieu of the regulation sound signal that is required to be used in conditions of reduced visibility. These sound signals were not heard from the *Narrabeen* or *Palm Cat*.

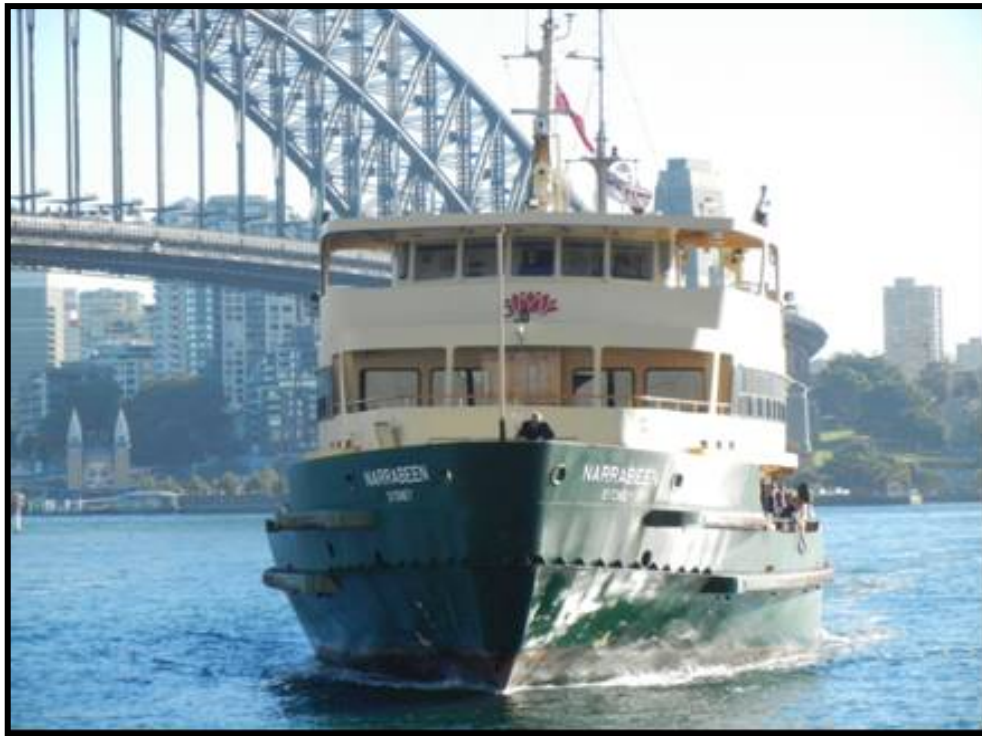
Photograph 2: *Narrabeen*

- 1.8 *Narrabeen* was exhibiting the prescribed lights for a power-driven vessel over 50 metres in length in accordance with COLREGS Rule 23 (a) (i) to (iv).

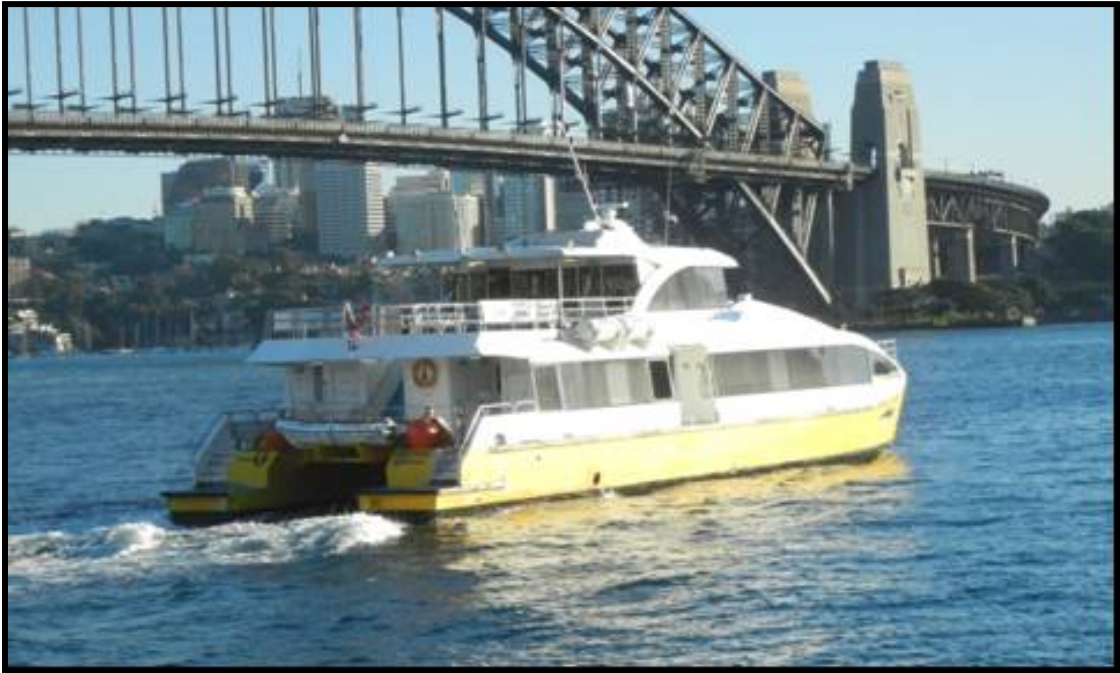
Photograph 3: *Palm Cat*

- 1.11 *Palm Cat* was exhibiting the prescribed lights for a power-driven vessel less than 50 metres in length as required under COLREGs Rule 23 (a) (i), (iii) and (iv).

- 2.26 *Palm Cat* overtook *Francesca* at a distance estimated to be no more than 5 to 10 metres. *Palm Cat* then came to within the same estimated distance when passing *Narrabeen*. The Master of *Francesca* considered this was very close and “*expected to hear the sound of a collision*”. He considered the *Palm Cat* was “*travelling far too fast*” (for the conditions). The *Palm Cat* had slowed considerably but was still travelling at least three times faster than the other vessels. The Master of *Palm Cat* did not have the same opinion of the visibility conditions as the other masters and, additionally, had a vessel with superior manoeuvrability.

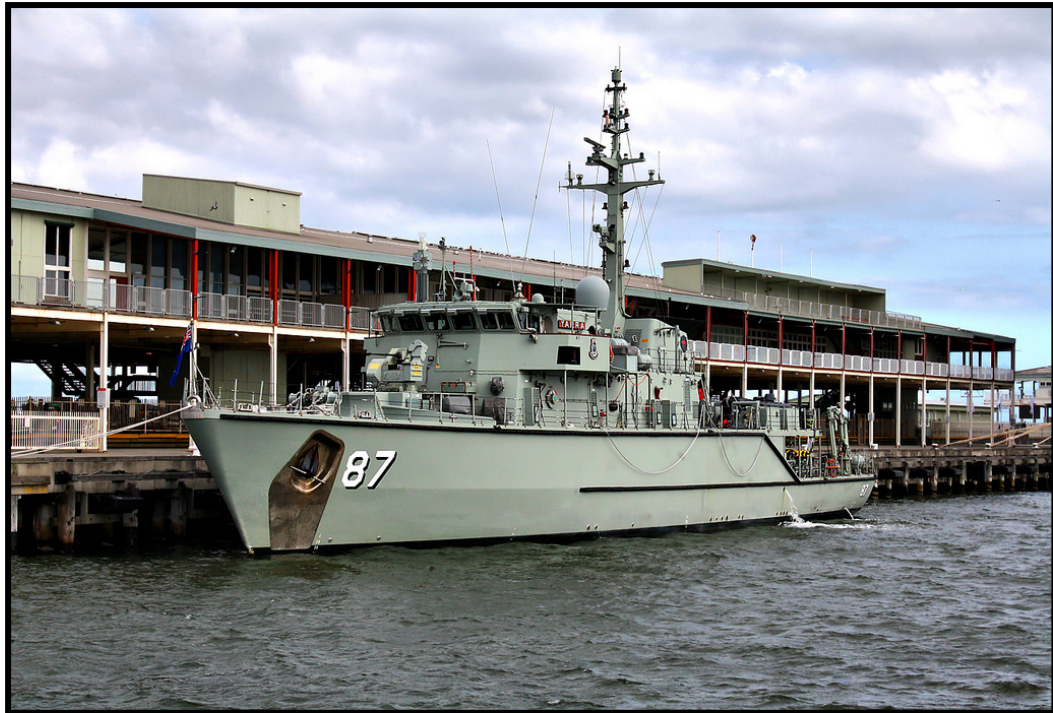
Photograph 4: HMAS Yarra

- 1.12 The Royal Australian Navy (RAN) Mine Hunter Coastal vessel *HMAS Yarra* was commissioned on 1 March 2003 and is the last of six “Huon” Class minehunters built in Newcastle, Australia. It is a monohull vessel, 52.5 metres in length and displacing 720 tonnes. It is powered by a Fincantieri diesel driving a controllable pitch propeller and three Riva Calzoni auxiliary propulsion units. The vessel was equipped with radar and VHF and HF radio. It was not equipped with AIS. For more details refer to *Appendix 4*.
- 1.13 *HMAS Yarra* had a full complement of crew with a Commanding Officer of lieutenant commander rank.
- 1.14 *HMAS Yarra* was exhibiting the appropriate navigation lights for a power-driven vessel over 50 metres in length. In addition, it was exhibiting three all-round green lights signifying it was engaged in mine clearance operations (COLREGs Rule 27 (f) refers).

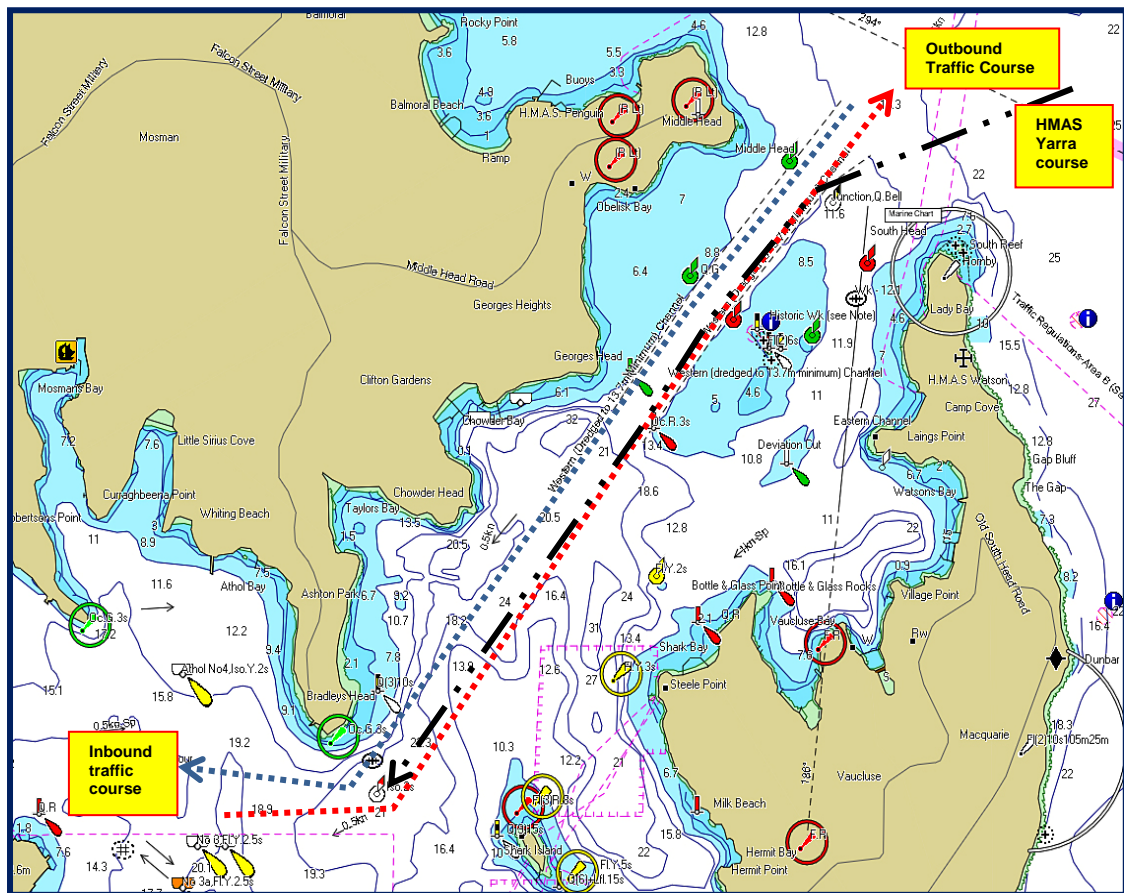
Chart Extract 2: HMAS Yarra track

- 2.23 In the conditions, and with *Francesca* unsighted, a 22° alteration of course might not be considered to be fully compliant with Rule 8 (b) of the COLREGS: “Any alteration of course and/or speed to avoid collision shall, if the circumstances of the case admit, be large enough to be readily apparent to another vessel observing visually or by radar ...”. Determining what is a “large enough” alteration is a matter of personal interpretation.
