FERRY SAFETY INVESTIGATION REPORT

COLLISION OF RIVERCAT *BETTY CUTHBERT* NUMBER 5 EAST WHARF, CIRCULAR QUAY 23 SEPTEMBER 2005

OTSI File Ref: 04205

23 February 2006

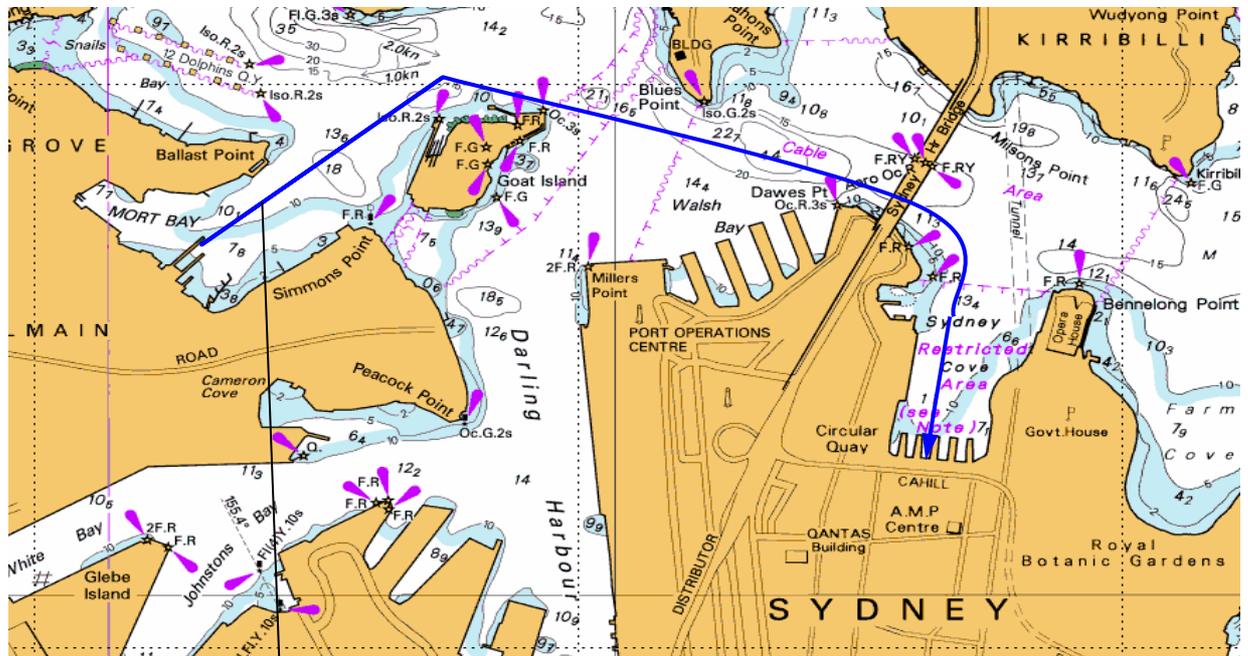
Figure 1. Extract from Chart Aus 202

Approximate track of the 'Betty Cuthbert' from the SFC Balmain facility to No. 5E Wharf, Circular Quay

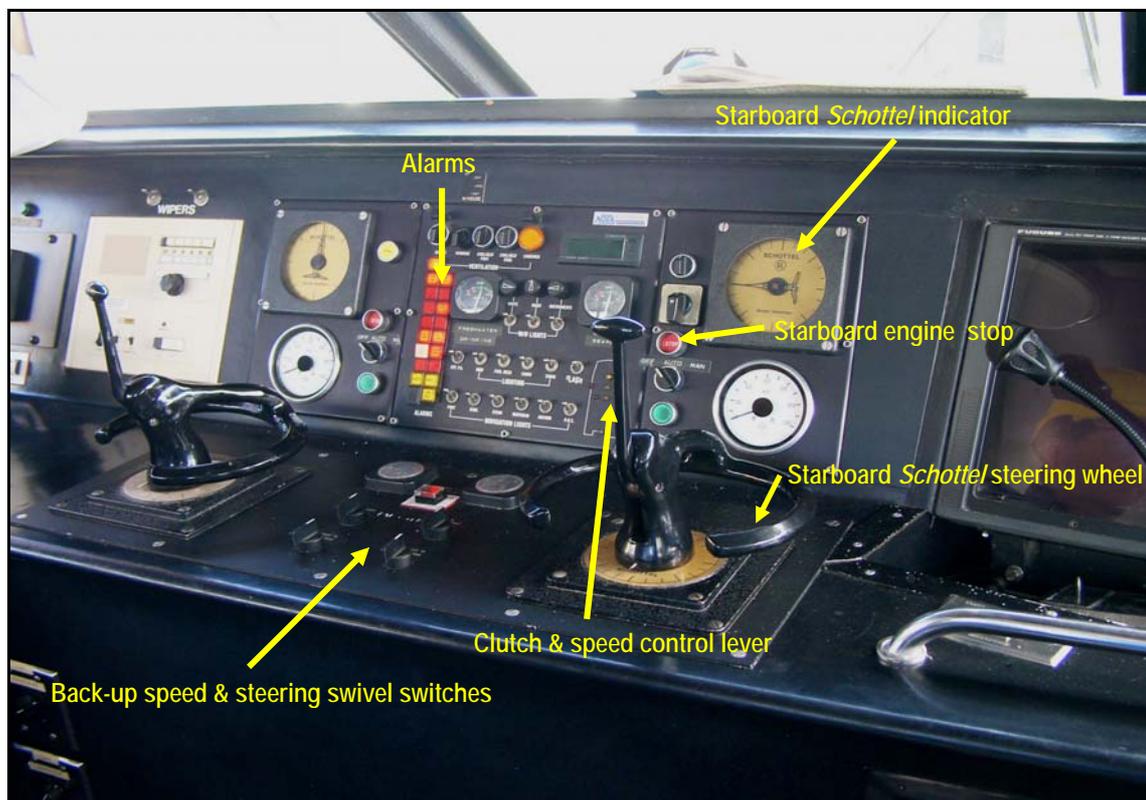
Figure 4. Bridge, centre control station

3.1 Control of the *Rivercats*' propulsion system is exercised through a *Schottel* control system which consists of a number of subsystems. The 'Speedronic' sub-system sets the engine speed and controls the engagement and disengagement of the clutch by way of an activating micro-switch that activates a solenoid. An electro-hydraulic Co-Pilot sub-system controls the rotation of the rudder/propeller units. These sub-systems are integrated into three sets of identical operating hand wheels located at port-side, centre and starboard-side consoles. Each set has two hand wheels. The port-side and starboard-side hand wheels in each set are linked to the port-side and starboard-side engines respectively and their clutch, propeller and rudder unit. The control configuration at the centre and starboard stations are depicted in *Figures 4* and *5* respectively.
