FERRY SAFETY INVESTIGATION REPORT

COLLISION OF THE MANLY FERRY *COLLARROY* NUMBER 3 WEST WHARF, CIRCULAR QUAY 4 MARCH 2005

OTSI File Ref: 03545

25 November 2005

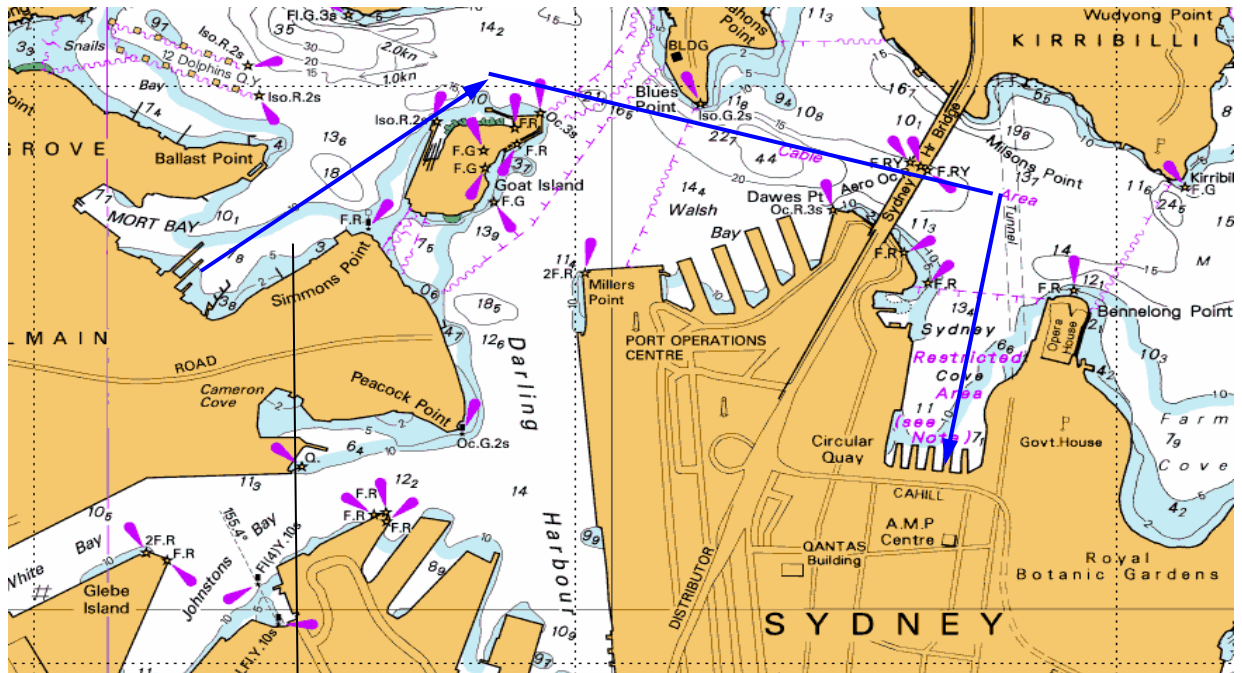
Figure 1: Extract from chart Aus 202

Approximate track of the *Collaroy* from the Balmain facility to No. 3W Circular Quay

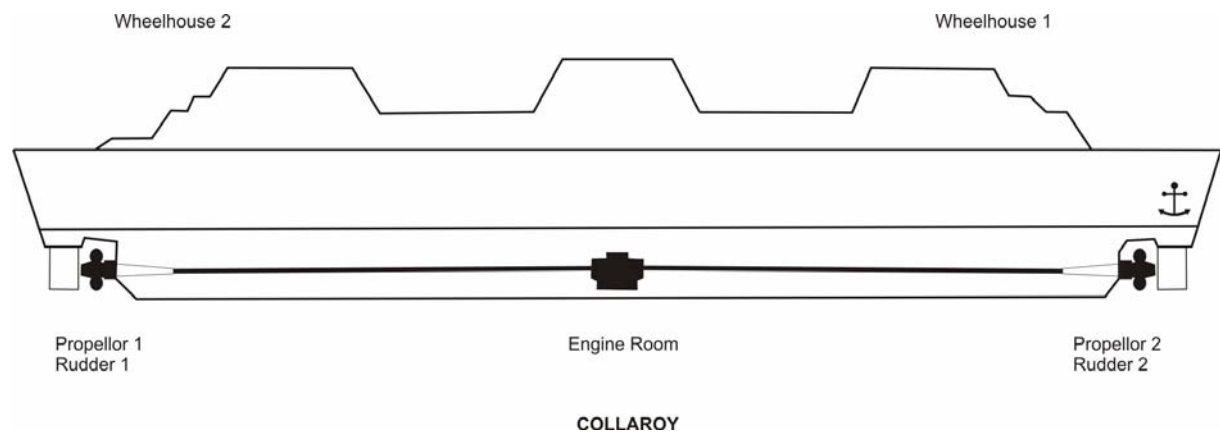
Figure 4: Diagrammatic Representation of the *Collaroy*

2.9 *Collaroy* is one of four “Freshwater” class vessels operated by Sydney Ferries Corporation. It is 69.5 metres long and 13 metres in beam. *Collaroy* has a ‘double-ended’ configuration, with a centre-line propeller and rudder fitted at both ends, allowing the ferry to be operated on return trips from Sydney to Manly without having to turn around. *Collaroy* is propelled by two 2238kW (3000BHP) Daihatsu marine diesel engines, only one of which is normally in use during routine service. Its normal service speed is 14 knots; it has a displacement of 1140 tonnes and has a maximum carrying capacity of 1100 passengers. A schematic of the vessel is shown at Figure 4.

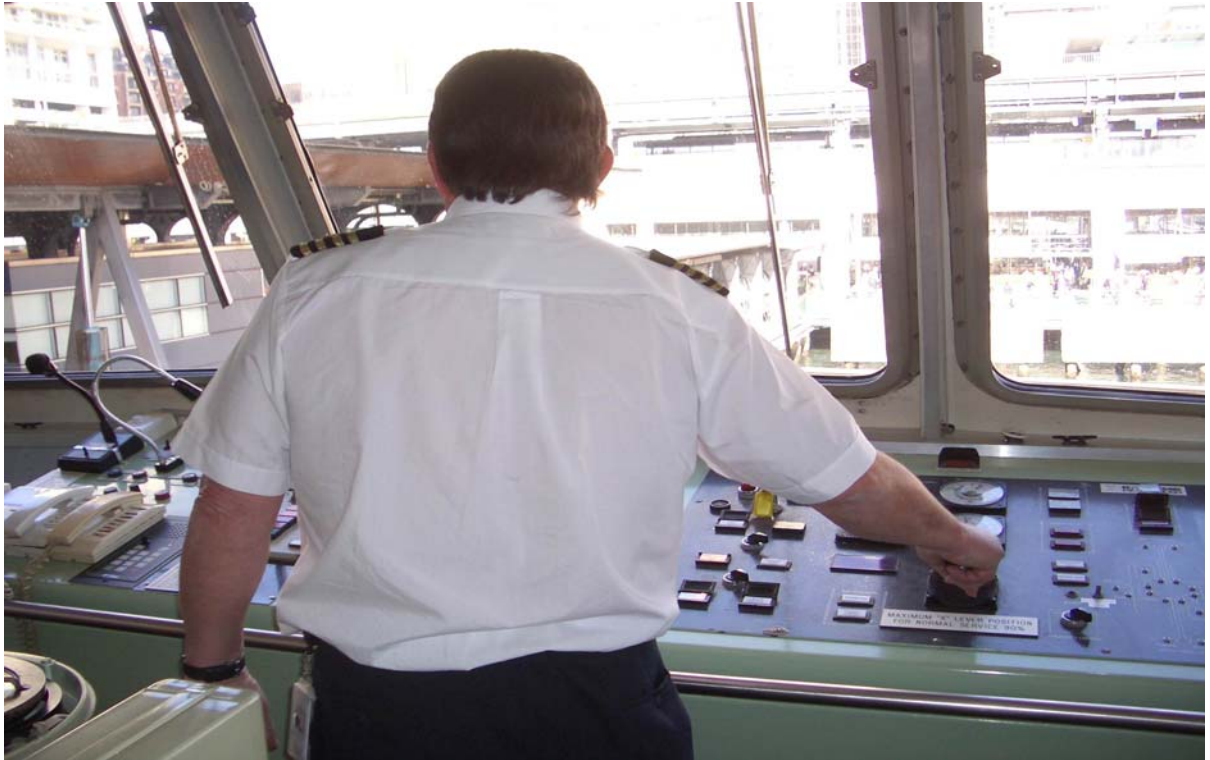
Figure 5: A master at the No. 2 Bridge centre control console

- 2.12 *Collaroy*’s Master controls and navigates the vessel from one of two identical enclosed bridges on the ferry’s superstructure. Each control console is fitted with external bridge wing control stations, i.e., the master can exercise control from three stations at either end of the ferry. The centre console station is shown at Figure 5 *overleaf*.

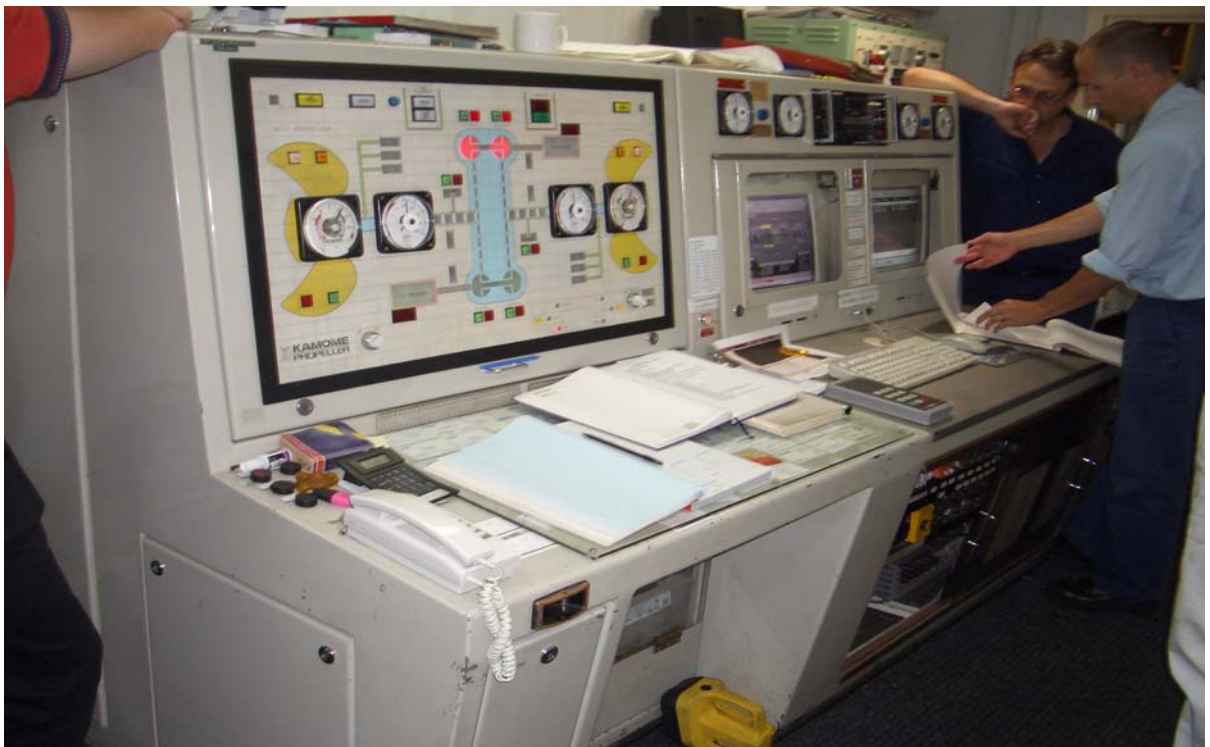
Figure 6: The Machinery Control Room (MCR) Mimic Panel and Data Logger Console

- 2.13 Like its sister vessels in the class, *Collaroy* is akin to a small sea-going ship and has a separate Machinery Control Room (MCR) that is controlled by an engineer. The master may direct control of the propulsion settings through the engineer located in the MCR. A part of the MCR is shown at Figure 6 *overleaf*.
