FERRY SAFETY INVESTIGATION REPORT

COLLISION OF THE MANLY FERRY *COLLARROY* NUMBER 3 WEST WHARF, CIRCULAR QUAY 4 MARCH 2005

OTSI File Ref: 03545

25 November 2005

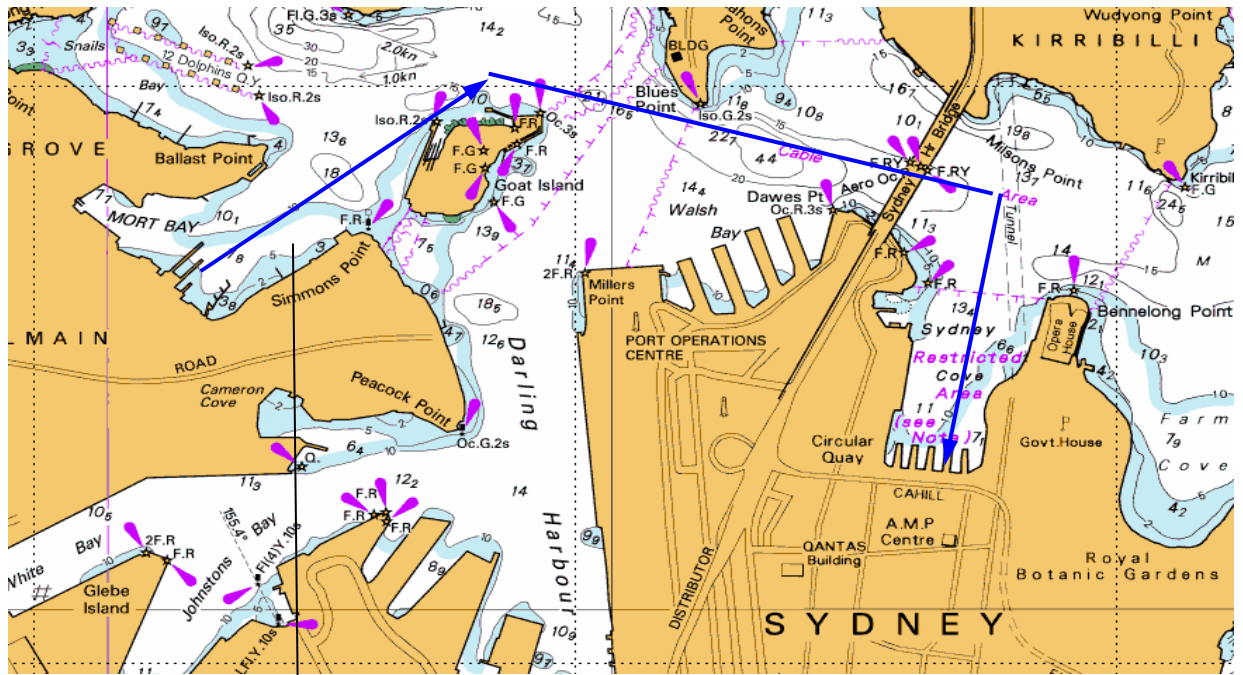
Figure 1: Extract from chart Aus 202

Approximate track of the *Collaroy* from the Balmain facility to No. 3W Circular Quay
