FERRY SAFETY INVESTIGATION REPORT

COLLISION OF THE MANLY FERRY COLLAROY NUMBER 2 WHARF, CIRCULAR QUAY

19 SEPTEMBER 2005

OTSI File Ref: 04202

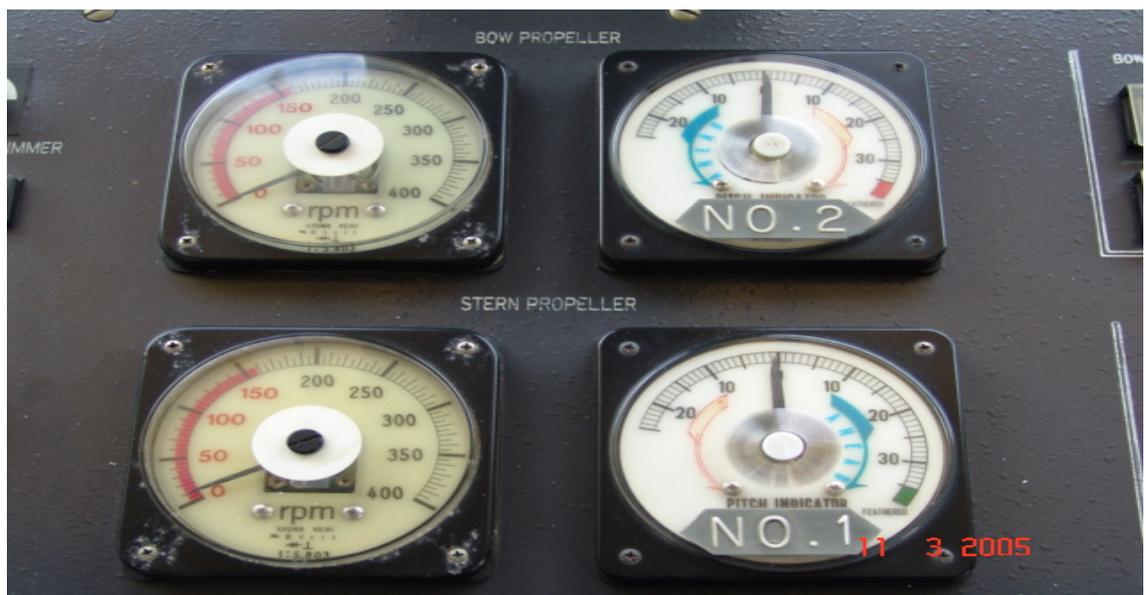
Figure 7 Pitch Setting Indicating Gauges, at right

- 3.4 Masters activate the propulsion control system by operating a switch, not unlike a car's ignition switch, on the centre console. Once the vessel's master makes this switch, or **Keys In**, control of the vessel's propulsion and steering is set at that location.
- 3.5 Masters usually remain at the centre console until they have stopped the vessel just short of its final position, then relocate to the bridge wing on the side closest to the wharf to complete the berthing procedure. Although the Master has radar and instrumentation that indicates each of the vessel's rudder and propeller pitch settings, as indicated in *Figure 7*, there is no speedometer and the master visually estimates his/her vessel's closing rate towards the berth.
