Office of Transport Safety Investigations

FERRY SAFETY INVESTIGATION

**COLLISION BETWEEN SYDNEY FERRIES' *DAWN FRASER*
AND A DINGHY, REGISTERED No. AAP694N
WALSH BAY, SYDNEY**

5 JANUARY 2007

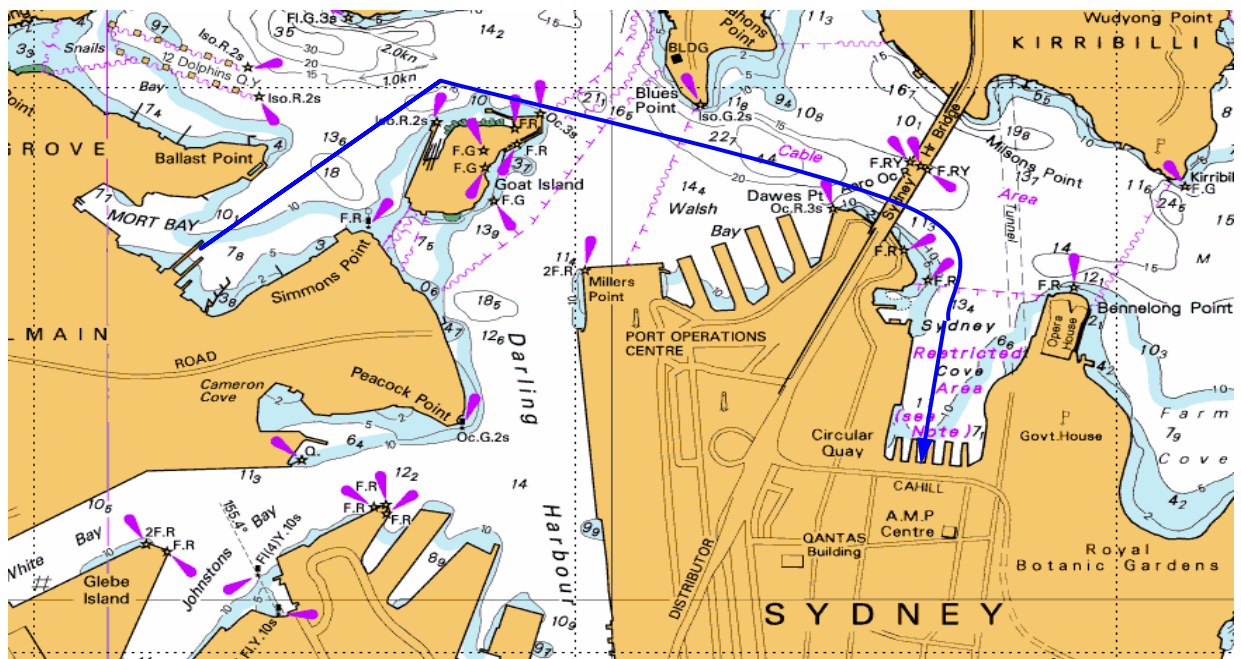
Chart 1:
Seafarer chart showing the approximate course of *Dawn Fraser's* usual track to Circular Quay

- 2.13 The approximate course of *Dawn Fraser's* usual track to Circular Quay is shown on the Chart at *Figure 1* and in the Aerial Photo at *Photo 1*. The Easternmost point of the track in *Photo 1* indicates the general locality of the collision.
