Ferry Safety Investigation Report

Circular Quay

20 February 2004

***'Lady Herron'* – Collision with wharf**

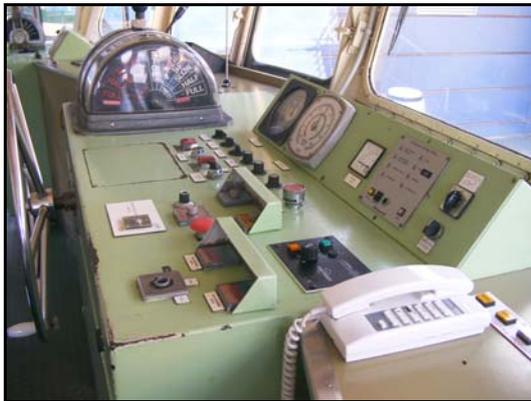
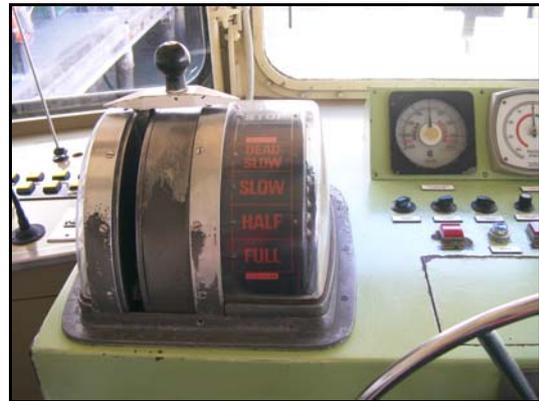
Wheelhouse forward console, engine telegraph

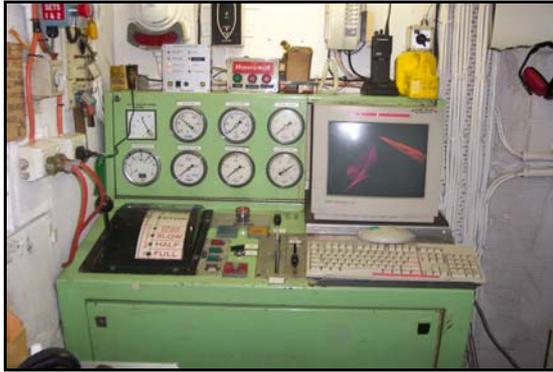
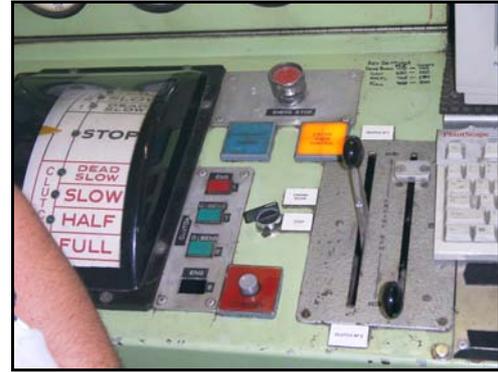
The emergency control process takes longer to achieve the desired engine movement than the automated wheelhouse control system. In addition, while the engineer is manoeuvring from the MCR in the engine room, he is blind to the vessel's situation.

Machinery control room, engine telegraph and clutch/engine speed controls
