# FERRY SAFETY INVESTIGATION REPORT

## COLLISION OF THE MANLY FERRY *NARRABEEN* NUMBER 5 WHARF, CIRCULAR QUAY 26 MAY 2005

**OTSI File Ref: 04066**  
**24 March 2006**

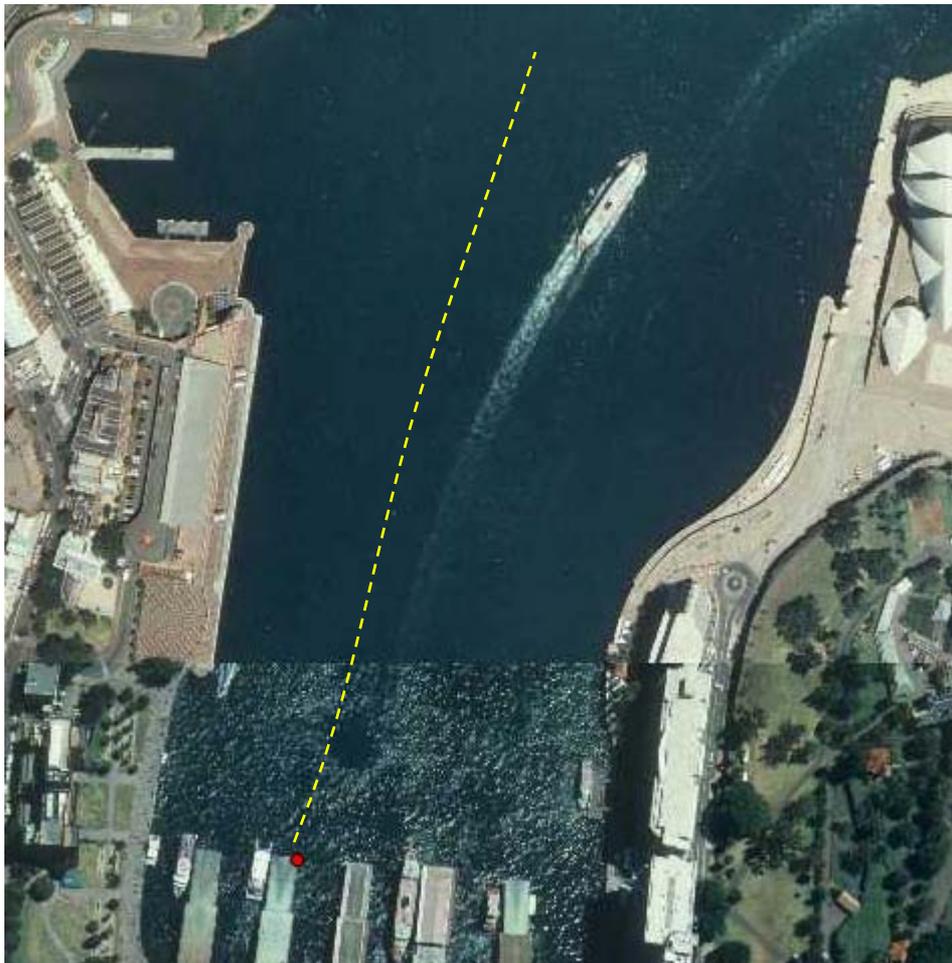
**Figure 2: Aerial View of Circular Quay**

than 10 vessel movements may occur in Sydney Cove concurrently and in recent years, there has been an increase both in traffic frequency and the size of vessels operating therein. Significantly, Circular Quay is less than 300 metres wide at its Southern end. The facility's layout, showing *Narrabeen's* final route and the point of collision, is shown at *Figure 2*. The distance from the Sydney Cove limit line to the wharves is approximately 500m.

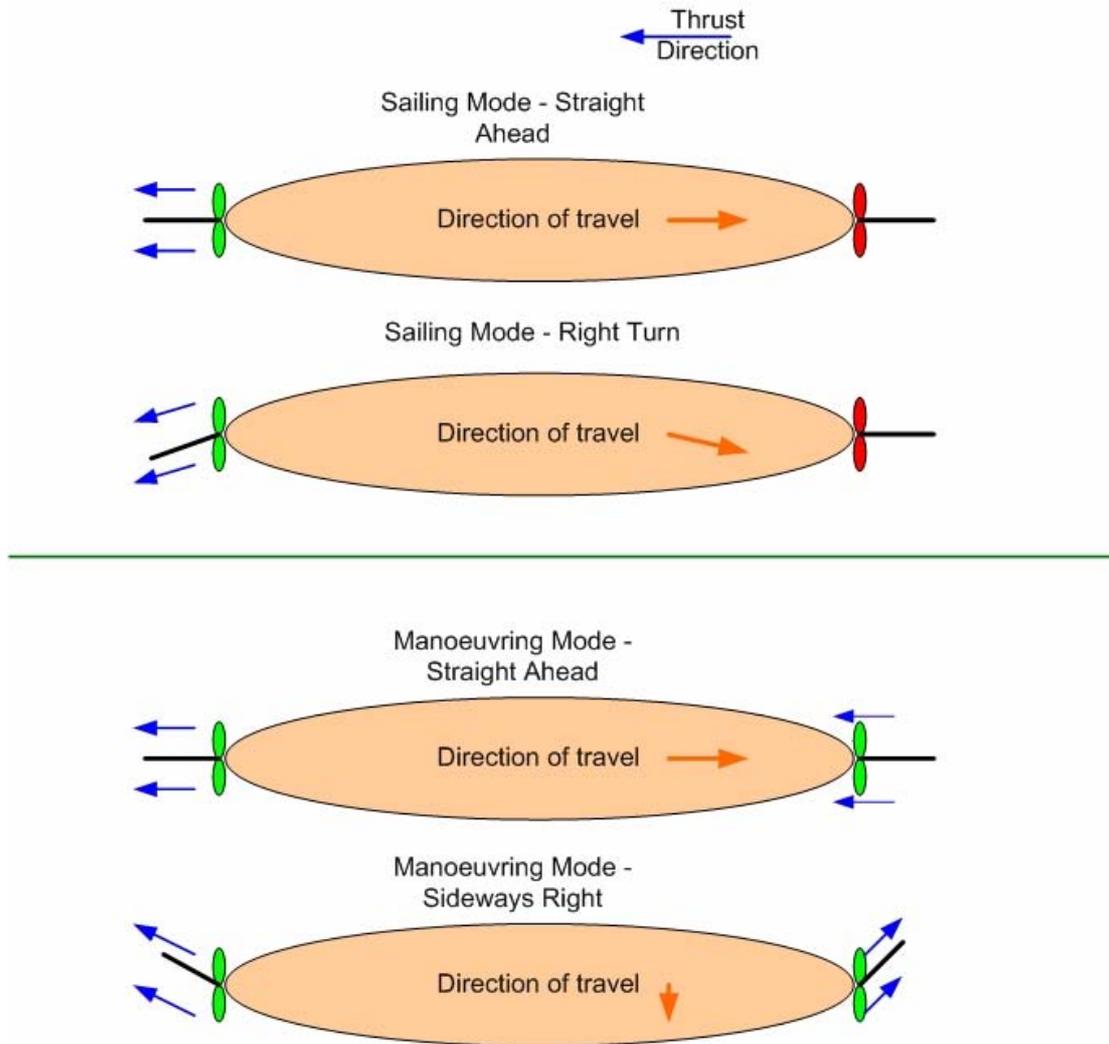
**Figure 3: Propulsion Mode Illustration**

- 2.17 **Manoeuvring** mode is selected when the vessel is required to commence a berthing operation. In this mode, the inactive bow propeller is taken out of feather to a 0° pitch state. The evolution from the feathered state to the 0° pitch state takes approximately 17 seconds, during which time the bow propeller shaft commences to spin due to the force of the water passing over the now pitched propeller blades. Once active, both the stern and bow rudder work in conjunction to enable the vessel to be highly manoeuvrable, including sideways movement which is necessary for berthing. In **Manoeuvring** mode, the bow propeller provides the majority of the reverse thrust and control, with the stern propeller providing the greater forward thrust. *Figure 3* illustrates the utilisation of propellers and rudders in **Sailing** and **Manoeuvring** modes.

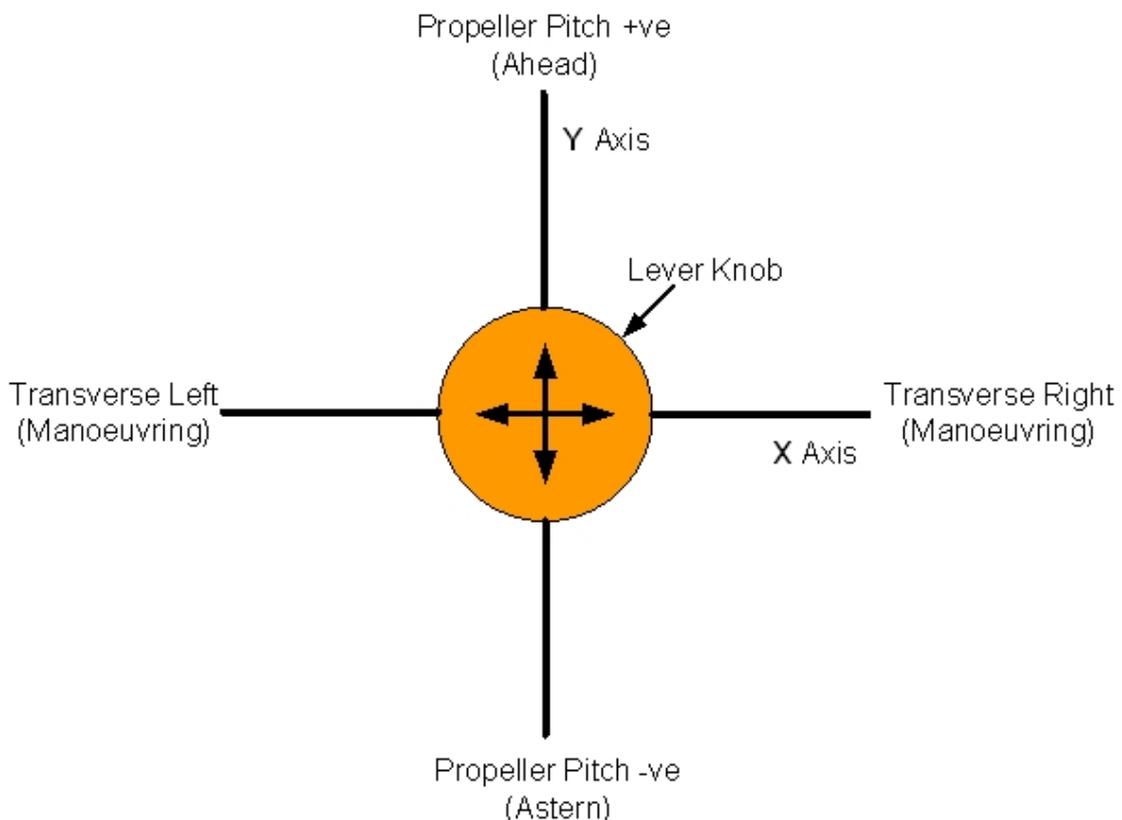
**Figure 4: X-Y Lever Function**

2.19 In **Sailing** and **Manoeuvring** modes, the Master controls the direction and speed of the vessel via the X-Y lever and a stern rudder joystick. To turn the vessel, the stern rudder joystick is moved side to side, and to go astern or ahead or increase or decrease speed, the X-Y lever is moved forward or backwards. In **Sailing** mode, vessel direction is controlled by the stern rudder joystick; however in **Manoeuvring** mode, the pitch of both propellers and the angle of both rudders are affected simultaneously by the X-Y lever. If the vessel is in **Sailing** mode and **Backup** mode is selected, control of the vessel is only effected through the stern propeller and rudder, with the X-Y lever being disabled, and pitch and rudder angles are altered via separate controls, as described in paragraph 2.18. If the vessel is in **Manoeuvring** mode and **Backup** mode is selected, pitch and rudder angle at both ends of the vessel can be controlled via independent toggles. *Figure 4* illustrates the function of the X-Y lever.
