Office of Transport Safety Investigations

FERRY SAFETY INVESTIGATION REPORT

COLLISION MV *KATIKA*

4 DECEMBER 2010

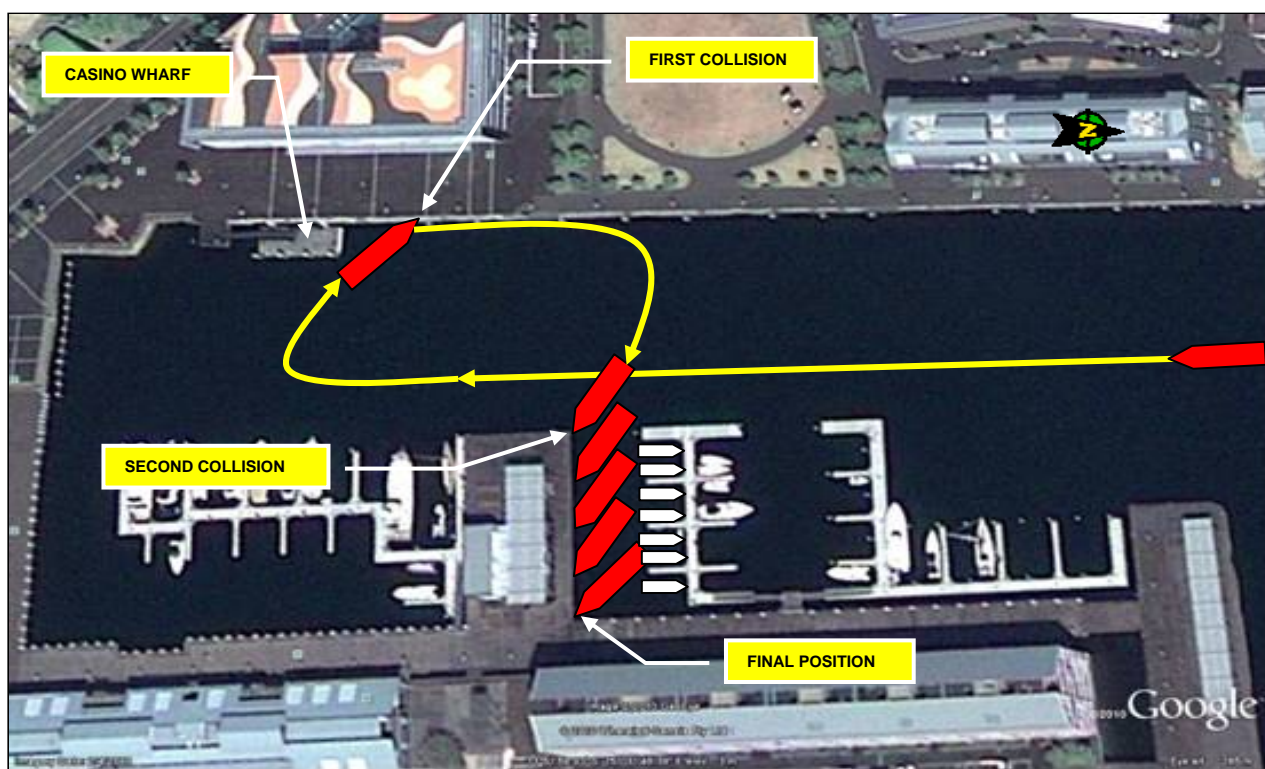
Figure 1: MV *Katika*'s track

- 1.1 The MV *Katika* departed No. 7 King Street Wharf in Darling Harbour at approximately 7:45 pm¹ on Saturday 4 December 2010 for a Sydney Harbour “Fun Boat” cruise with 40 passengers and four crew onboard. The vessel is owned and operated by CSH Management trading as CSH Cruises. There were no incidents during the cruise until the vessel approached Casino Wharf in Pyrmont Bay to disembark passengers on completion of the cruise.
- 1.2 At about 11:40 pm, the Master navigated the vessel South in Pyrmont Bay, near the Sydney Wharf Marina complex on the Eastern side of the bay, and turned to starboard before reaching the Northern extremity of the Casino Wharf where he planned to berth port side to the wharf (see *Figure 1*).
