## MARINE SAFETY INVESTIGATION REPORT

**COLLISION BETWEEN SYDNEY FERRIES' HARBOURCAT  
*PAM BURRIDGE* and MOTOR LAUNCH *MERINDA***

**SYDNEY HARBOUR**

**28 MARCH 2007**

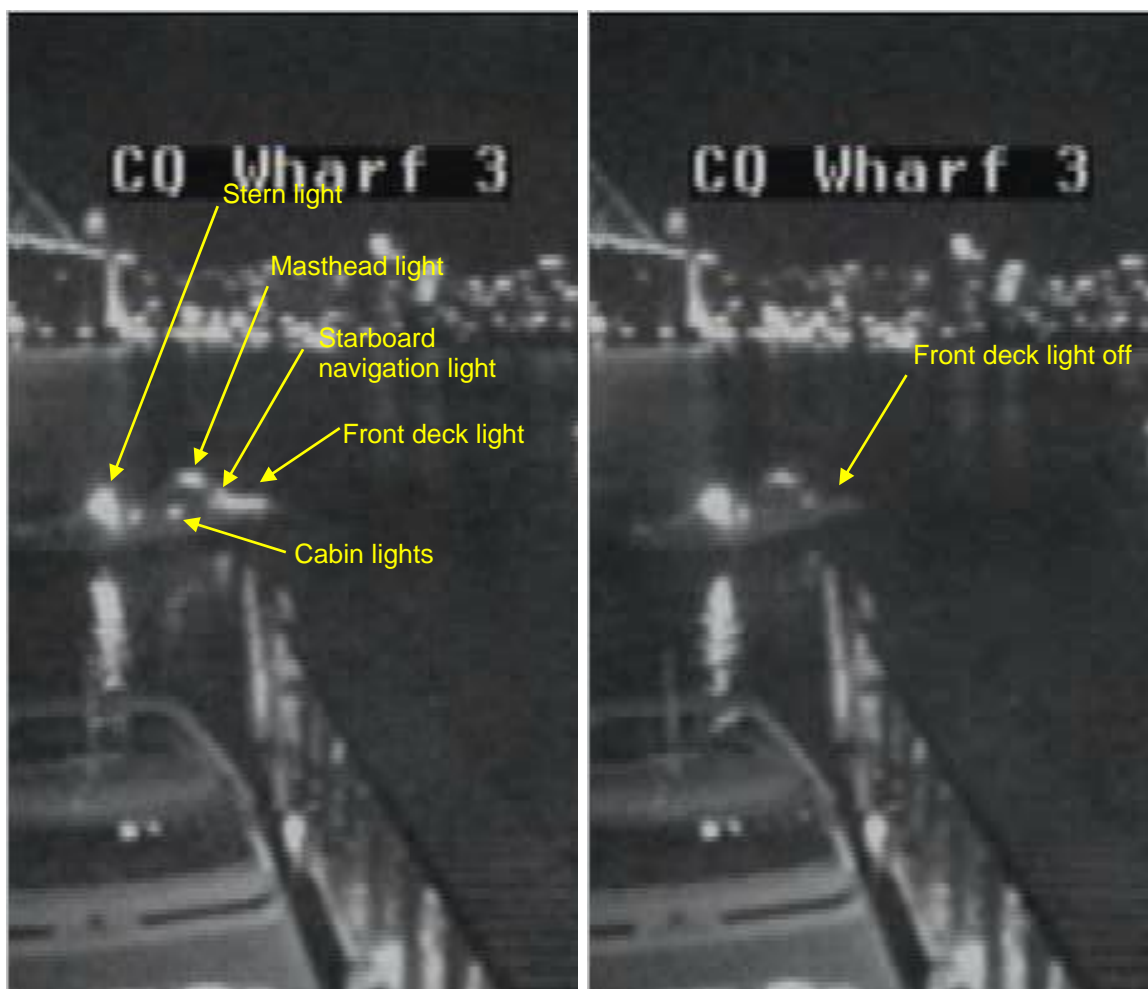
**Photo 6: *PB* departing from Circular Quay**

illuminated and, in accordance with prescribed operating instructions, the overhead lighting in the wheelhouse to be extinguished.<sup>34</sup> Photos 6 and 7, below, were obtained from this footage. These lights, less the Starboard navigation light which could not be seen, were also apparent when the vessel returned to the scene of the collision.

**Photo 7: *PB* departing from Circular Quay**

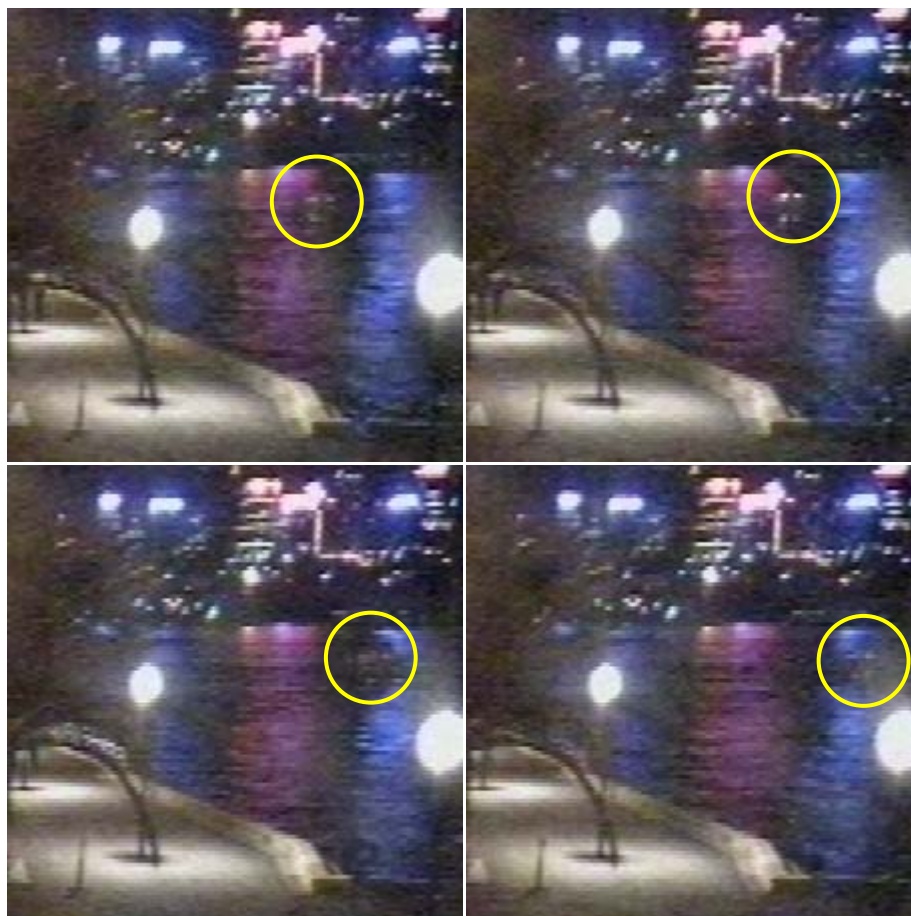
**Photo 10: Set of four frames indicating *Merinda* (circled) immediately East of the Bridge moments before the collision**

2.47 It is important to note when viewing *Photos 8-10*, and any others taken at night appearing in this report, that camera lenses are less capable than the human eye in discerning and capturing images. That said, the four frames in *Photo 10* do illustrate the extent to which visibility of *Merinda* in the area immediately East of the Harbour Bridge, as viewed from the South, could change in a very short period of time.

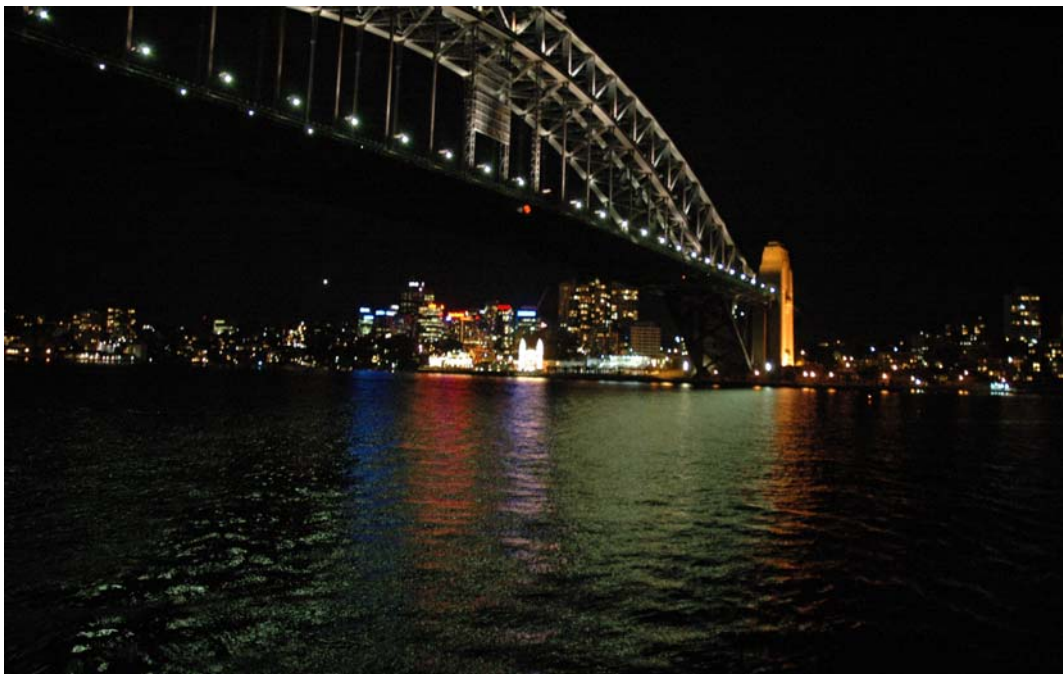
**Photo 12: Lighting conditions looking Northwards and showing the Red Diamond on the Harbour Bridge**

<sup>41</sup> *Photo 11* was taken from Dawes Point and the perspective is therefore slightly different to that which would have been seen by the Helmsman. The bright horizontal yellow line in front of the Opera House is emanating from a passing ferry. *Photo 12* was also taken from Dawes Point, so it too provides an approximation only. Nonetheless, the two photographs do illustrate that the lighting to the North was less even than that to the East.

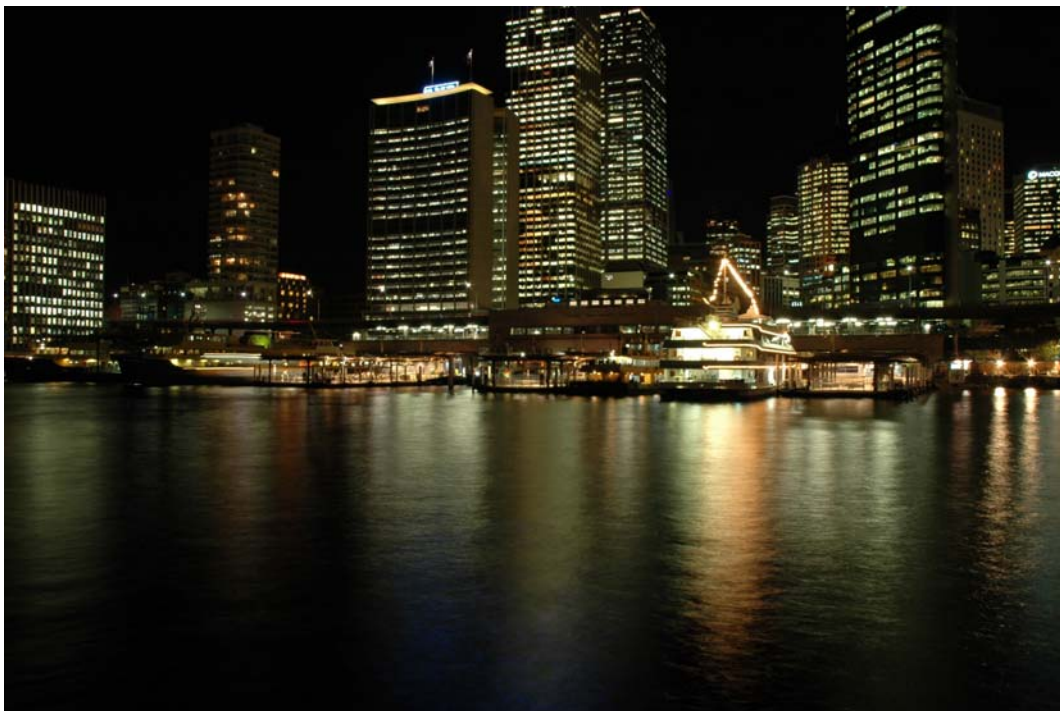
**Photo 13: View of Circular Quay, looking Southwards**

- 2.68 Considering that the *Pam Burridge* departed No. 5 West Wharf within seconds of having entered it, it is possible that the Master's vision may not have adjusted fully to the difference between the bright view that confronted him at the Wharf and the relative darkness that prevailed as he departed Sydney Cove.<sup>42</sup> The relative brightness of Circular Quay is shown in *Photo 13*, although it is important to note that the large vessel which can be seen in the right of this photograph was not berthed at Circular Quay when *Pam Burridge* came into Circular Quay to drop-off the Cashier.

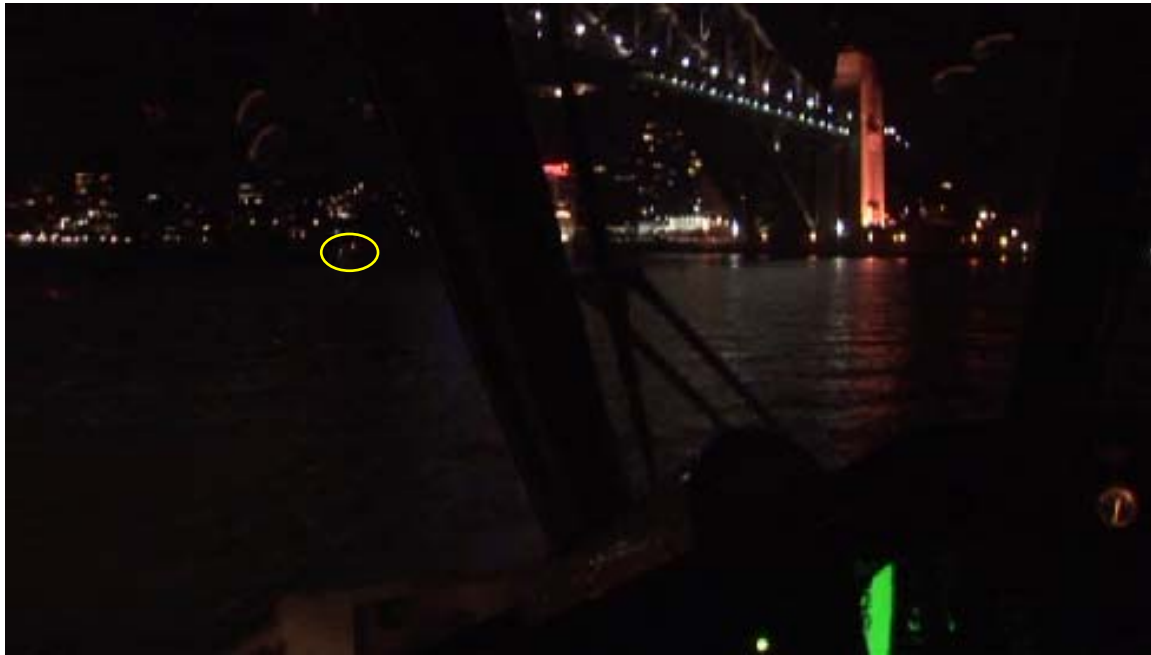
**Photo 17: Island Gypsy’s Starboard and mast lights as seen from *Pam Burrridge***

- c. When the overhead lighting is extinguished in the wheelhouse, as it was on the night of the accident, *Pam Burrridge*’s controls are readily apparent and there is no reflected light from the vessel’s instrumentation, radar or any other source of onboard illumination to distract a master.
- d. The *Island Gypsy*’s navigation lights, which were retro-fitted after having been removed from *Merinda*, were visible from *Pam Burrridge* when illuminated, as can be seen in part in *Photo 17*.<sup>44</sup> These lights were even more apparent when the *Island Gypsy* was moving because they contrasted more clearly with the stationary lights on the Northern side of the Harbour’s foreshore.

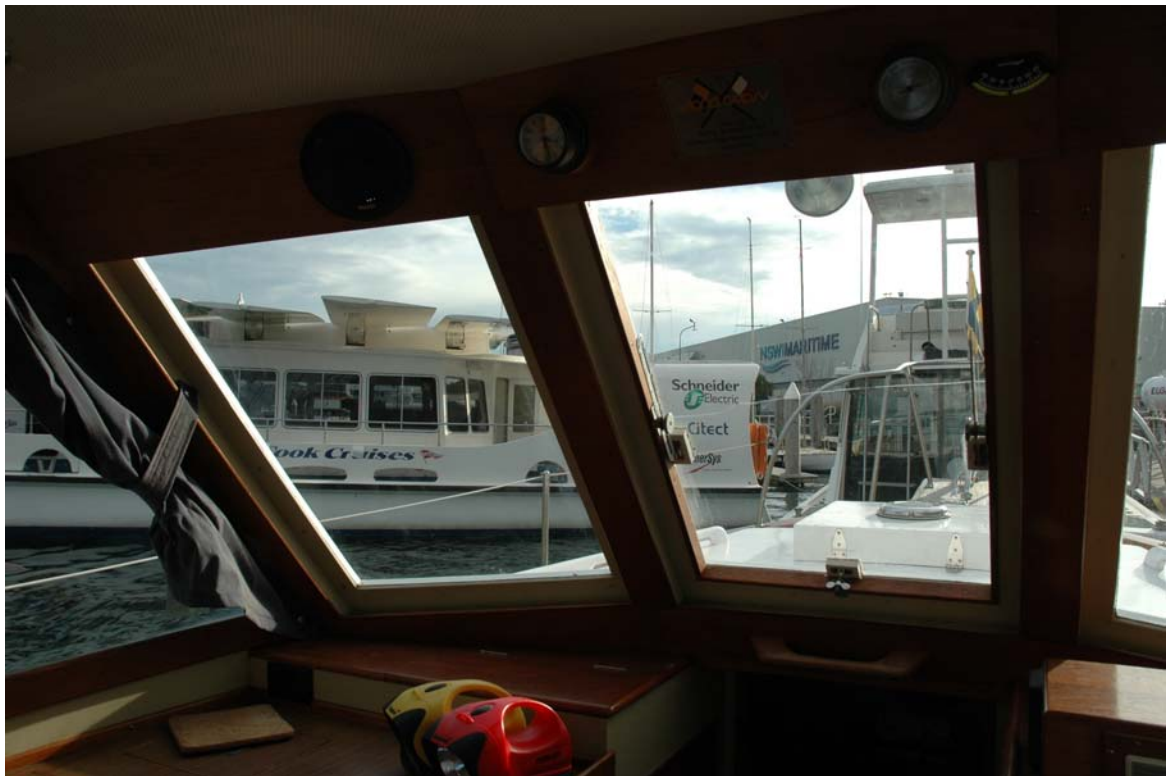
**Photo 19: Forward view from the saloon of the Island Gypsy**

- g. With the forward-most of its main saloon lighting extinguished, as was the case with *Merinda* at the time of the accident, the Island Gypsy's controls are readily apparent to a helmsman operating from the driving station within the saloon and there is no source of light from elsewhere on the vessel to affect or distract his/her views ahead, or to the Port and Starboard. The illumination provided by the two rear saloon lights might impact on a helmsman's view astern.
- h. *Pam Burridge's* 17 metre long superstructure and its navigation lights were clearly visible to the Island Gypsy's helmsman from the fly-bridge, but significantly less so from within the saloon.
- i. Vision within the Island Gypsy's saloon, which was identical in design to *Merinda's*, is significantly affected by the position and dimension of the cabin's supporting pillars which are depicted in *Photos 19 and 20*.

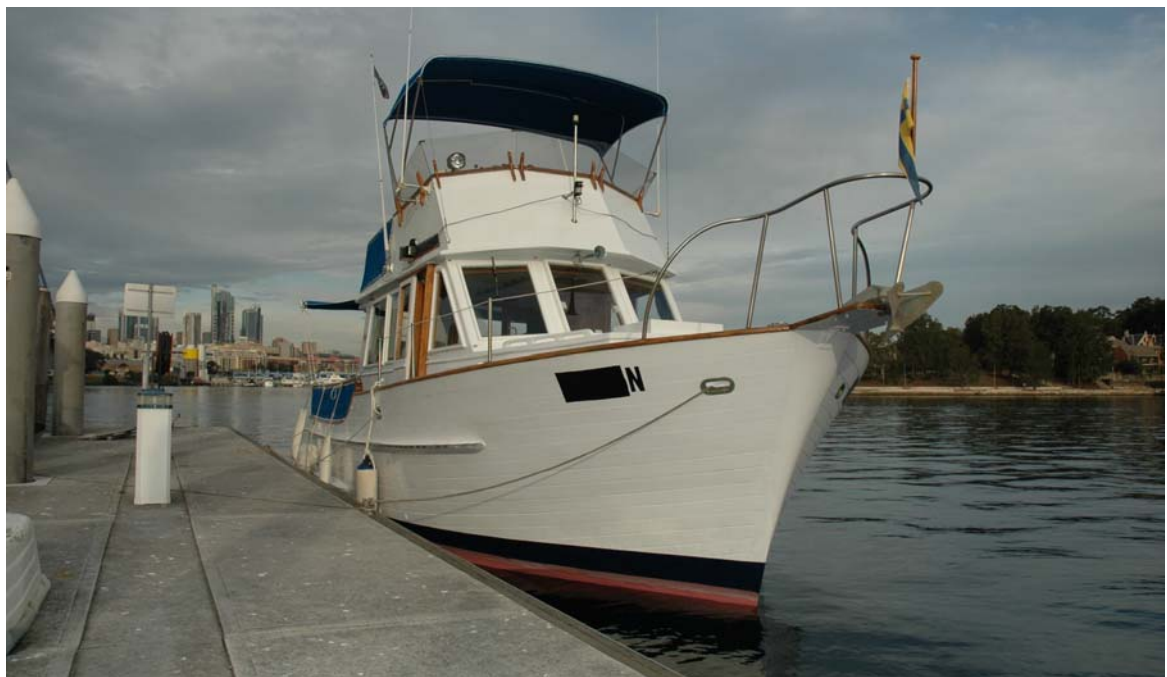
**Photo 20: Front view of the Island Gypsy showing the width and position of the supporting pillars and the relatively small side window**

2.76 *Diagram 3*, a scaled representation which takes into account the height of the Helmsman and the position from which he was controlling *Merinda*, illustrates the extent to which the main saloon's design can restrict visibility if a helmsman remains in a relatively static position.

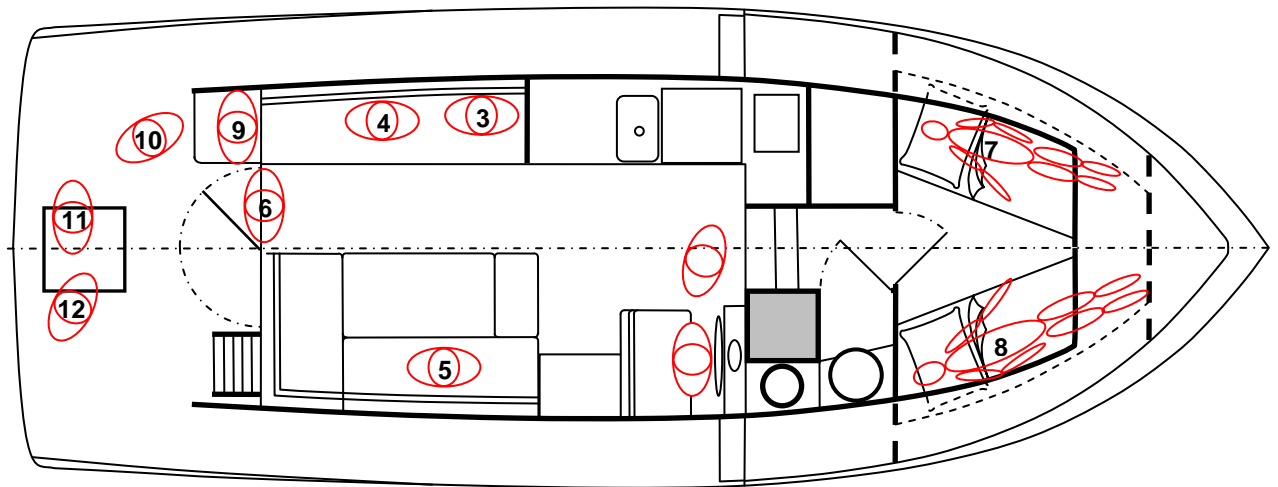
**Diagram 5: Plan of *Merinda*'s deck and below, showing reported positions of passengers**

- 2.26 The witness seated in position 3 on the *Merinda*, as indicated in *Diagram 5*, advised that she was looking at the person in position 5 “when at the same instant I saw something green like a nose coming towards me through the windows”. This witness described what proved to be *Pam Burridge* passing behind the passenger seated in position 5 and in front of her, and indicated that she did not see any lights or hear a horn on/from the object that struck *Merinda*. However, she recalled the object seeming to veer away from her after it struck and then pass through *Merinda*. She further recalled water entering *Merinda* very quickly. Another witness, seated in position 4, stated that she had just finished a conversation with the witness in position 3, when she saw a pale grey shape “well out” from them through the door on the Starboard side. This door is depicted in *Photo 2* (on page 2), albeit in the closed position. She described this shape then becoming white and finally, when it was upon them, white and green. When asked what she meant by “well out”, the witness could not estimate the distance at which she first saw the vessel and described herself as only having time to turn her head to the right and take a breath in order to speak before the collision occurred, after which she was
