FERRY SAFETY INVESTIGATION REPORT

COLLISION INVOLVING SYDNEY FERRIES' *SIRIUS* WITH THE AQUARIUM WHARF, *OCEAN DREAMING* AND THE PYRMONT BRIDGE

22 MARCH 2007

Investigation Reference 04359

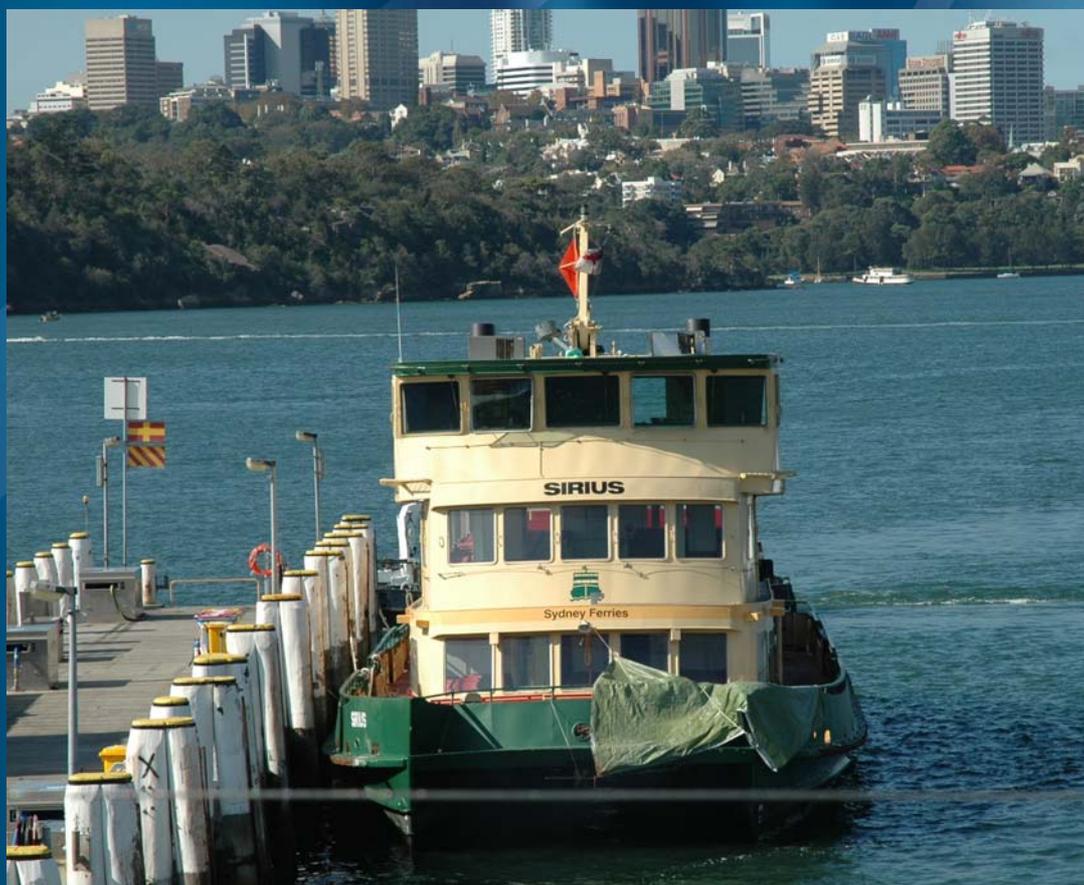
- 1.5 The three incidents of collision occurred in quick succession and at low speed and as a consequence there were no injuries and the resulting damage was largely superficial. *Photograph 1* depicts the approximate points at which the collisions occurred.
