FERRY SAFETY INVESTIGATION REPORT

CLOSE QUARTERS INCIDENT INVOLVING

MV NARRABEEN AND BARQUENTINE *SOUTHERN SWAN*

17 MAY 2013

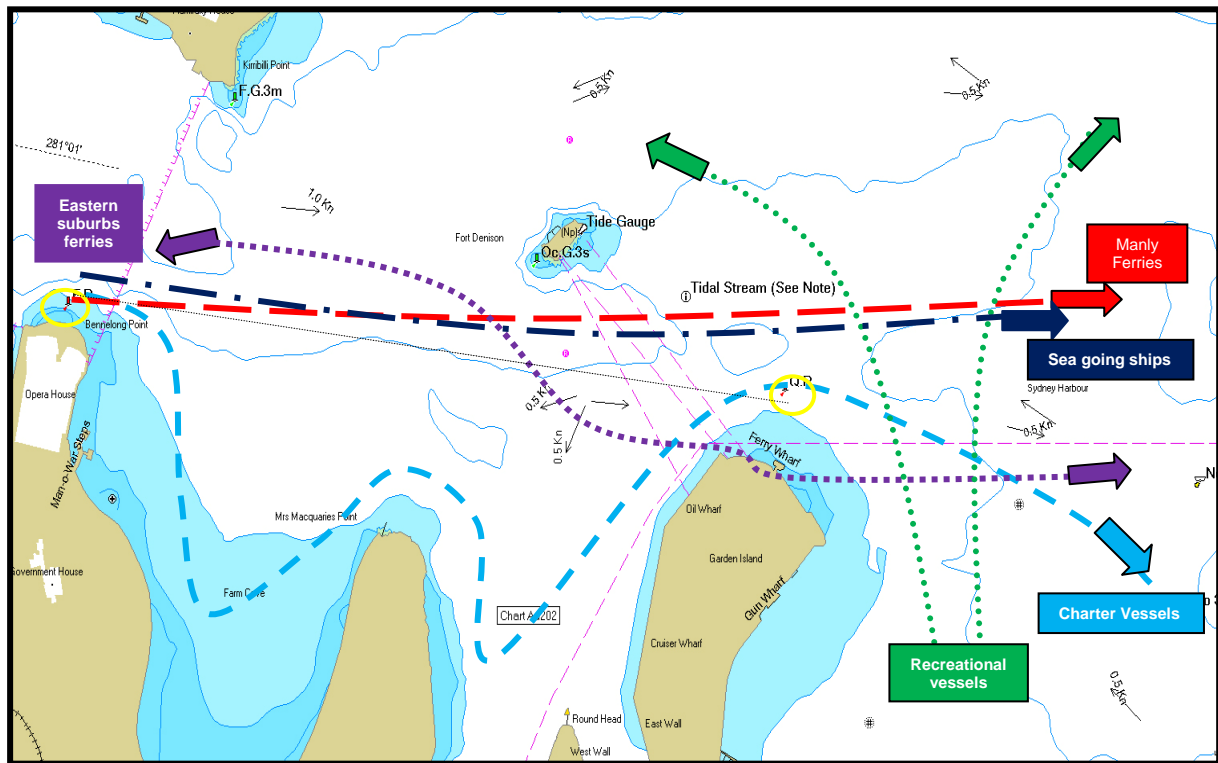
Figure 2: Chart Extract 2 - Traffic routes

- 1.14 Recreational and ferry traffic north of Garden Island can further constrict the manoeuvre room for outbound traffic. Additionally, a large fleet of commercial charter vessels operating within Sydney Port traverse this area to enable passengers to enjoy foreshore views including the Opera House, Botanic Gardens and the city beyond. These charter vessels keep to the south following the southern shore line as they travel east (see Figure 2).
