FERRY SAFETY INVESTIGATION REPORT

STEERING LOSS *OCEAN RIDER*

SYDNEY HARBOUR

5 MAY 2016

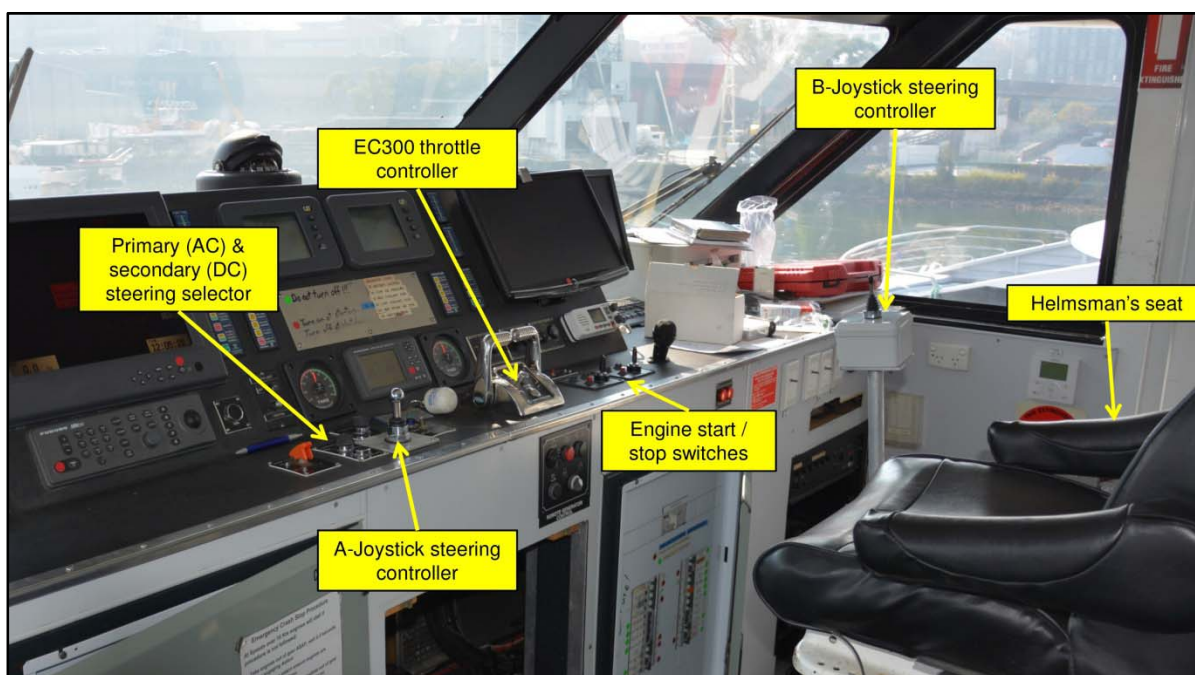
Figure 4: Main helm position

- 1.6 The mate, standing to the right of the master, was able to restart the port and then the starboard engines utilising the engine start / stop switches on the helm's dashboard (see *Figure 4*). The mate then selected astern gear which slowed and stopped *Ocean Rider* from colliding with *Collaroy*.

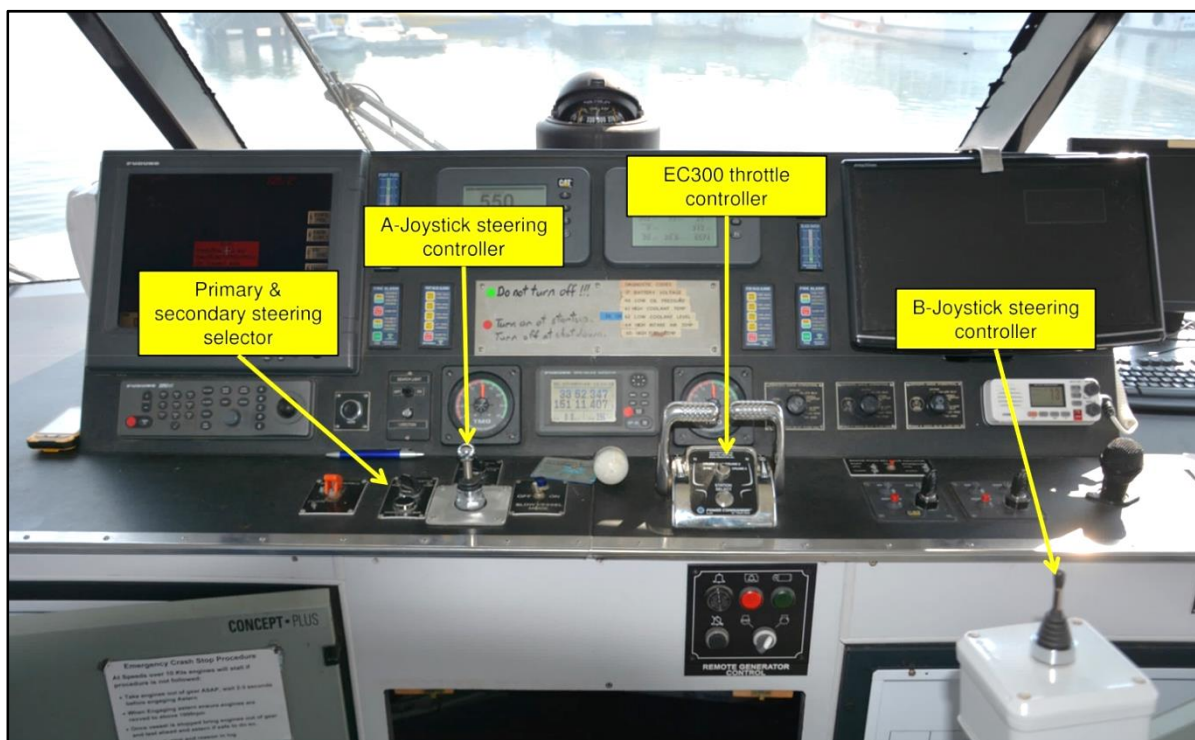
Figure 7: *Ocean Rider* dash layout

- 1.20 *Ocean Rider* is primarily steered through the controller (B-Joystick) located next to the helmsman's seat, or alternatively through the dashboard controller (A-Joystick) adjacent to the EC300 throttle controller (see *Figure 7*).

- 2.2 The master stated that he was controlling *Ocean Rider* from the centre wheelhouse position. Steering was performed by the use of B-Joystick situated on the right hand side of the helmsman chair. The engine throttles and gear selection were on the dashboard in front of the helmsman's chair position (see *Figure 7*). The master stated that the rudders went abruptly to starboard without any control input from him.

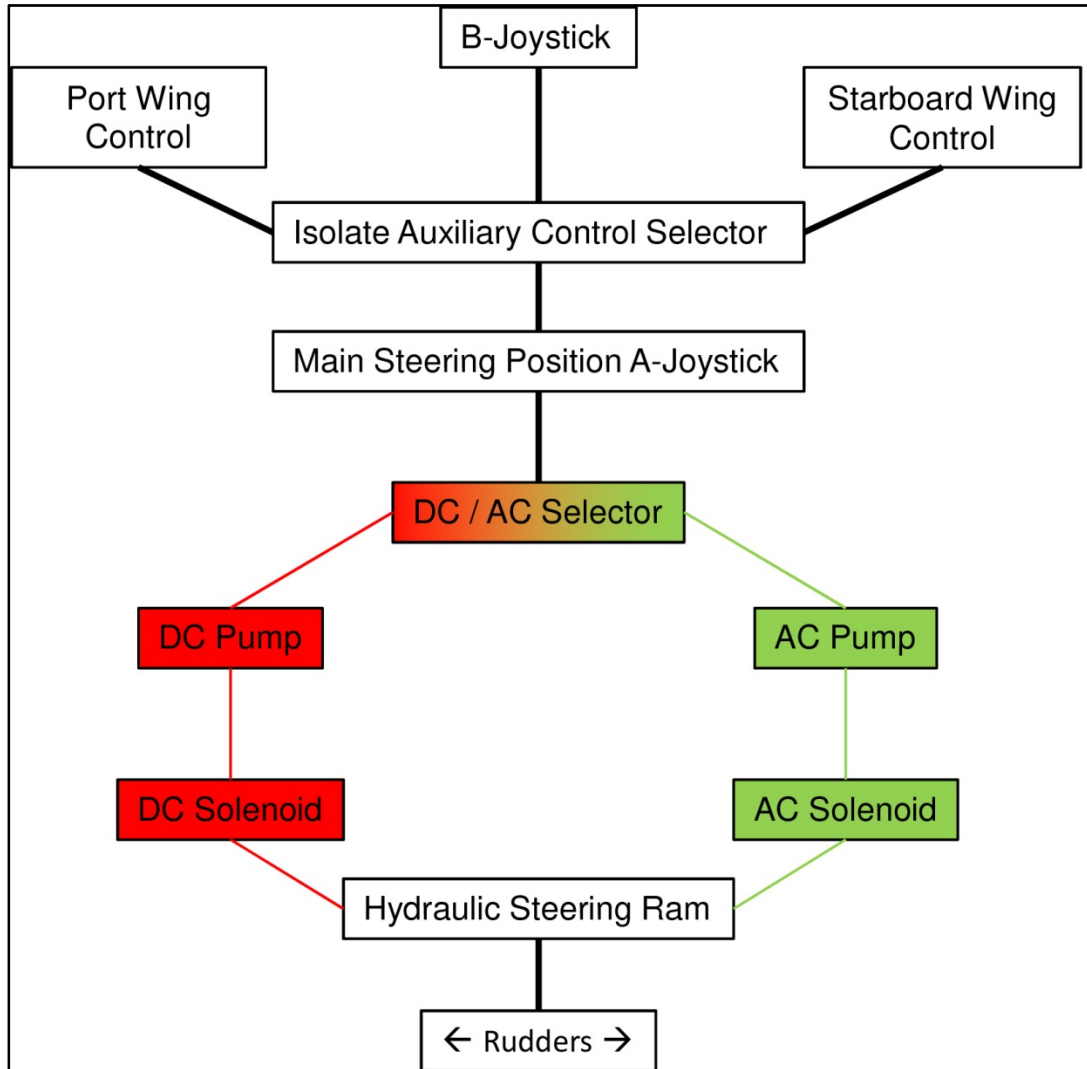
Figure 8: Steering system

- 1.25 *Ocean Rider* has two rudders, one at the stern of each hull. The rudders are moved by hydraulic pressure in unison. Their range of movement is 38° either side of the ferries centre line. Hydraulic fluid is pressurised by either of the two electric pumps, the primary AC or the secondary DC (see *Figure 8*).

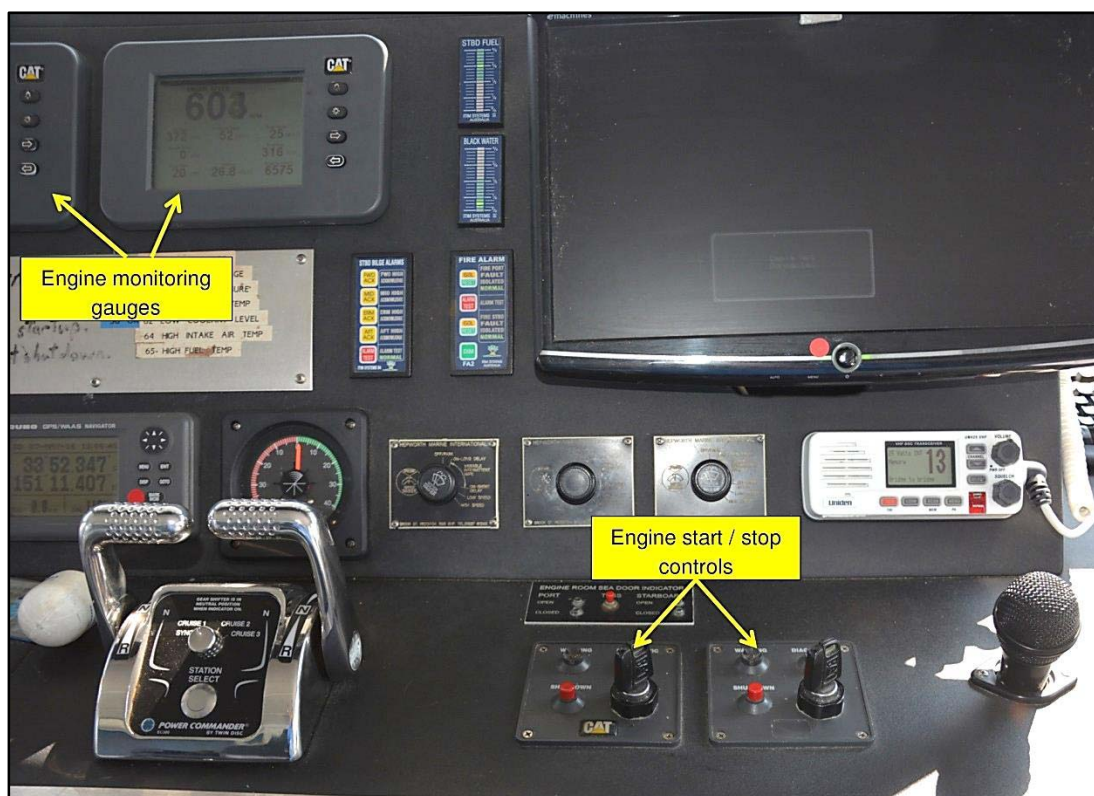
Figure 9: Engine start / Stop switches

- 2.5 The mate described that while the master was focused on regaining steering control, he realised both engines were stalled by looking at the engine monitoring gauges. The mate then restarted both engines by utilising the start switches on the right side of the dash (see *Figure 9*).
