**Office of Transport Safety Investigations**

## **FERRY OCCURRENCE: FACTUAL STATEMENT**

***OCEAN WAVE* LOSS OF CONTROL**

**9 JUNE 2016**

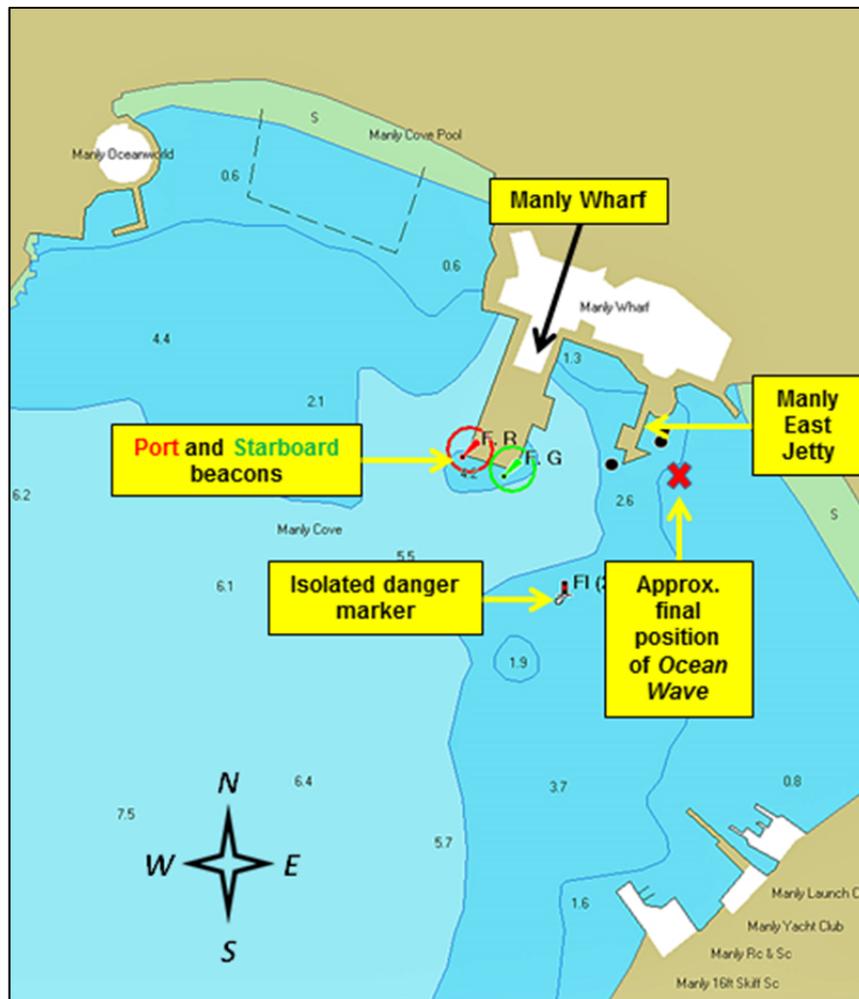
**Figure 1: Incident location.** Image courtesy of Garman® Bluechart

Manly Wharf and Manly East Jetty are both located within Manly Cove in Port Jackson (Sydney Harbour) (refer to *Figure 1* which shows the relative position of navigational markers and the vessel within the Cove).
