FERRY SAFETY INVESTIGATION REPORT

**COLLISION INVOLVING SYDNEY FERRIES VESSEL
MARJORIE JACKSON**

BALMAIN SHIPYARD

2 AUGUST 2010

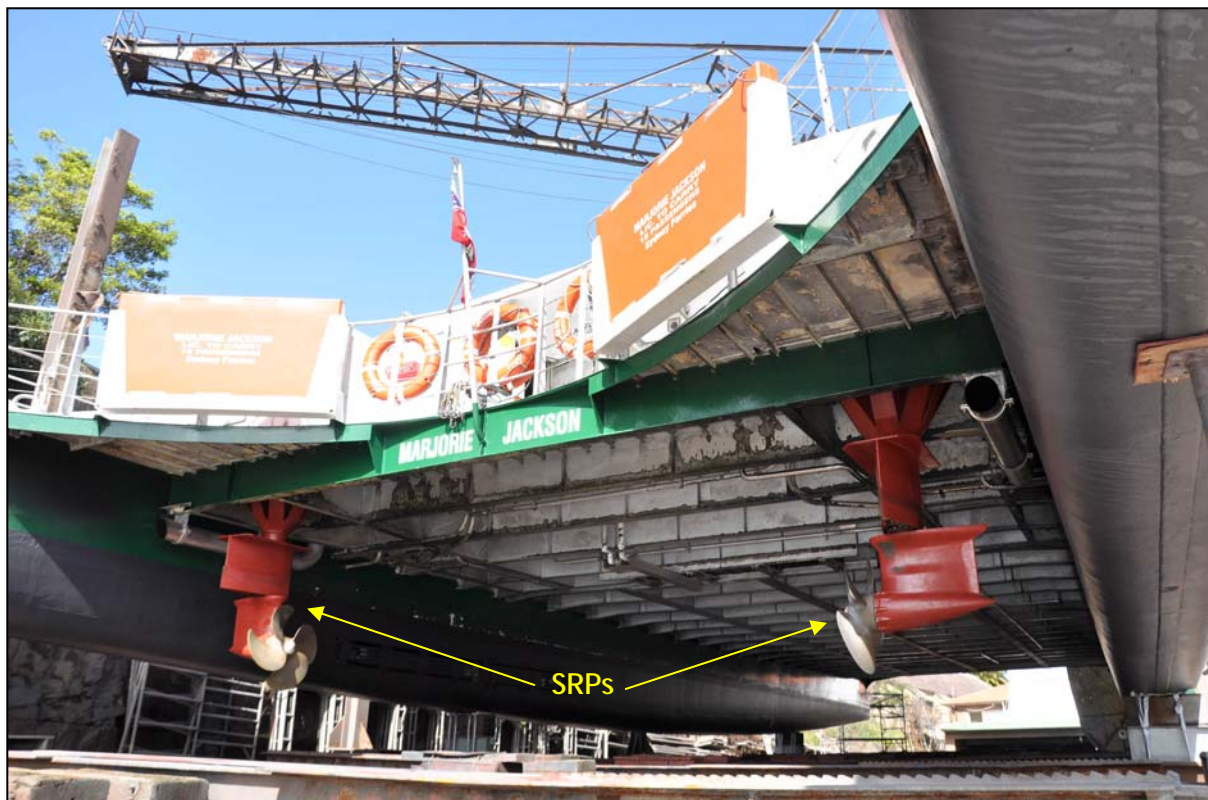
Photograph 3: Bottom-up view of SRPs on the *Marjorie Jackson*

- 1.10 Propulsion is by way of twin 372.8 kW engines driving Schottel steerable rudder propellers (SRP) (see *Photograph 3*). The engines and auxiliary generators are situated with the SRPs at the rear of both hulls. The SRP is similar to an outboard motor leg but it operates in reverse. The propeller sits in front of the leg in the direction of travel, effectively pulling the leg through the water, whereas the propeller on outboard motors is at the rear of the leg and pushing the leg forward.

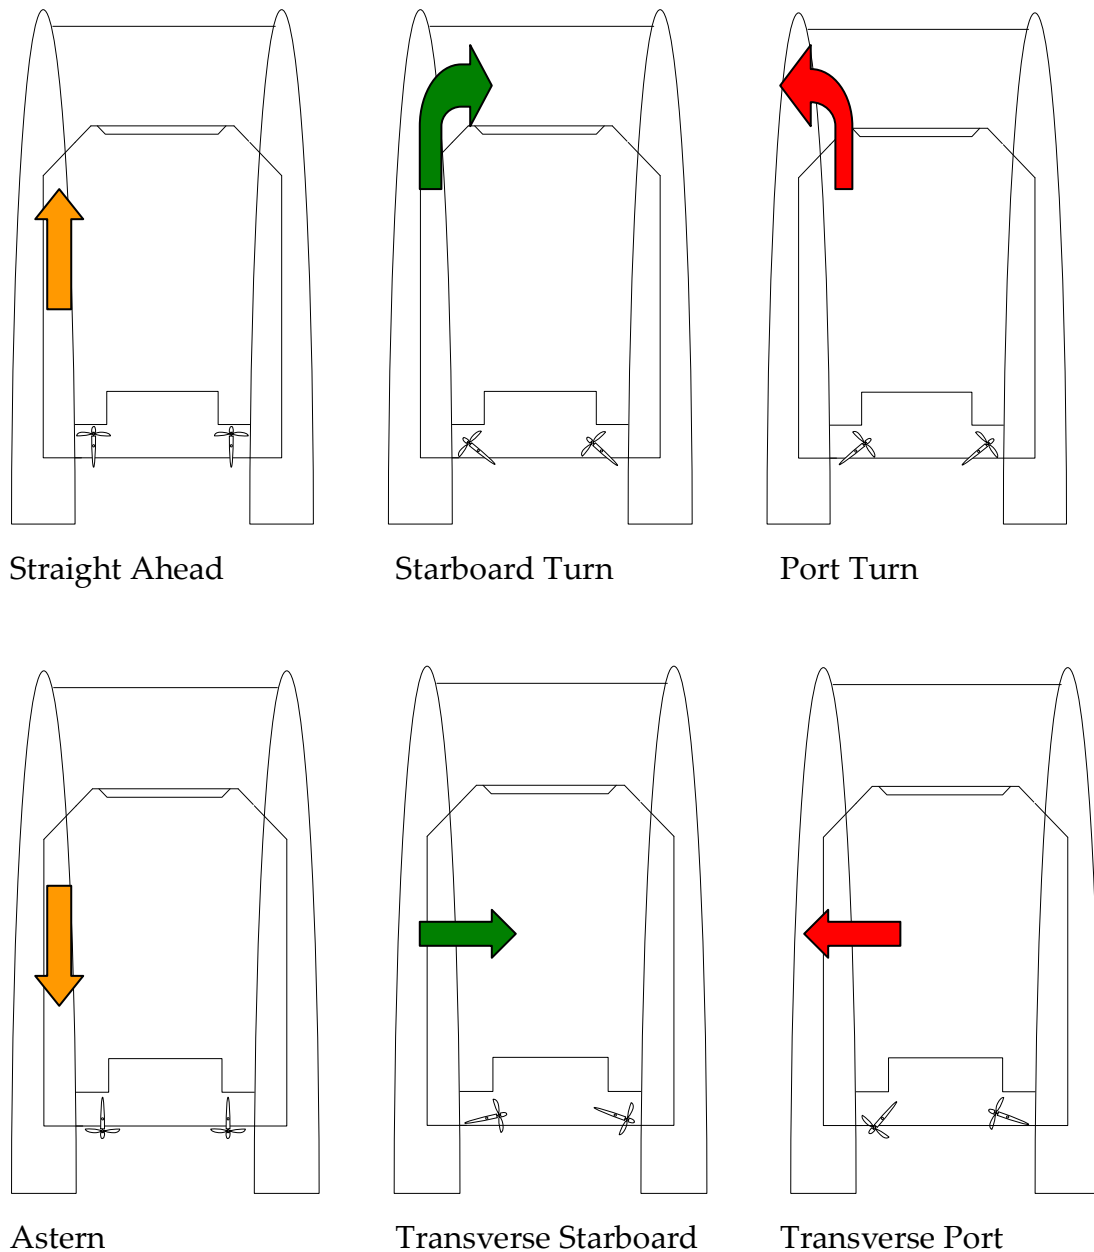
Figure 1: Thrust vectors and vessel responses

- 1.11 The two legs can be independently steered through 360° providing exceptional manoeuvrability. *Figure 1* illustrates how the thrust vectors of each SRP influence vessel movement.

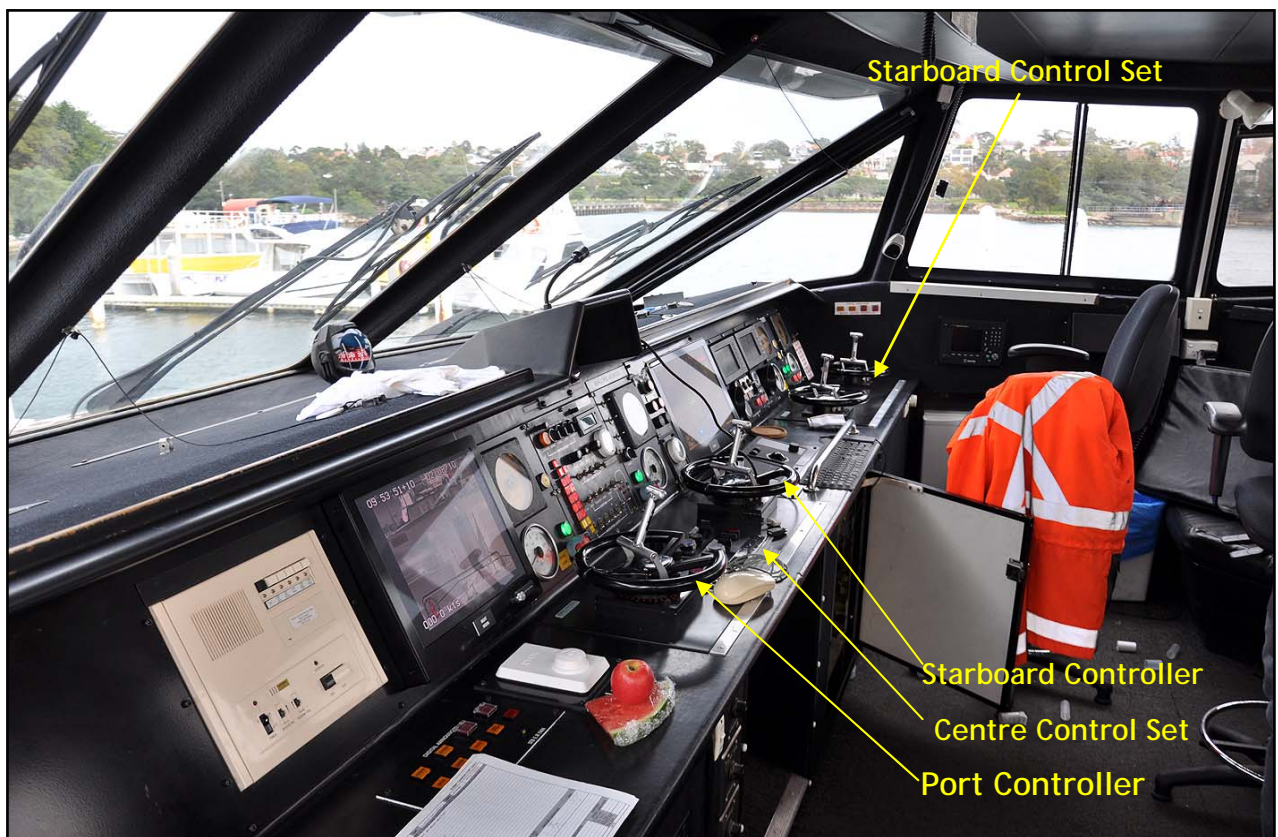
Photograph 4: Controller layout

- 1.14 There are three groups of controls in the wheelhouse of the RiverCats. The centre control station is the master control station consisting of a port and a starboard controller. These controllers are duplicated on the port and starboard sides (wings) of the control console thus enabling the Master to move to either position to gain a clearer view of a wharf on approach during docking (see *Photograph 4*). The controllers are designed and manufactured by the Dutch company, Kwant Controls.

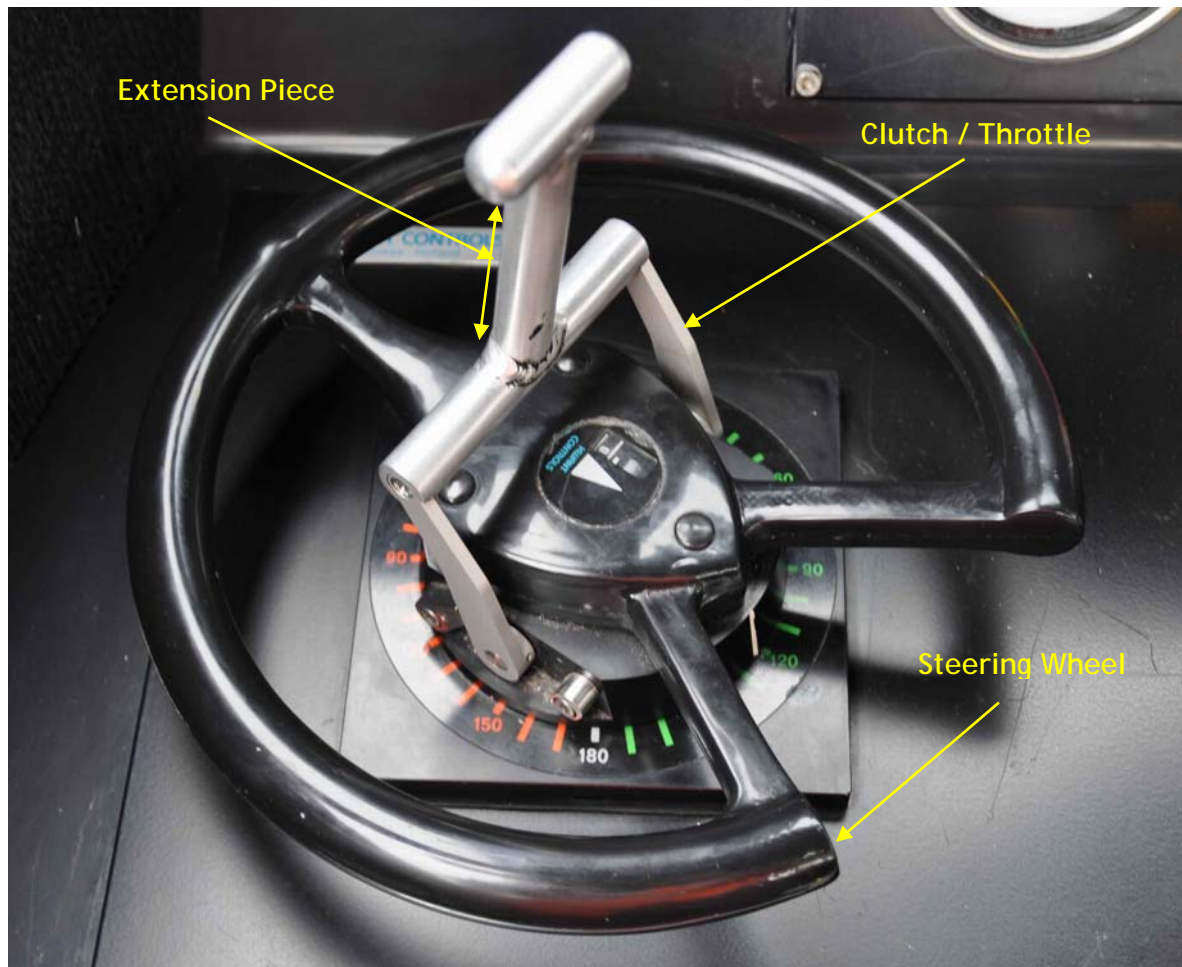
**Photograph 5: Kwant control wheel**

- 1.15 Controllers rotate through 360° and have a throttle / clutch lever in the centre (see *Photograph 5*). As the control lever is moved forward, a micro-switch inside the control head engages the clutch and further movement forward of the lever provides a signal to the engine management unit to increase engine speed.
